AirMaintenance

The Magazine for Aircraft Maintenance Professionals

December - January 2023
Volume 21/Issue 4

TC Feedback

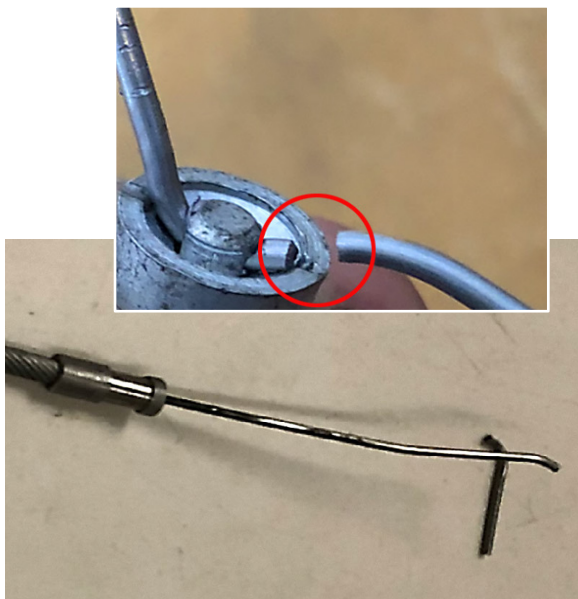
Below: Fracture located at swivel fitting connection.

Bottom: Broken fuel selector valve control cable inner wire.

Although the fuel selector valve control cable had been recently inspected prior to the incident, the defect was not uncovered at that time. The fuel selector valve control cable inner wire fractured under the crimping cup of the swivel fitting. It is important to remain vigilant and avoid complacency when completing all maintenance, with special attention to the requirements of an AD.

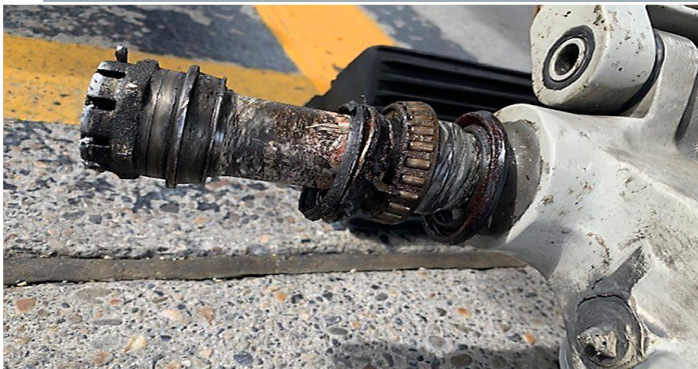
Above: A SAAB 340B in flight.
Left: The axle with the remainder of the wheel bearings after the wheel departed the aircraft on takeoff.

The pilot conducted an emergency landing. The maintenance crew inspected the nose landing gear and found that the nose wheel assembly bearing mount was still on the nose landing gear axle. The nose wheel axle was damaged. Upon inspecting the nose wheel bearing, it was suspected to be inadequately greased, causing bearing failure.

There have been a number of wheel bearing failures on a number of different aircraft models. Maintenance personnel are advised to ensure that wheel bearings are properly greased and torqued to specifications published by the manufacturer.

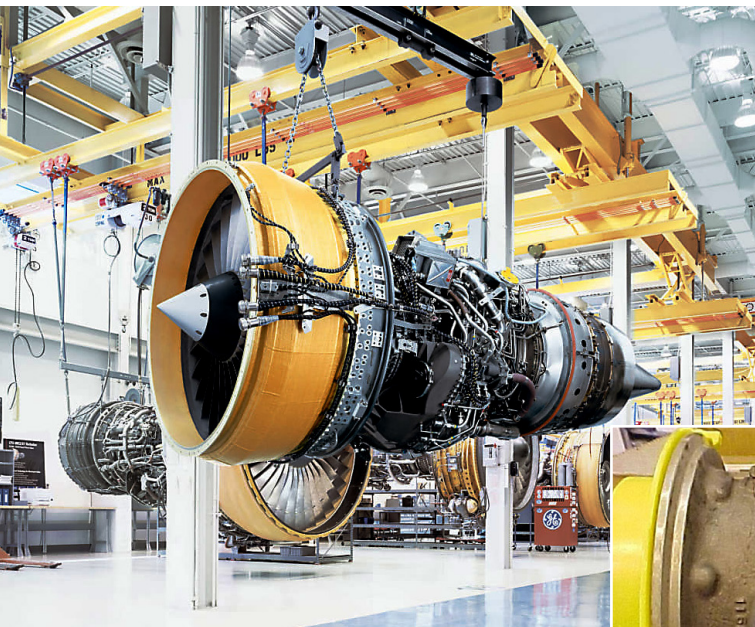
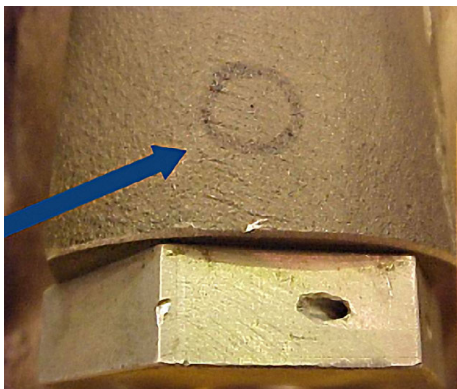
General Electric: Above, and Right: Main fuel pump secondary housing. Below right: Pinhole at secondary housing.

During a routine inspection, fuel was discovered in the lower engine cowl. Upon further investigation, it was discovered that the engine-driven fuel pump had developed a small pinhole in the inlet case allowing boost pump pressure to leak from the pump body. The affected pump was replaced, and the aircraft returned to service.

We have received several Service Difficulty Reports (SDRs) related to fuel leaks from a pinhole on this particular fuel pump part number. The leakage is attributed to a pinhole on the relief valve wall of the secondary housing as a result of erosion caused by the effect of cavitation over the relief valve cavity threads. These leaks may be barely detectable due to the size of the pinhole.

Transport Canada Civil Aviation (TCCA) would like to make operators and maintainers of similar models aware of these events, and urges everyone to be vigilant while inspecting the fuel pump area for leaks.

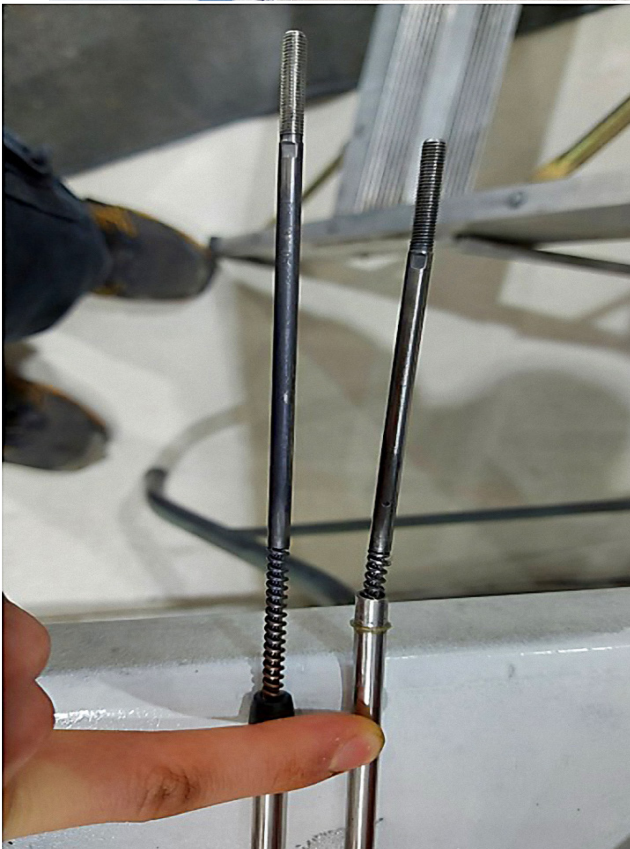
Left: Pilatus, Below left: Difference in cable length from old (left) to new (right).

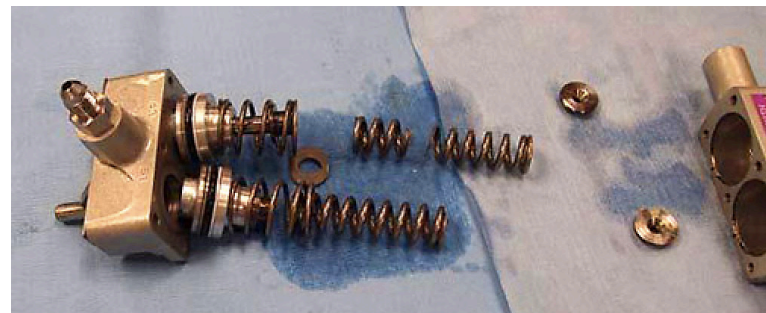
Above: Close up of a broken spring of the BCV.

During an investigation of an aircraft landing overrun, the dual BCV, Tactair part number (P/N) HP1333100-9 (Bombardier P/N 600-75115-9), was found with a broken spring that reduced the brake pressure to the #2 brake. The #2 BCV (position left inboard) was shop tested and found that the brake performance was degraded as the output pressure was 150 psi instead of the normal pressure of 2850 to 3000 psi. During the pre-disassembly visual inspection, the input plunger (rod) on the BVC was found to be recessed and was asymmetrical when compared with the adjacent input plunger (rod). The vendor found that the root cause of this condition was determined to be a broken power brake spring inside the valve assembly.

cluded that the BCV spring failed (due to fatigue) during the incident as braking operation had been normal on the previous landing.

Maintainers and operators should investigate any brake pedal issues reported by the crew as BCVs with high time in service may be prone to spring breakage. To check the integrity of the internal brake valve spring, depress both brake pedals and release. Then perform a visual inspection of the BCV with a light and mirror to confirm the brake valve plungers contact the brake levers. If both valve plungers are contacting the levers, the brake springs are not broken.

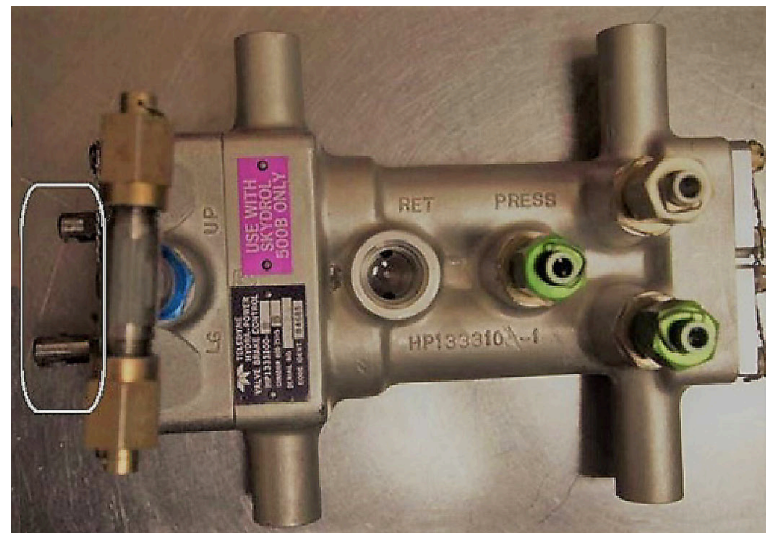
Below: BCV showing misalignment of valve plunger positions.

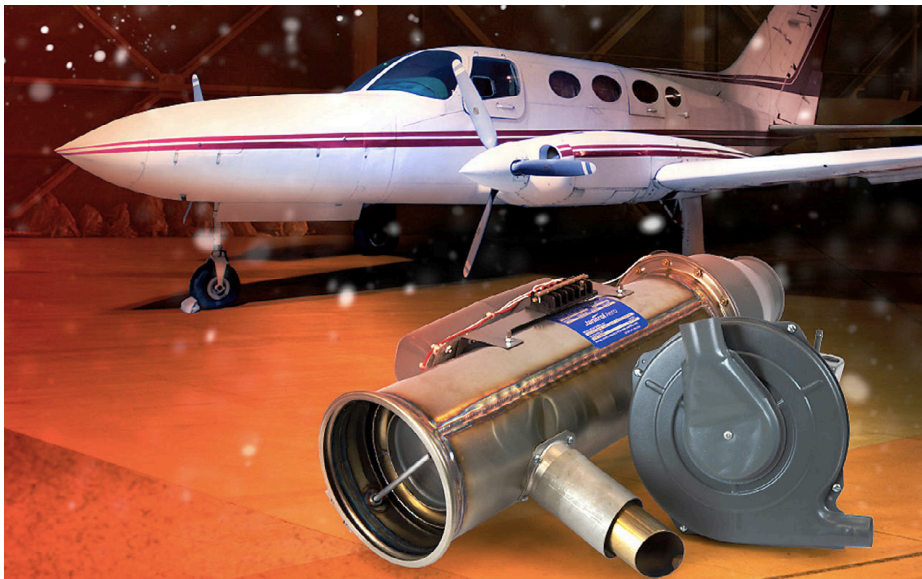
Above: Cracks in the Heater. The heater was never inspected or even disassembled by the NTSB.

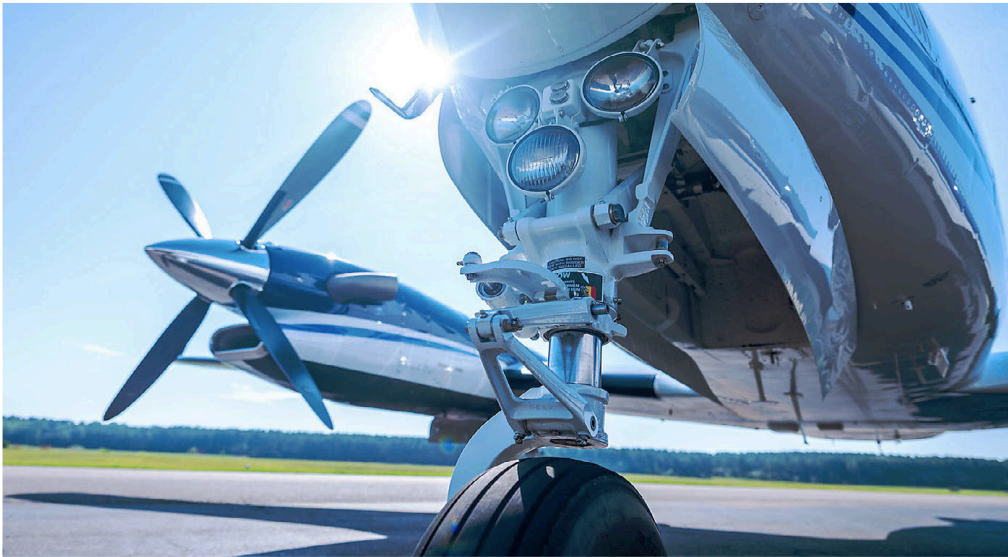
Above: Parts not Available. A twin-engine turbine aircraft was inbound for landing, but the pilot was unable to extend the main landing gear.

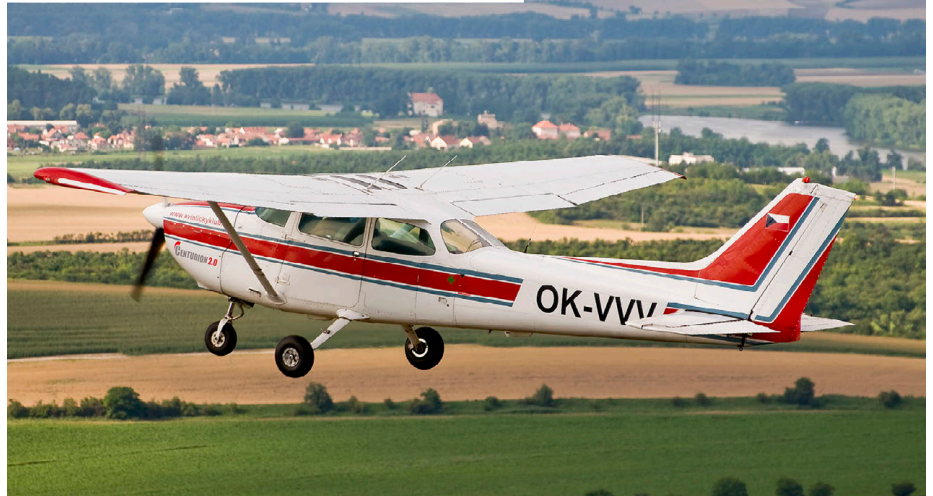
Right: Snagged on the Stop Bolt. A student pilot and certified flight instructor were practicing spins and spin recovery.

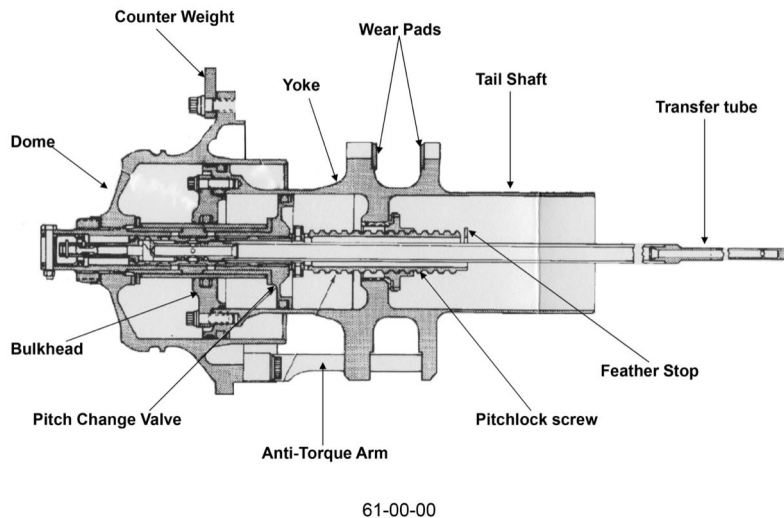
Left: Pitch-change actuator showing pitch lock.

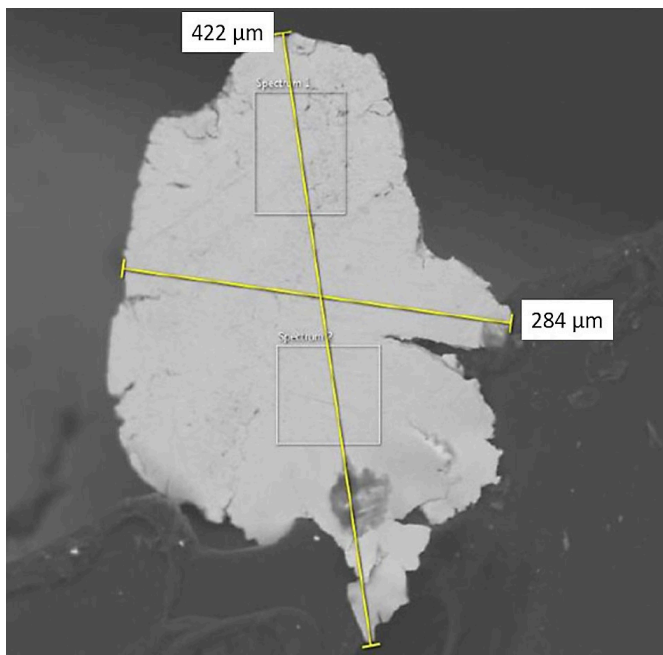
The metal fragment, retrieved from the sealing surface, was composed of a low-grade iron substance not common to the parts tested.
