AirMaintenance

The Magazine for Aircraft Maintenance Professionals

Coatings as an alternative to hard chrome

June - July 2018
Volume 17/Issue 1

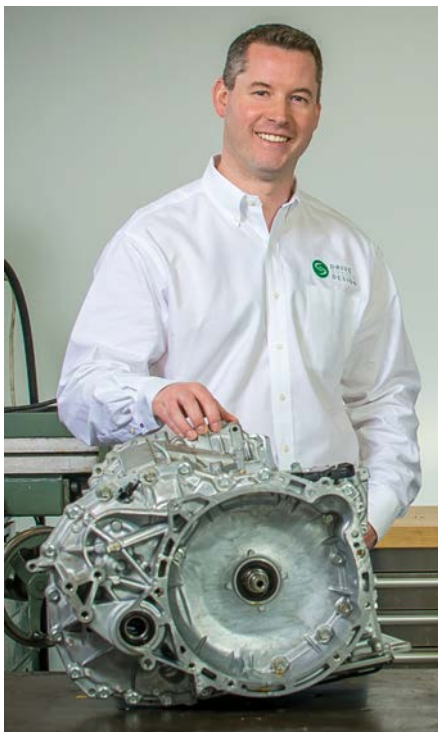
Drive System Design Inc. says its new facility in Michigan will offer a unique approach to the design, test and development of various sub-systems in the aerospace industry. The facility will initially house a loaded gearbox efficiency test rig and will be developed throughout the year to finally include three pieces of gearbox test equipment.

The current rig, which is fully operational, is suitable for various applications, such as layshaft and planetary gearboxes for auxiliary power units and landing gear applications. Further expansion throughout the year will include a hydraulic test stand for hydraulic valve body development and a dynamic tilt rig, which provides enhanced lubrication flow analysis capability.

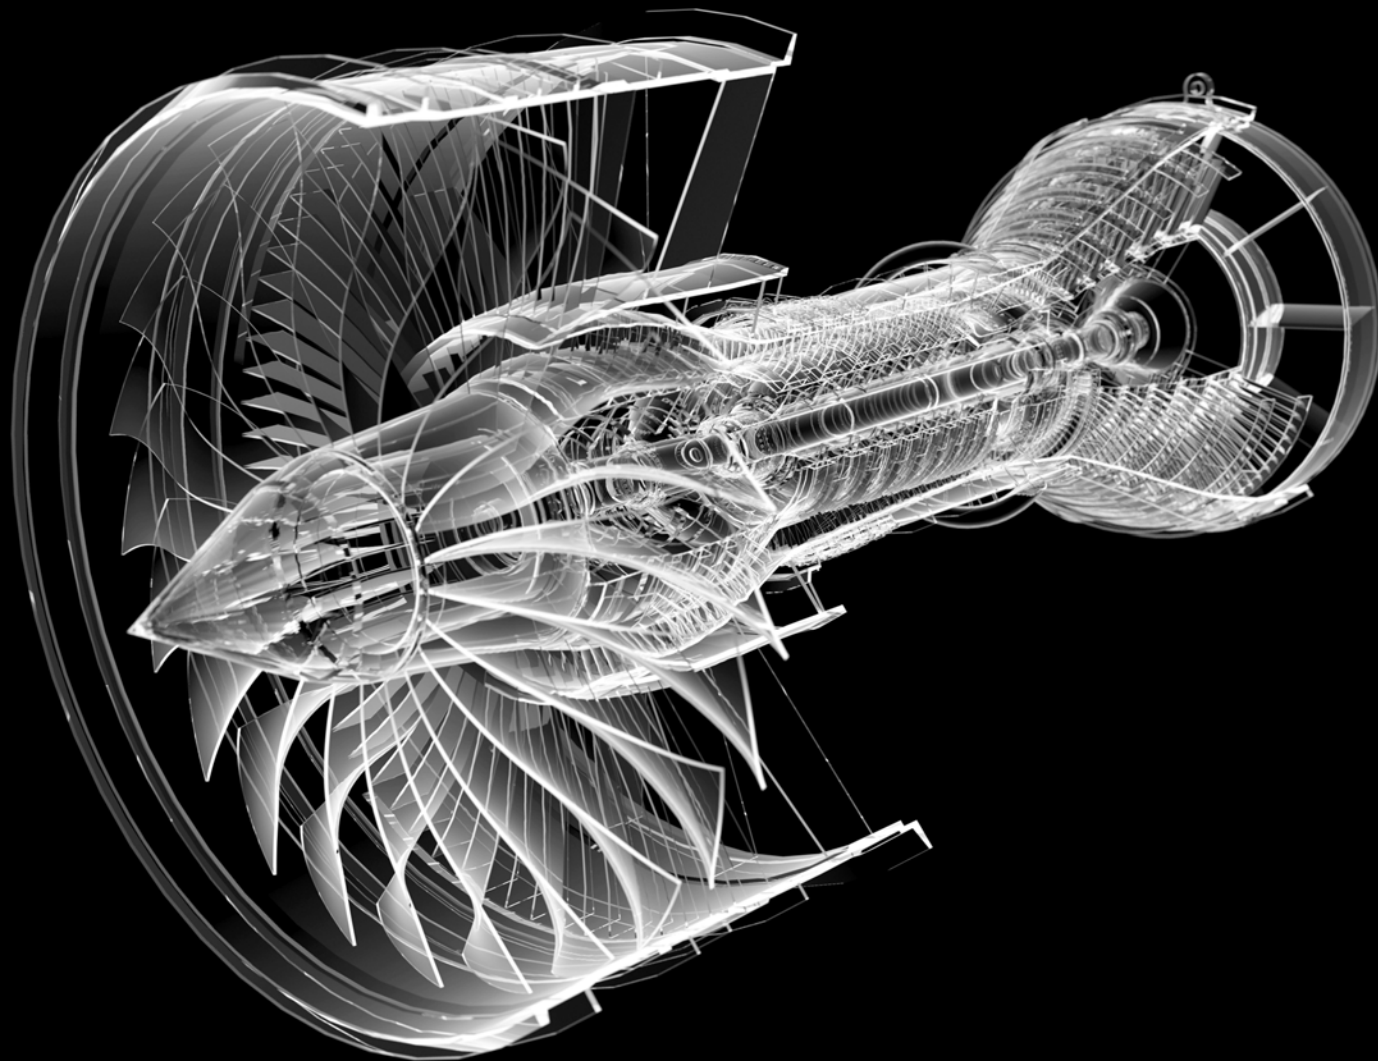
Opposite: In the aircraft industry, the goal is to reduce fuel use as much as possible. **Above:** One PVD coating, called BALINIT Turbine Pro from Oerlikon Balzers, is specifically geared towards protecting engine compressor blades, vanes or integrated bladed rotors.

One PVD coating, called BALINIT Turbine Pro from Oerlikon Balzers, is specifically geared towards protecting engine compressor blades, vanes or integrated bladed rotors (blisks) from erosion, pollution and corrosion. Often, previously these blades are left unprotected. Oerlikon Balzers, a long time coating provider working in the aviation industry for over 20 years, recently achieved NADCAP accreditation at its facility in Guelph, Ontario, which serves the US and Canadian aerospace markets.

BALINIT Turbine Pro utilizes a metal aluminum nitride (MeAlN) structure that results in an optimal relation of high hardness to residual compressive stress even under high thermal conditions. It can be applied to steels, super

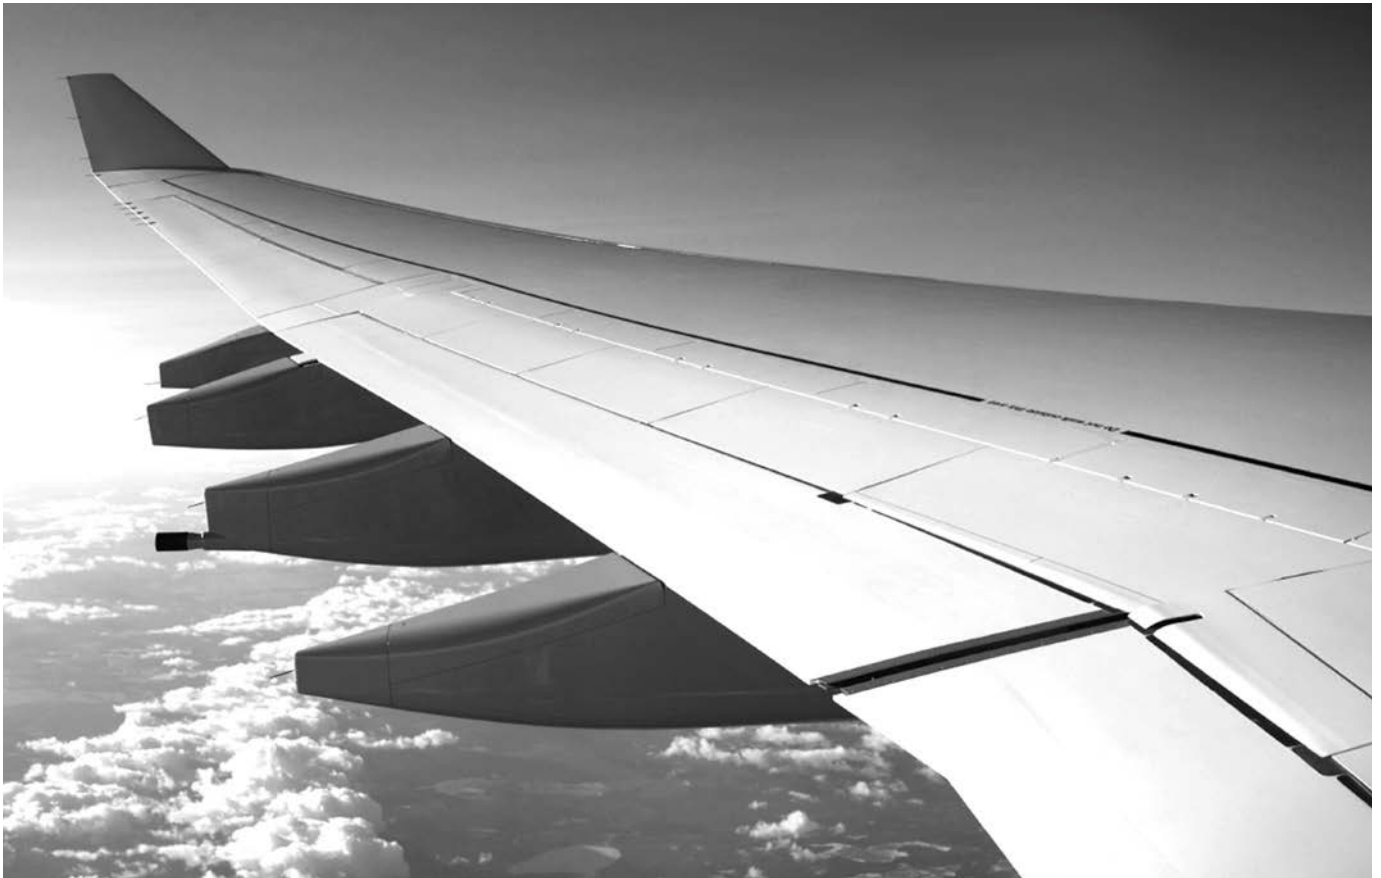
Above: Components must be designed and manufactured to withstand erosion, corrosion, extreme temperatures, and high loads.

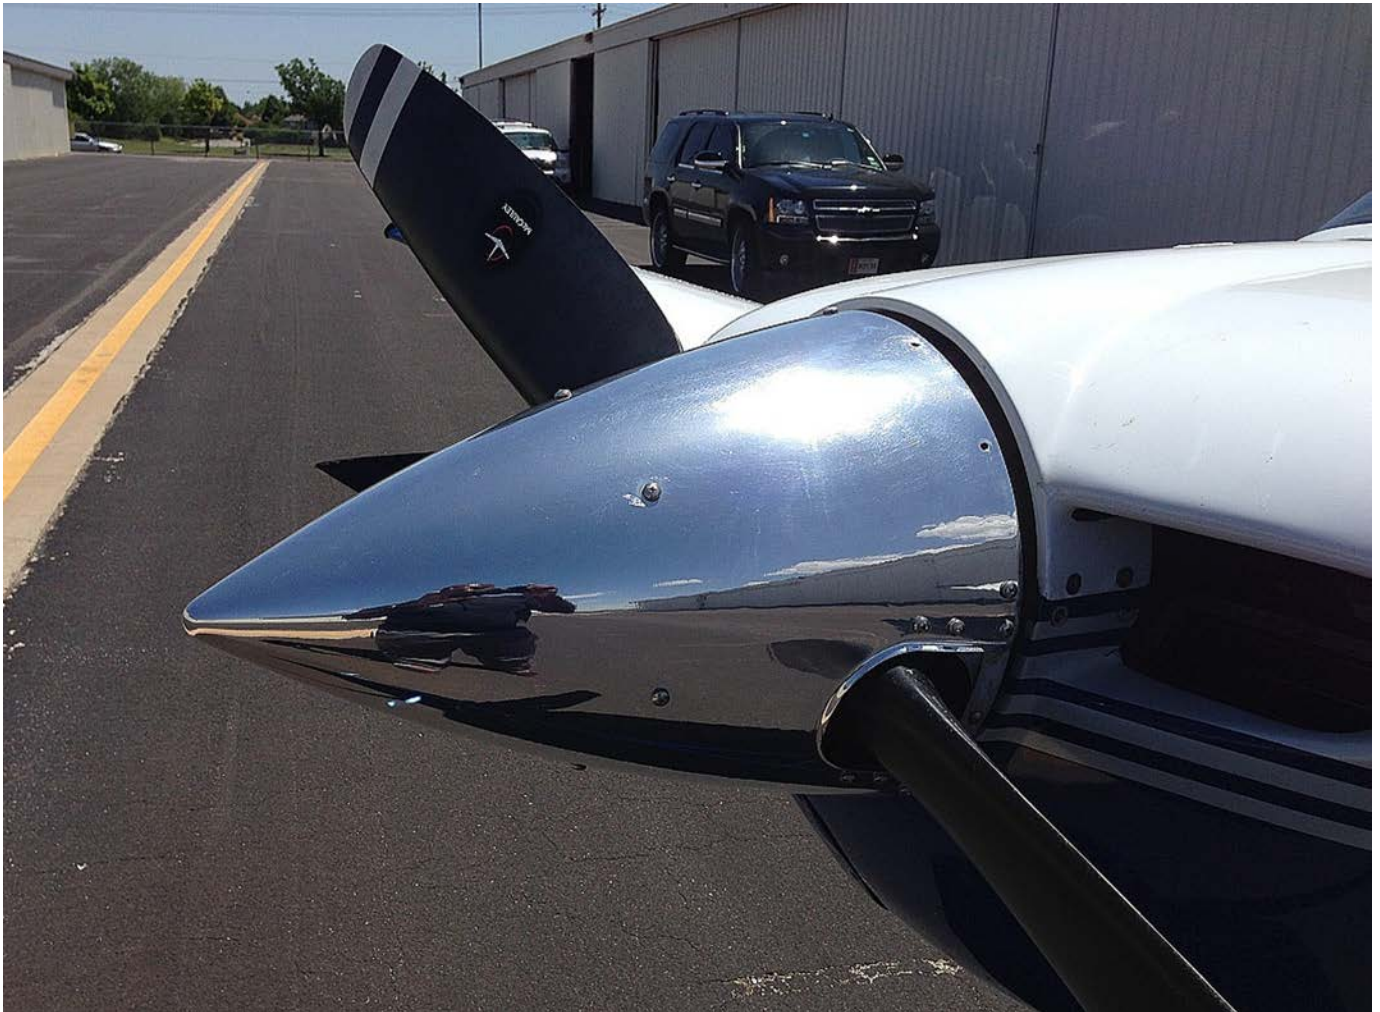
Above: Due to new regulations the application of hard chrome plating is now highly regulated.

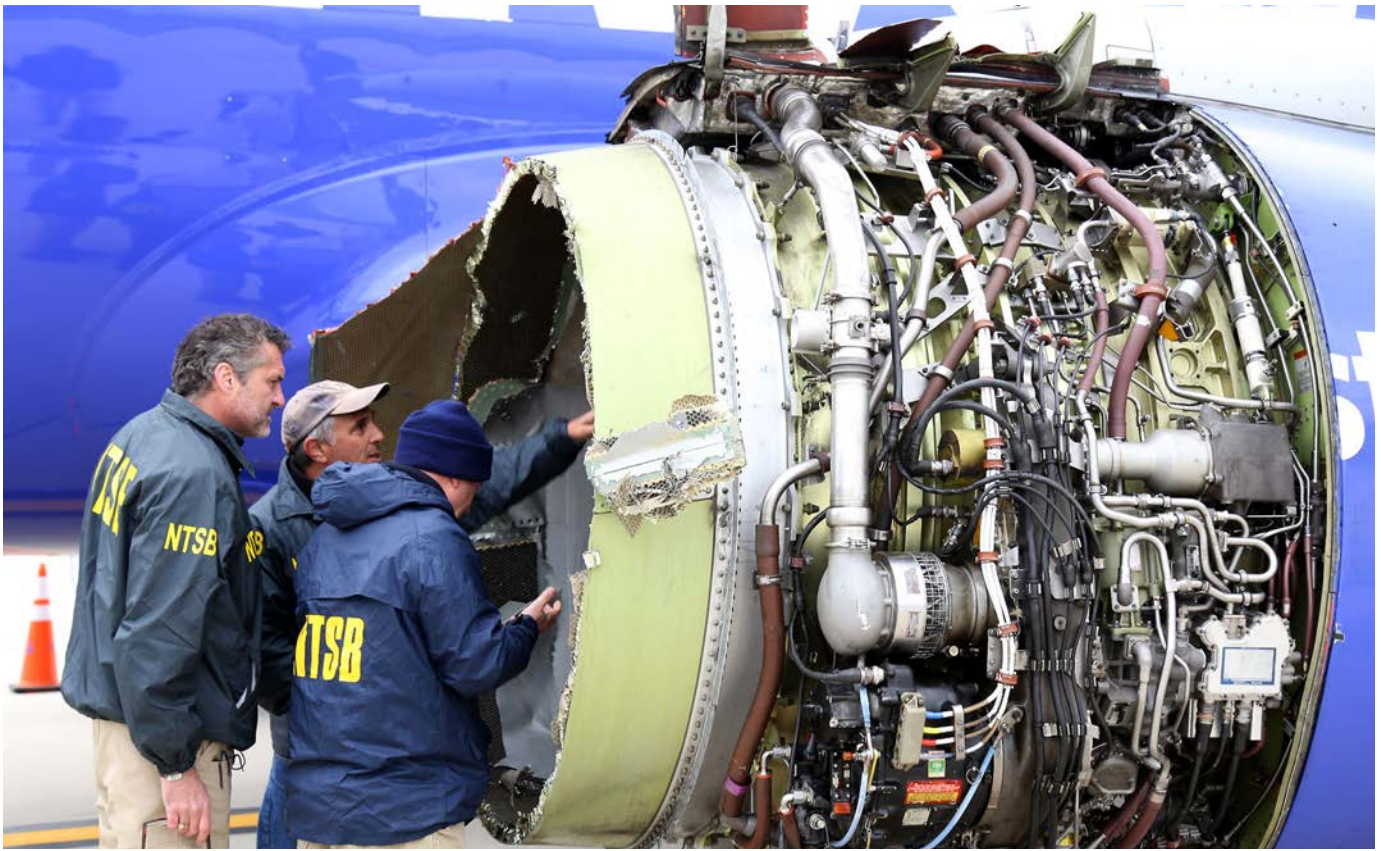
Above: NTSB investigators examine damage to the CFM International 56-7B turbofan engine belonging Southwest Airlines Flight 1380.

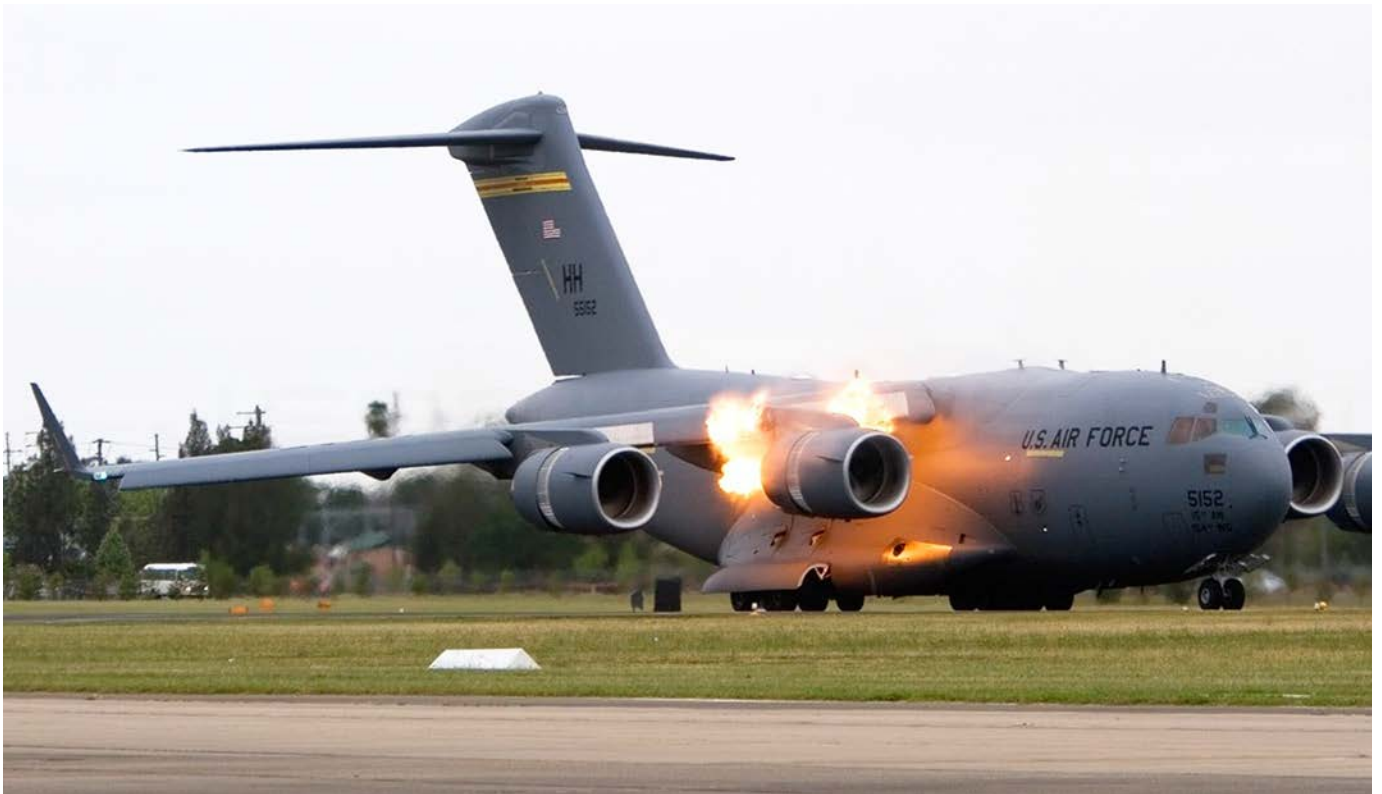
Above: A C-17 with an engine compressor stall during reverse engine operations. Below: An engine's compressor section.

The cause for the compressor surge is often complex and may or may not result from severe engine damage. Rarely does a single compressor surge cause severe engine damage, but sustained surging will eventually over-heat the turbine, as too much fuel is being provided for the volume of air that is reaching the combustor. Compressor blades may also be damaged and fail due to repeated violent surges, resulting in the the engine's inability to run at any power setting.

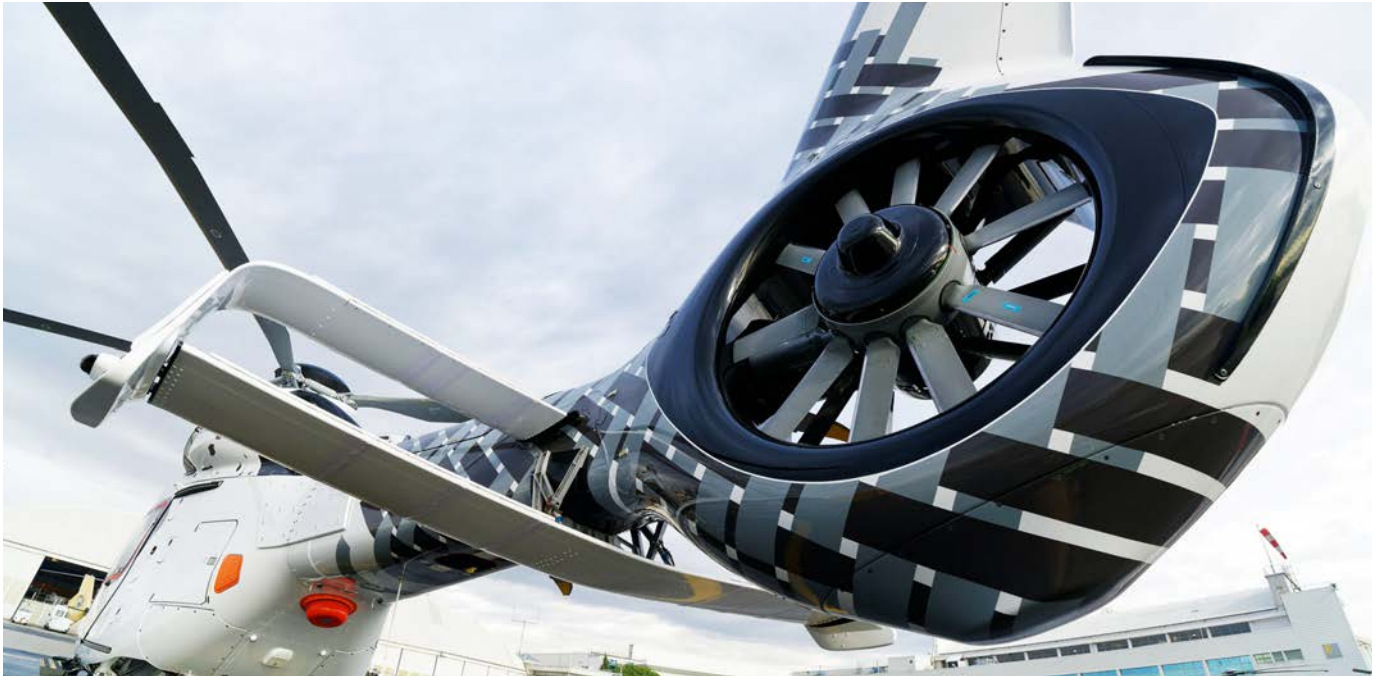
The Little Window's Half-Century

Originally designed as a safety measure, the Fenestron has evolved as critical rotorcraft technology that now celebrates 50 years of steady employment.

This spring marked 50 years since the first Fenestron took to the skies on April 12, 1968 on the second prototype of the Gazelle. It has since become emblematic of Sud Aviation, Aerospatiale, Eurocopter and now Airbus helicopters with the H160 carrying this sound-reducing, safety-enhancing technology into the next generation of rotorcraft. Here, we look back on the history of this seminal rotorcraft technology.

The idea behind shrouding the tail rotor was initially developed to provide additional safeguards for workers on the ground but also to protect the tail rotor in forward flight and in complicated operational environments, such as working around high-voltage power lines. Sound reduction benefits followed after much research and optimisation from one generation of the Fenestron to the next.
