AirMaintenance

The Magazine for Aircraft Maintenance Professionals

2020 Recurrent Training Exam

June - July 2020
Volume 19/Issue 1

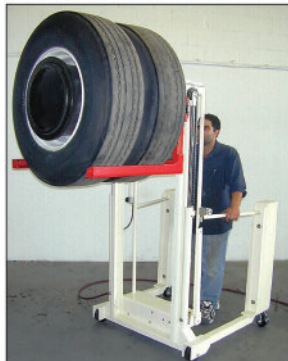
Stertil-Koni's WDA-500 model lift wheel dolly has a telescopic crane arm option that turns this model into a universal lifting tool. The crane arm offers efficiency and stable ergonomics when lifting disc brakes, brake drums, fuel tanks, toolboxes, calipers, and many other heavy parts. It can accommodate wheel sizes from 10.63 to 51.18 inches. The dolly stands 47.17 inches high with a width of 45.28 inches and length of 33.30 inches. Lifting height is 28.23 inches. It weighs 220 pounds. **For more information visit** www.Stertil-Koni.com

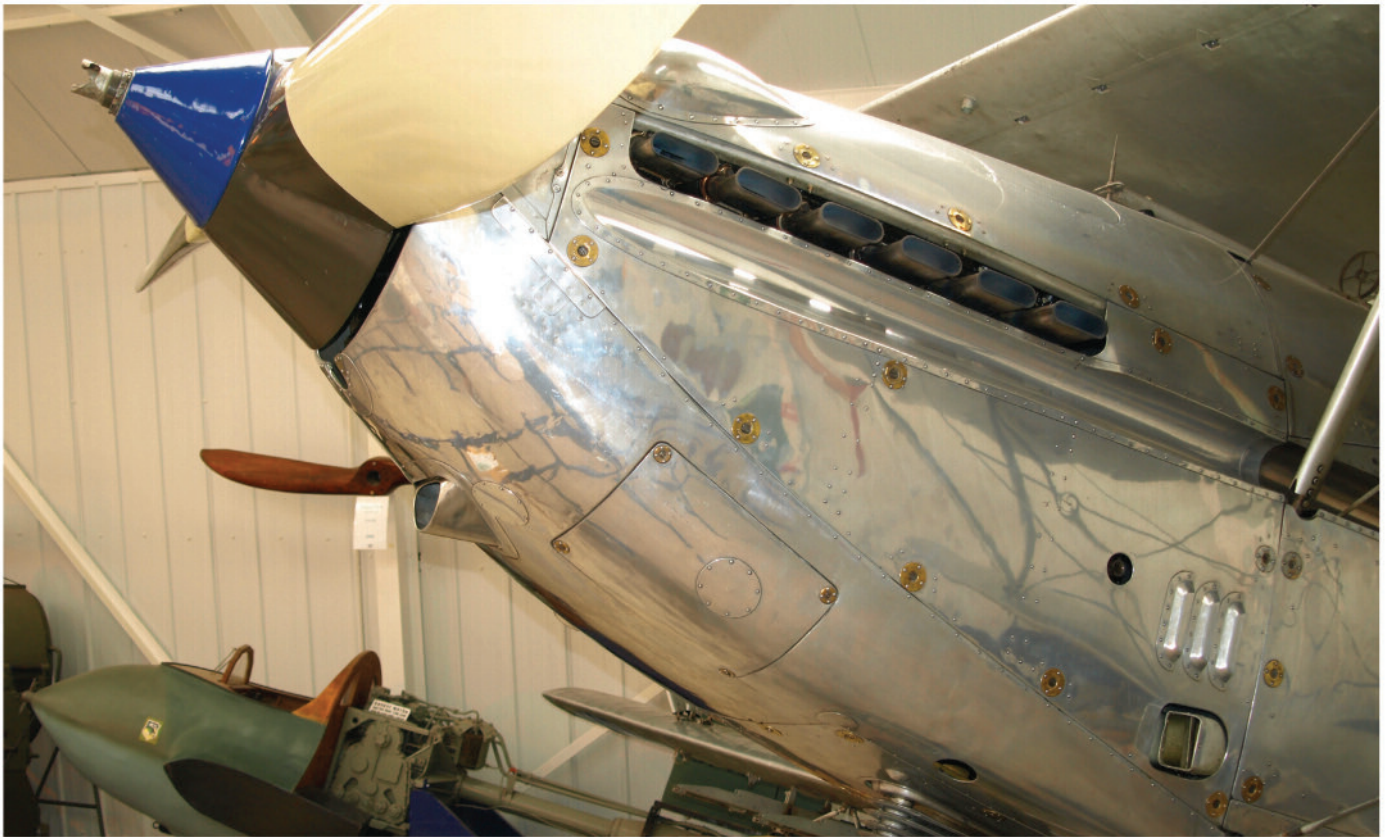
Dzus fasteners attach the cowling panels of the 1930s Hawker Hind.

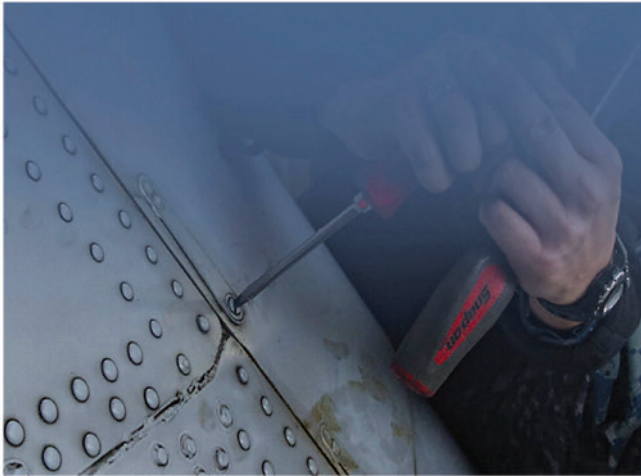
A variety of fastener designs attempt to stop bolted joint loosening.

OEMs have long used a variety of fastener designs that attempt to stop bolted joint loosening through the use of adhesives or added components that physically restrain the bolt or nut from loosening. However, these methods have significant drawbacks.

With mechanical locking approaches, the goal is to physically prevent loosening. However, this often means adding components that increase the size of the fastener and add weight and complexity to component design. For land or air vehicles, “smaller and lighter” affects fuel efficiency, so heavier fasteners are a drawback.

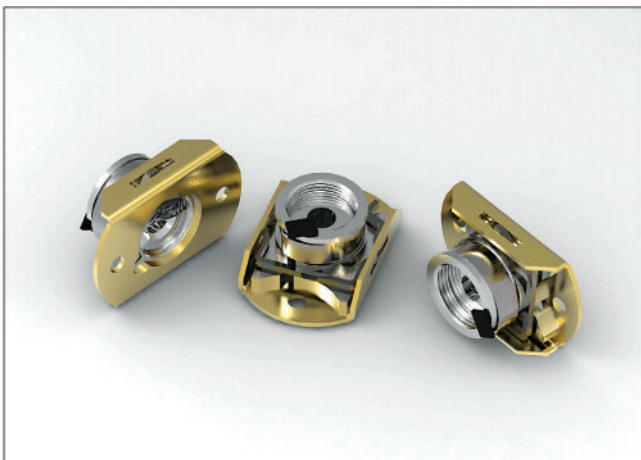
Aircraft panel fasteners with adjustable depth receptacles.

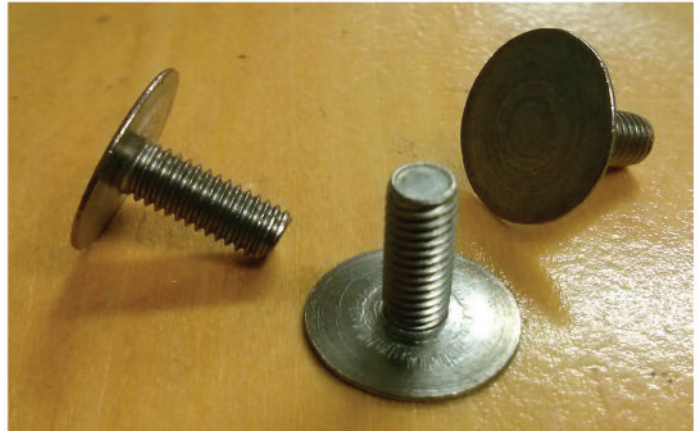
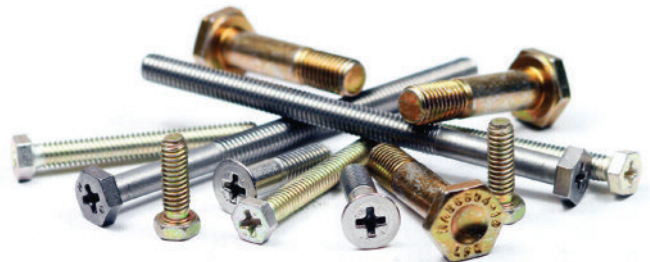
Above: Click Bond fasteners made from 300 Series Crest Stainless Steel (capable of 500 lbs. of pull and 1200 lbs. of shear) for mounting canard ailerons and rudders. Below: A jumble of specialty drilled fasteners and skin fasteners for interior and airframe applications.

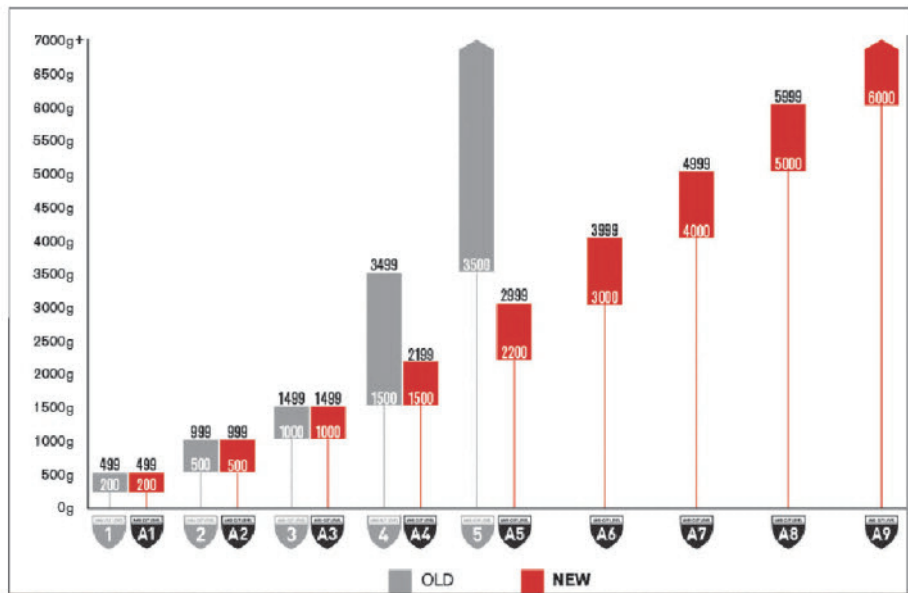
Top, left: When looking at glove specifications, the ANSI cut level will be displayed inside a badge that resembles a shield.

Chart, above: Comparison of new and old ANSI/ISEA cut resistance standards.

The new ANSI/ISEA 105 scale, characterized by an 'A' in front of level numbers from A1 to A9, measures a glove's per-

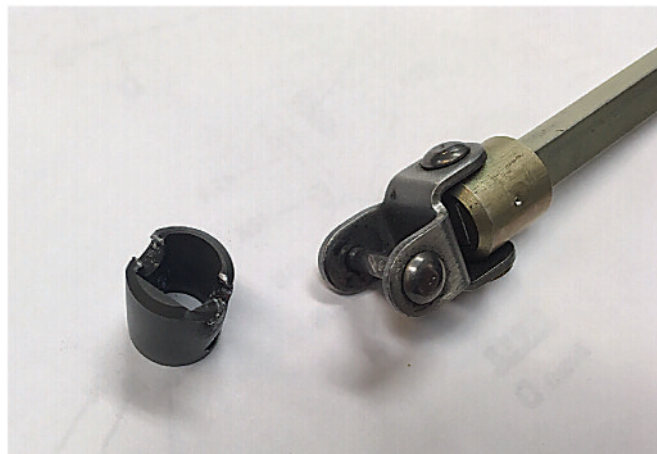
Above: Excessive wear resulting in drive shaft disconnect on a Cessna 172. Below left: A damaged battery from a Bombardier BD 700.

Report: Bombardier BD 700 1A10 Overheated Nickel-Cadmium (Ni-Cad) Battery

Cessna published Service Letter SE71-10 in 1971 highlighting the importance of regular inspections of the fuel selector valve and drive shaft linkage. Transport Canada would

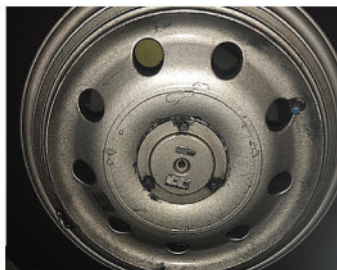
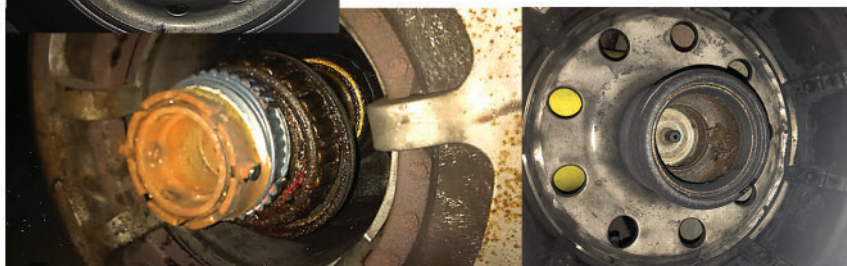
Left: Dassault Falcon. Wheel after being found. Bottom left: Axle showing bearings still there and wheel missing. Bottom right: Inside of wheel showing residual materials from broken bearing. Note the different sizes of bearing races with larger diameter inner bearing.

The aircraft landed uneventfully but the crew reported a significant loss of braking action. During the crew walk around after landing, the right outboard main wheel assembly was noticed to be

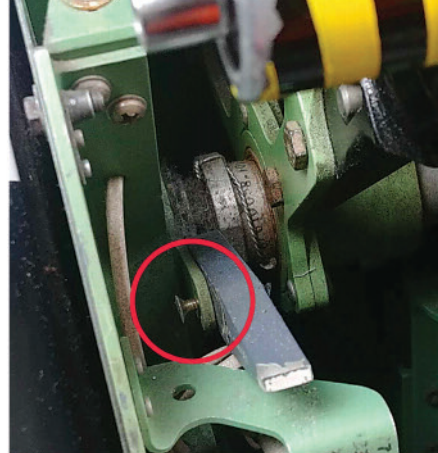
Image shows the screw backed out from the lever.

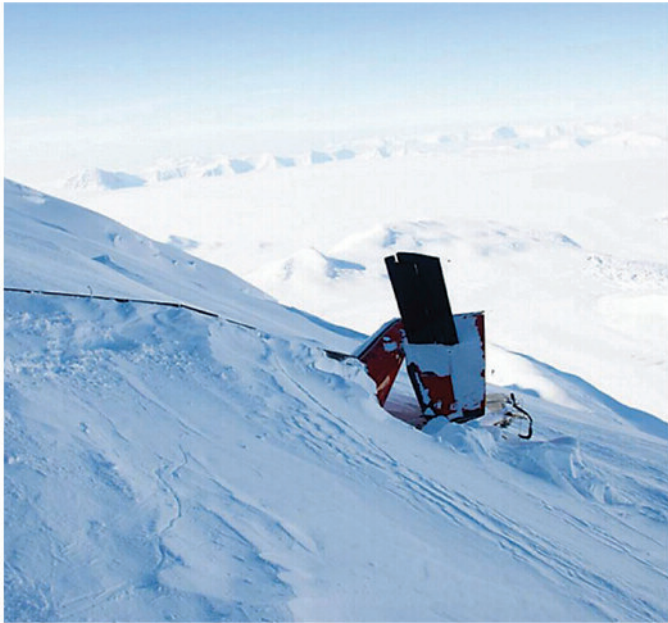
Wreckage of C-GKBC at the occurrence site, looking southeast.

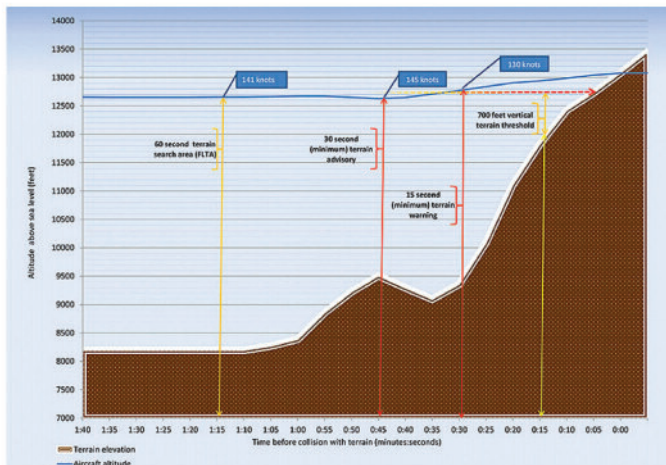
Garmin GNS 430W forward-looking terrain alert and geography advisory and warning criteria.

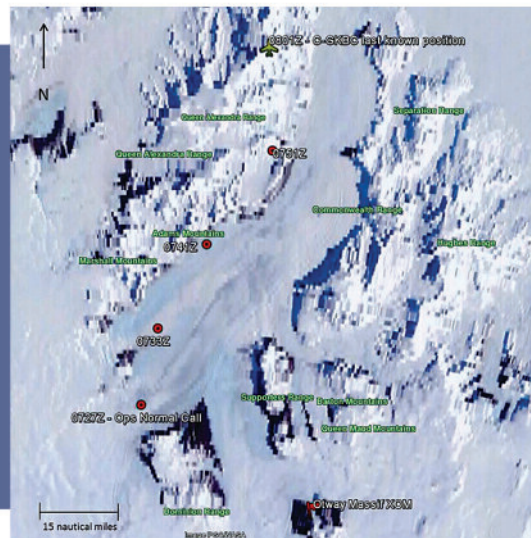
Route of C-GKBC in last minutes of the occurrence flight.

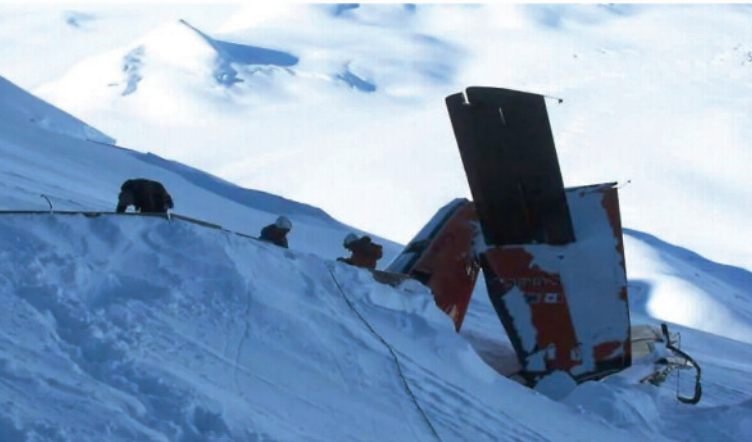
The wreckage from the incident aircraft that crashed in Antarctica on Jan. 23, 2013 killing three Canadians on board. Investigators with the Transportation Safety Board have concluded the cause of the crash may never be known (CBC).
