AirMaintenance

The Magazine for Aircraft Maintenance Professionals

June - July 2021
Volume 20/Issue 1

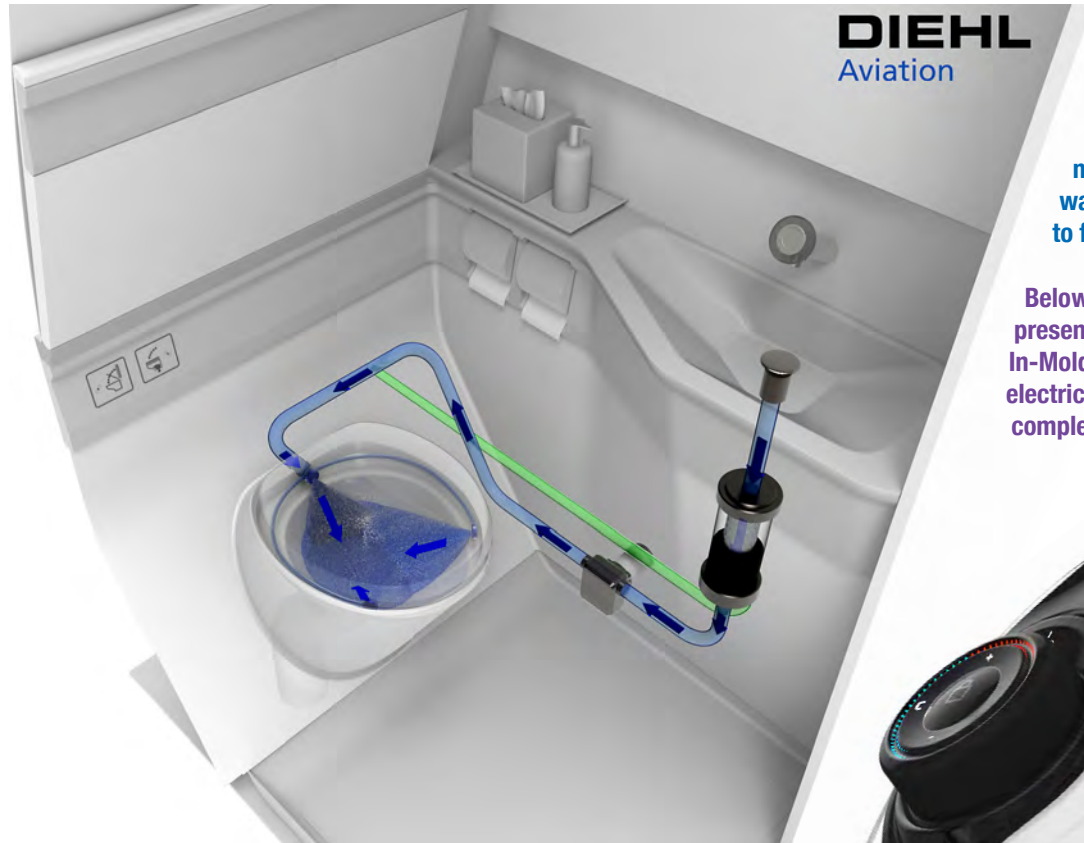
Left: Diehl Aviation's Greywater Reuse Unit makes it possible to re-use water from the handbasin to flush the lavatory.

Below: e₂ip technologies presented a panel based on In-Mold Electronics, surface-printed electrical circuitry that saves on complex, heavy cabin electronics.

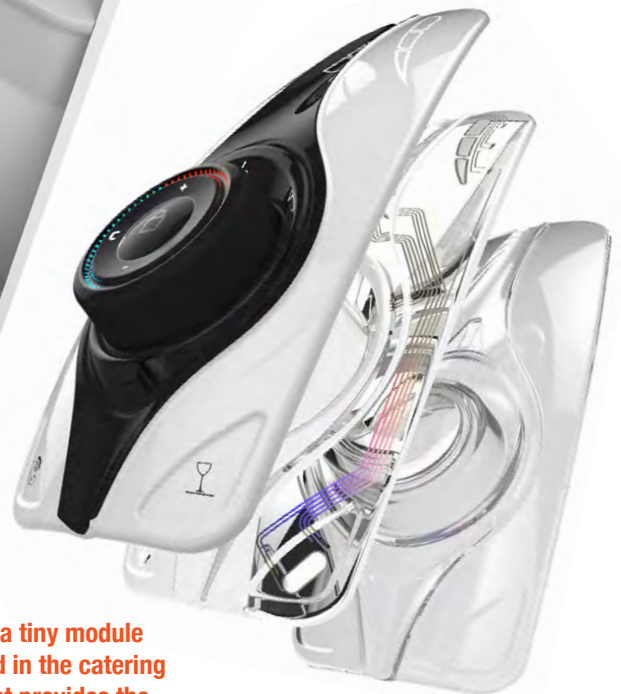
SOPHY is a tiny module integrated in the catering trolley that provides the operator with information on the entire journey of the equipment, from maintenance and cleaning needs to load.

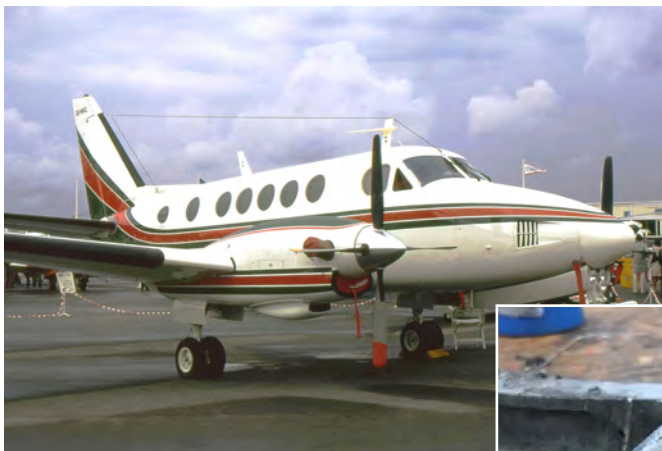
Beechcraft King air. Failure of the rudder pedal arm at the brake pedal pivot holes.

Report: Beechcraft King Air A100 Failure of the rudder pedal arm.

Pilot reported that the aircraft was hard to steer. Maintenance found the pilot’s right-hand rudder pedal arm had broken off where the pedal is attached to the arm.

Beechcraft does include detailed inspection criteria and possible bushing insert repair instructions. Multiple Service Difficulty Reports (SDRs) continue to be submitted regarding excessive wear or failure of the rudder pedal.

Transport Canada Civil Aviation recommends particular attention be given during scheduled inspection. Wear may be difficult to estimate or cracks may go unnoticed while the pedals are still attached.

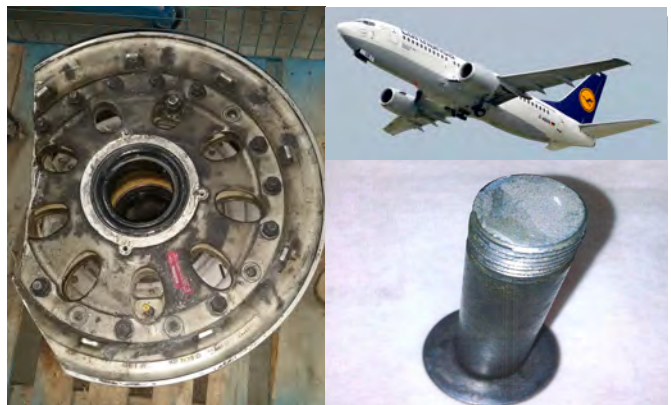
Boeing 737. Wheel showing wheel damage and missing tie bolts. Sheared tie bolt showing fracture at threads.

Report: Boeing 737 Wheel assembly missing/broken tie bolts

During the take-off roll, at approximately 120 to 130 knots, the crew reported that they heard a bang followed by a vibration and decided to reject the take-off. When maintenance arrived at the aircraft, they confirmed that the number 1 and 2 tires had blown and that damage was also found to the wheel halves. The cause of the tire blowout was unknown, but all affected components were changed out and sent to the appropriate vendor for assessment.

The number 1 and 2 wheel assembly halves were found still held together by the tie bolts. The number 1 wheel assembly had four sheared tie bolts and all the bolts appeared to be intact on the number 2 wheel assembly. The wheel fuse plugs on

1. All bolts were evaluated and met specifications for hardness, coating and material (H-11 steel) with no indications of a batch or quality issues.
2. The cause of the six fractured bolts was found to be fatigue. Four bolts were found with cracks initiating from the 8th to 9th thread root and two bolts were found with cracks initiating from the under-head radius transition area.
3. No abnormal cause of the fatigue cracking was detected (corrosion, mechanical damage).
4. Overload fractures detected on three of the six bolts were assumed to have occurred during the take-off roll.
5. No indication of bolt stretch was observed.

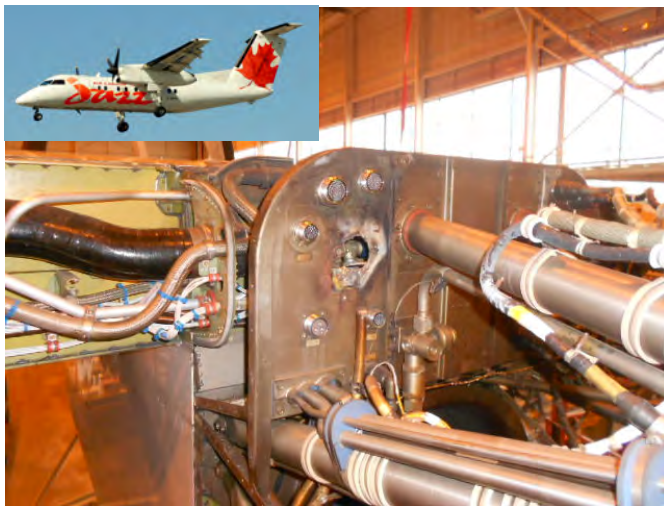
Report: DeHavilland Dash 8 Burnt Terminal Block

It is unknown what caused the feeder cables to short and burn the firewall, however, these images show the kind of damage that can be caused by large cables shorting and burning. On high current cables, sometimes the damage is already done by the time the protection devices trip and the power to the affected circuit is cut. Loose connections on these cables can cause overheating of the terminal blocks and should be checked for proper torque during inspections.

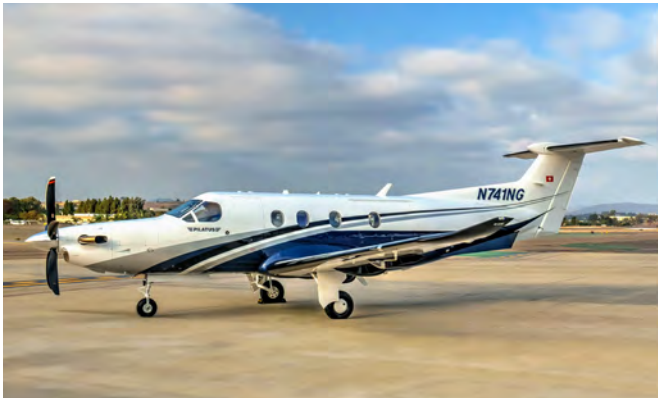
**Report: Pilatus PC-12
Improper Wiring Practices**

During a routine inspection of the windshield heat wiring and splice crimps, it was noted that the left-hand pilot windshield wires were crimped improperly. This is what this inspection was designed to look for, after finding some windshields that were installed improperly. The two separate splice crimps were found to have been crimped backwards.

This special inspection proved its worth. Sometimes routine maintenance can seem mundane and uninteresting. This particular maintenance staff was able to find the exact issue the inspection was calling out. Following procedure and being attentive during inspections can save a crew from an in-flight failure.

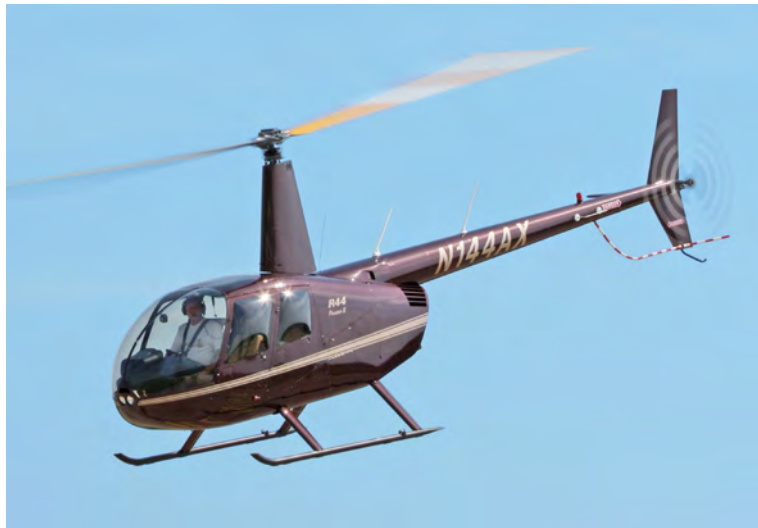
During run up, it was noted that the idle was high (around 70% belts engaged). Upon inspection, it was found that the bearing had come out of the part number (P/N) B564-2 link at the servo end.

It should be noted when inspecting or replacing throttle link P/N B564-2 for the R44 and R44 II model helicopters, that the Robinson Helicopter Company has published multiple service bulletins for this service difficulty.

R44 Service Bulletin (SB)-62 identifies a failed throttle link where the bearing separated from the housing. Compliance with this SB involves the installation of a large-diameter washer to prevent loss of control if a bearing fails. The incorporation of the large-diameter washer is also published in the Robinson Illustrated Parts Catalog throttle control installation.

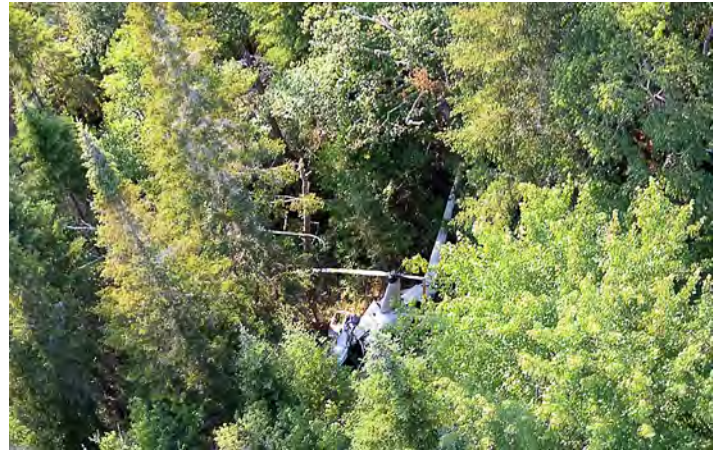
Left: Illustration of the interaction between immobile main rotor blades and trees during a vertical drop. Above: Aerial view of C-FJLH. Below: Area of the lower skin on a blade to visually inspect.
