AirMaintenance

The Magazine for Aircraft Maintenance Professionals

February - March 2022
Volume 20/Issue 5

Rust-Busting: Corrosion Prevention Maintenance

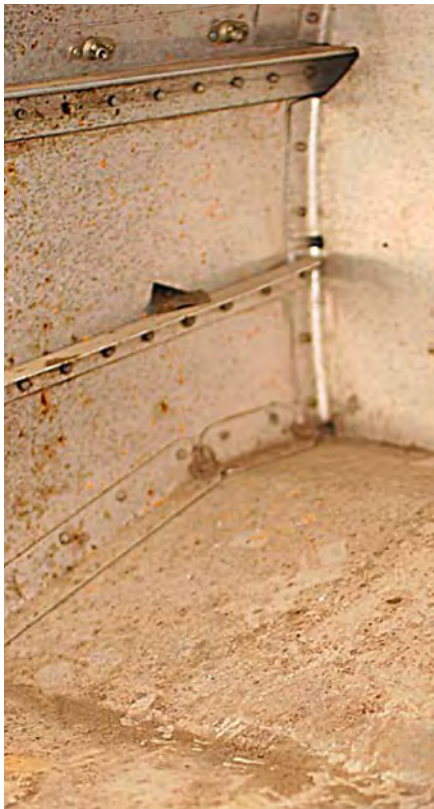
Above: Direct chemical attack in a battery compartment.

In spite of protective paint systems and extensive sealing and venting, battery compartments continue to be corrosion problem areas. Fumes from overheated battery electrolyte are difficult to contain and can spread to internal structures where unprotected surfaces can come under corrosive attack. For lead-acid batteries, frequent cleaning and neutralization of acid deposits with sodium bicarbonate solution will minimize corrosion.

If the battery installation includes external vent openings on the aircraft skin, these areas should be included in inspection and maintenance procedures. If aircraft have batteries with electrolytes of either sulphuric acid or potassium hydroxide, electrolyte leakage will cause corrosion. Consult applicable maintenance manuals to determine the battery type installed and recommended maintenance practices. Clean nickel cadmium compartments with ammonia or boric acid solution, dry thoroughly, then paint with an alkali-resistant varnish.

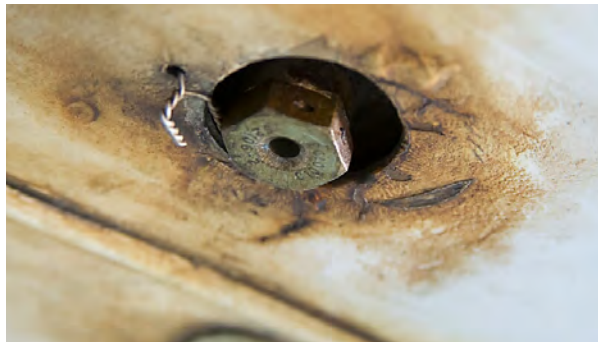
Left: During inspection pay special attention to attaching hardware, such as bolts or pins.

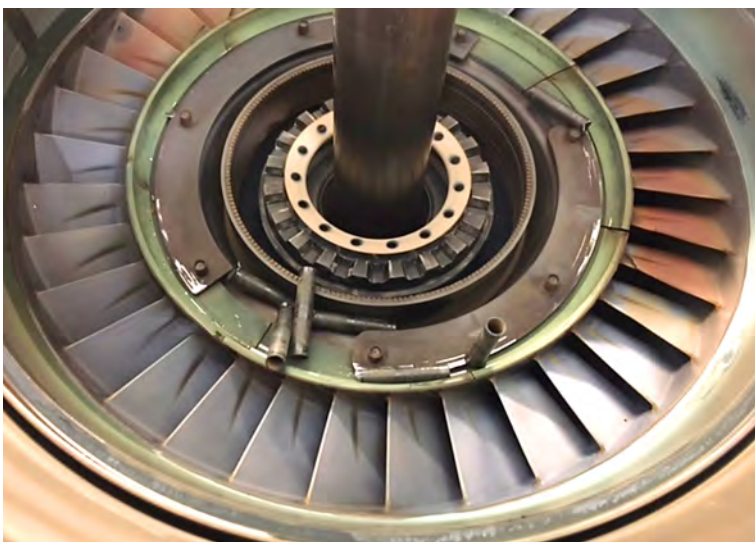
Honeywell. Rotor assembly with rivets that had fallen out due to incomplete setting.

The engine is being inspected at an approved overhaul facility and the second stage turbine is in the process of being replaced.

Fortunately this resulted in a ground incident rather than an inflight emergency.

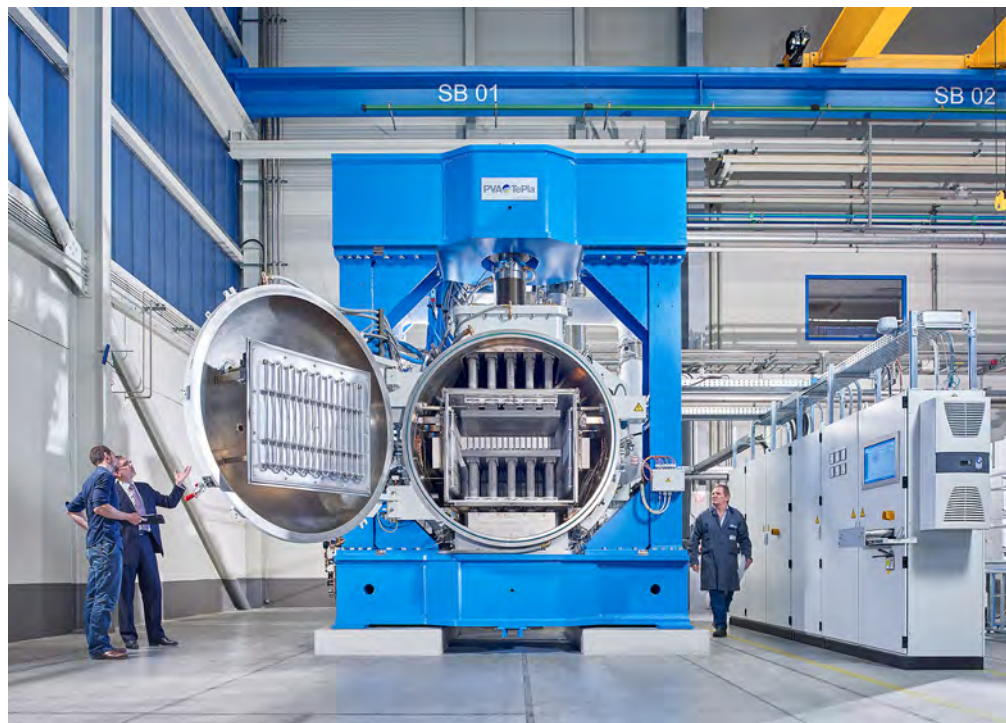
Advances in high vacuum hot presses now allow superior pressure control and rapid cooling systems to improve the bond.

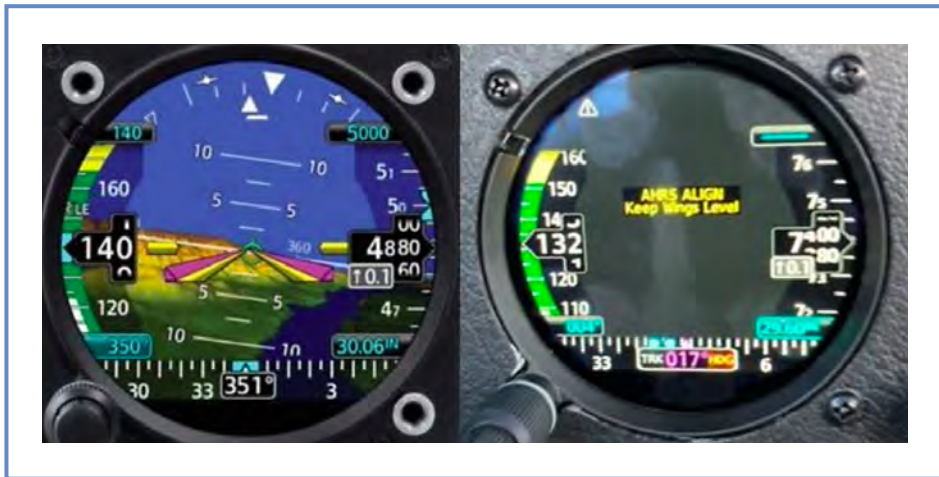
Opposite page, top: Map of BC and Alberta showing the location of the occurrence. Opposite page, bottom left: Garmin GI 275 multi-function instrument configured as an attitude direction indicator. Left image demonstrates a functioning attitude direction indicator.

The pilot accepted and climbed the additional 1000 feet, levelling off at 15 000 feet ASL at 1157. The pilot then requested a minor deviation from the route of flight to avoid entering clouds. However, during this deviation, the clouds could not be avoided, and the aircraft entered instrument meteorological conditions (IMC). Shortly thereafter, the aircraft's attitude direction indicator (ADI) displayed the "AHRS ALIGN" (attitude and heading reference system alignment) message, and indications of attitude (pitch and bank) were lost while indications of airspeed, altitude, and vertical speed were retained (See figure 1 above).
