AirMaintenance

The Magazine for Aircraft Maintenance Professionals

**December - January 2024
Volume 22/Issue 4**

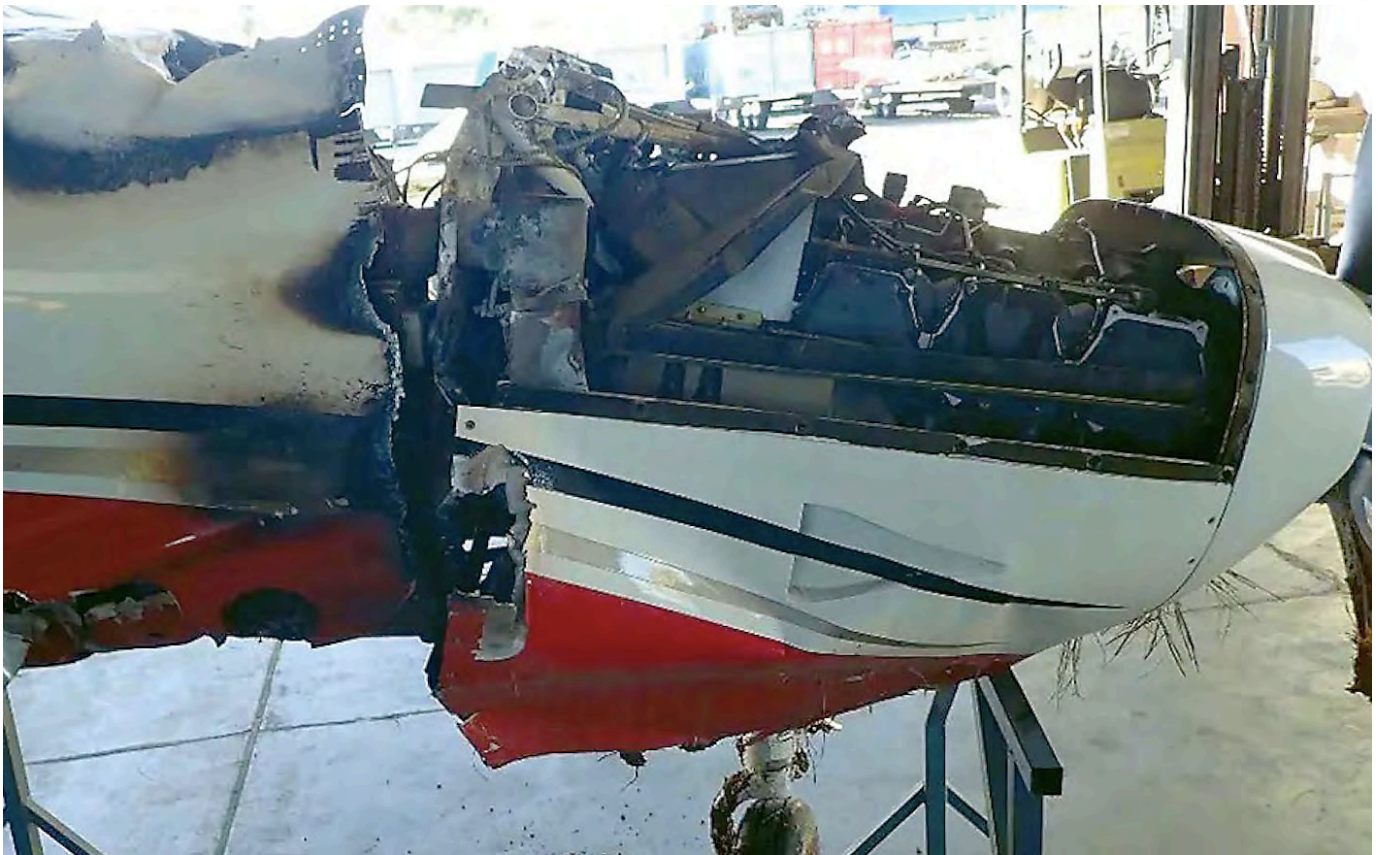
Above: A post-accident photo of the fire damage to the nose of the airplane.

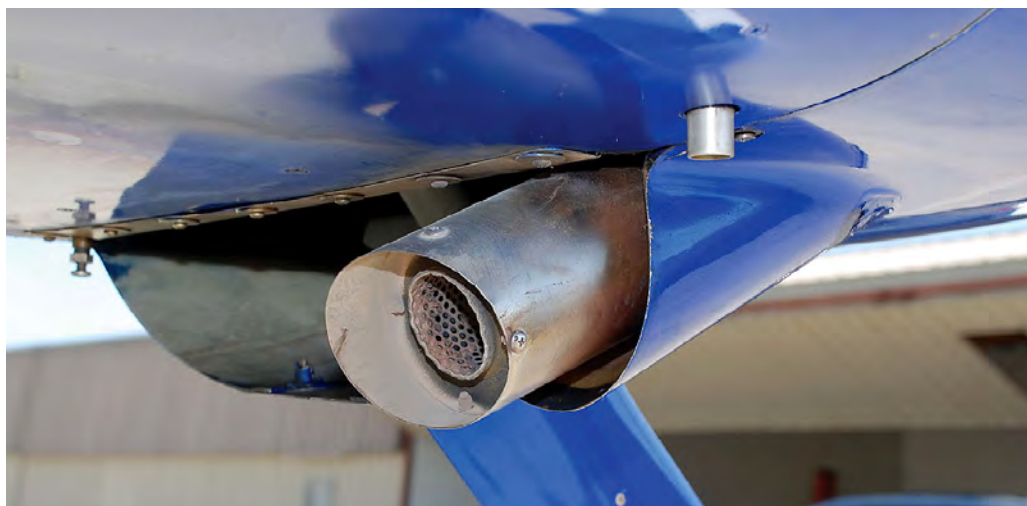
An exhaust system is more than just a bunch of crudely welded pipe sections.

There are three general types of exhaust failures: muffler failures/blockages, exhaust leaks causing noxious gases or fumes to permeate the cabin, and exhaust cracks causing heat

damage and/or fire. While there can be some overlap among the three, this framework offers a helpful way to think about preventing an exhaust-related accident.

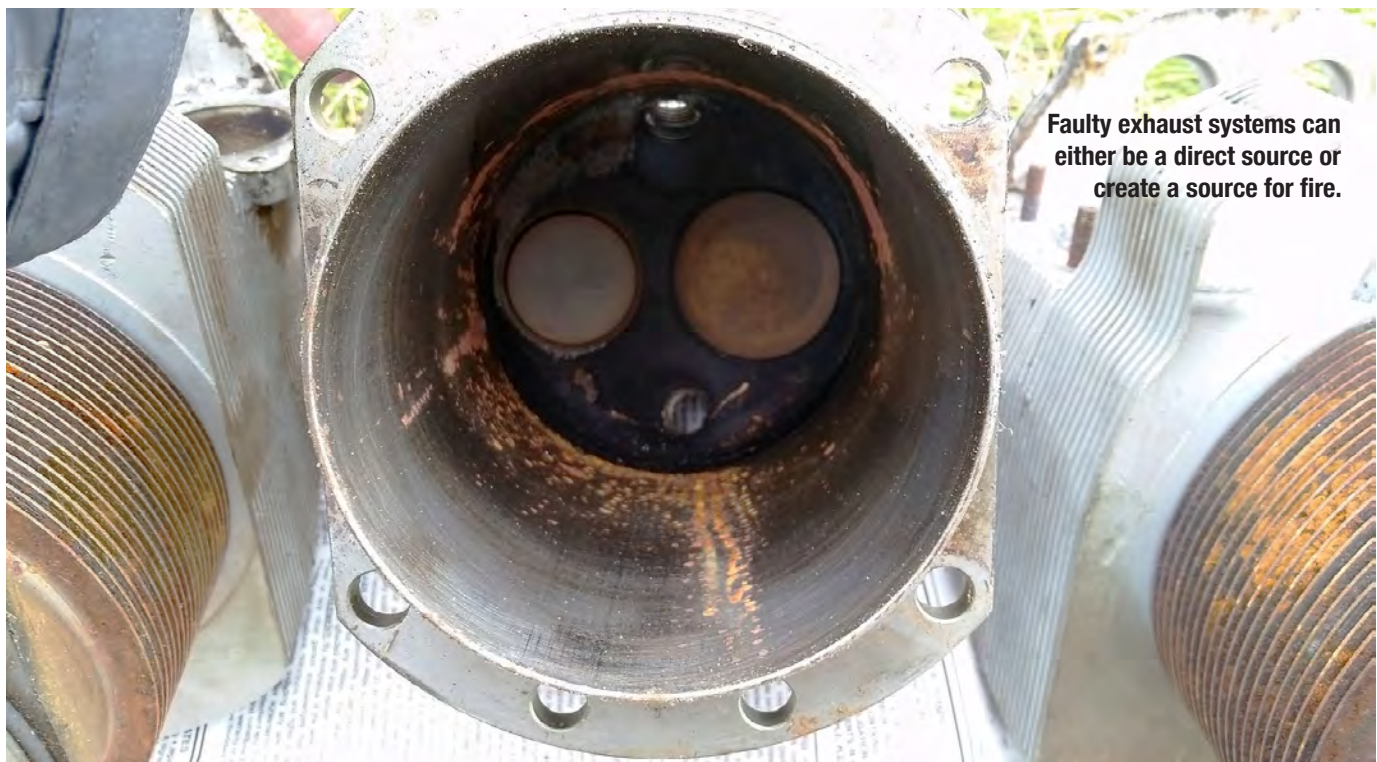
Faulty exhaust systems can either be a direct source or create a source for fire.

get me wrong: many potentially dangerous situations deserve consideration, but fire occupies a special place in my mind. Faulty exhaust systems can either be a direct source or create a source for fire. Many components in the engine compartment can be sensitive to high heat, including wiring and fuel lines (both of which can lead to fires if damaged).

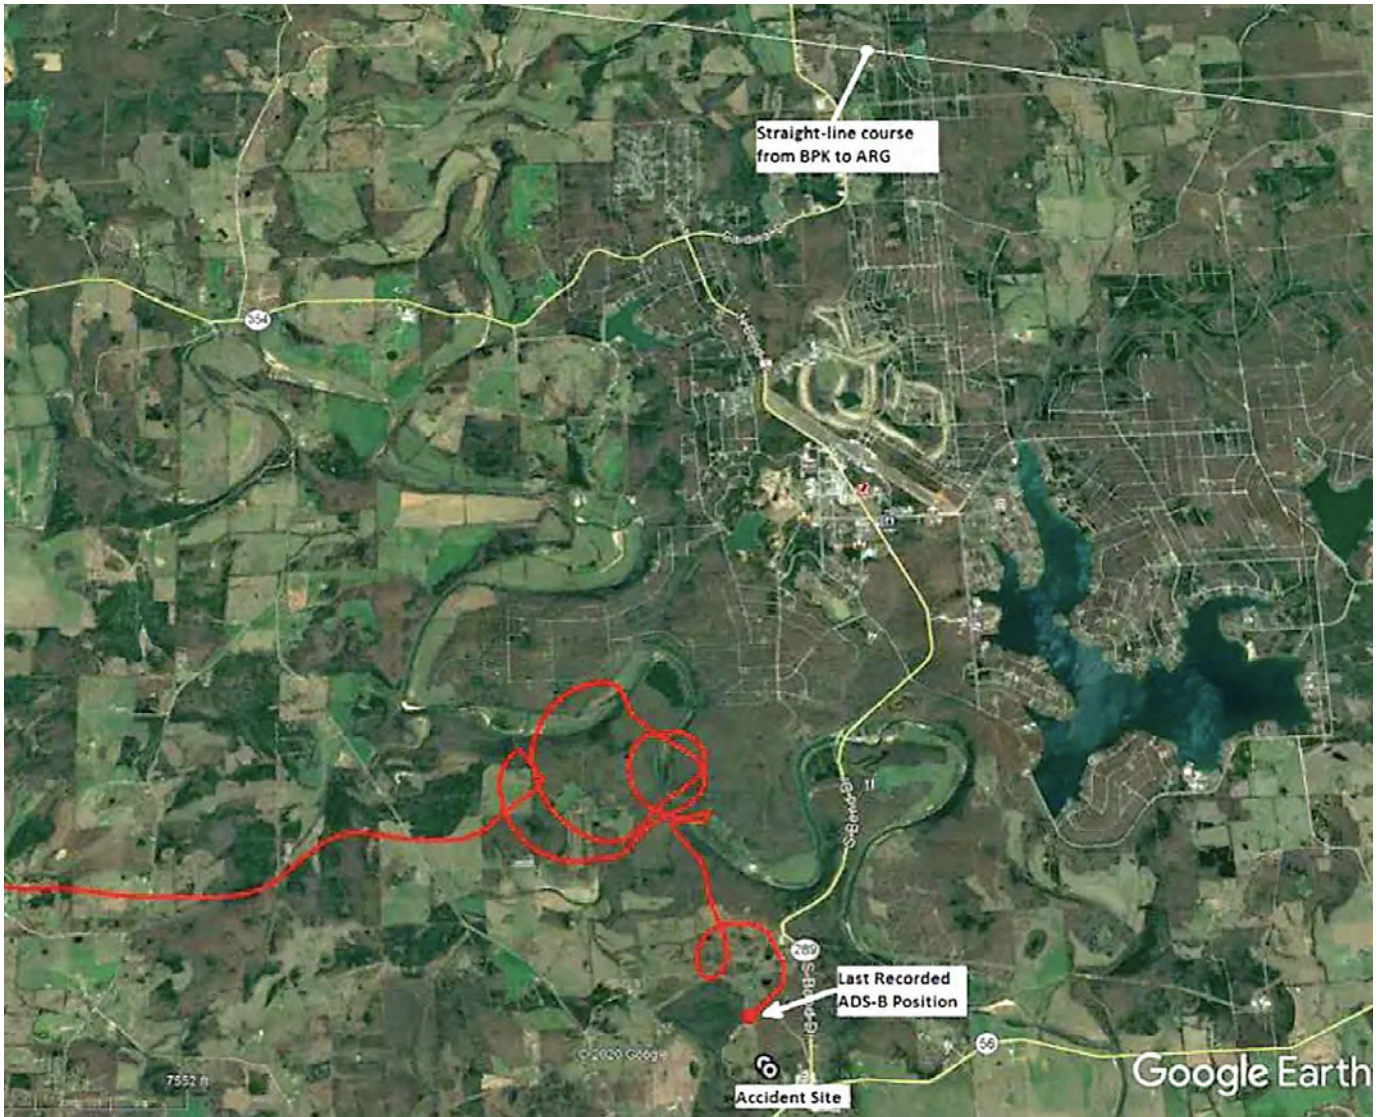
Above: The flight path of the last 7.5 minutes of the referenced CO poisoning accident.

a brief stop at an airport near the origination point, then flew up to northern Arkansas over a couple of airports before turning east southeast and requesting an IFR clearance to Walnut Ridge Airport (ARG) from Memphis Center. After initial radar and radio contact, the flight briefly proceeded before radar contact was lost and radio contact became intermittent. Efforts to contact the missing flight by ATC and aircraft in the area continued, but to no avail. The flight continued, but not directly toward the destination airport. The flight's last seven and a half minutes were an increasingly wobbly and looping mess ending just south of Franklin, Ark. The ADS-B track looked like a VFR into IMC accident despite it being clear below 5,000 feet above ground level (AGL) and 10 miles of visibility in daylight conditions.

Both pilots were killed, and the NTSB examination of the wreckage determined that there was cracking in the

muffler that predated the accident leading to CO poisoning. Toxicology reports from the flight instructor confirmed this finding.

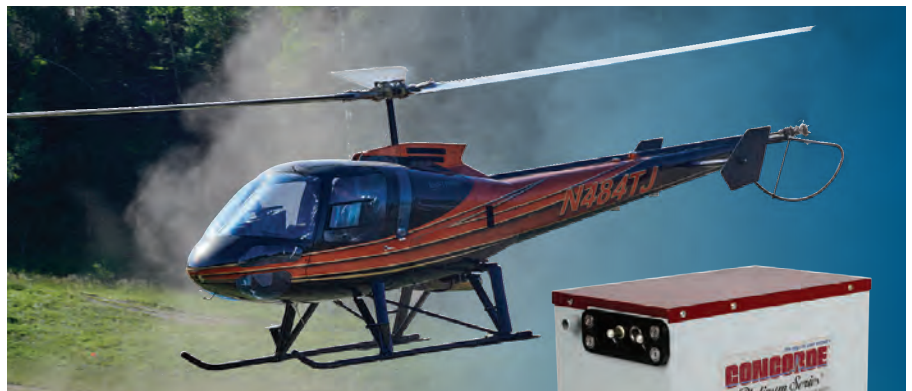
Top, right: This CO detector is affixed to the panel where it changes colour in the presence of CO gas.

While they certainly work and are very cost-effective (in the vicinity of \$5), these devices lack any kind of alarm, meaning you must actively scan them. Paradoxically this means that if CO is potentially impairing you, you must actively monitor a small dot on the panel

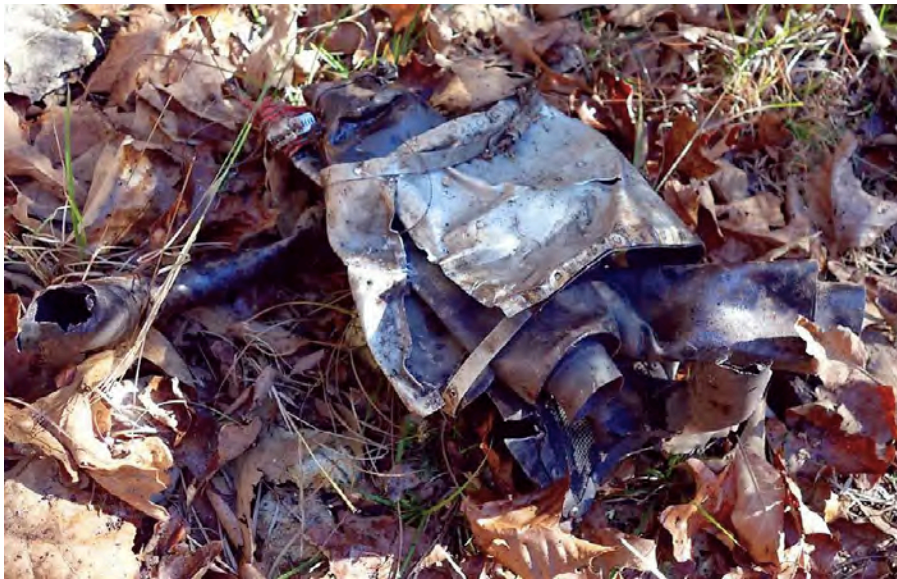
Left: The wreckage of the muffler from the CO poisoning accident.

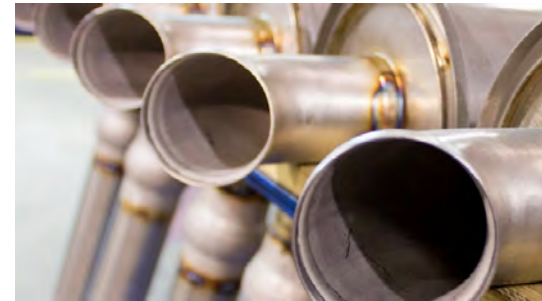
Below: There are three types of exhaust failures including cracks causing heat damage.

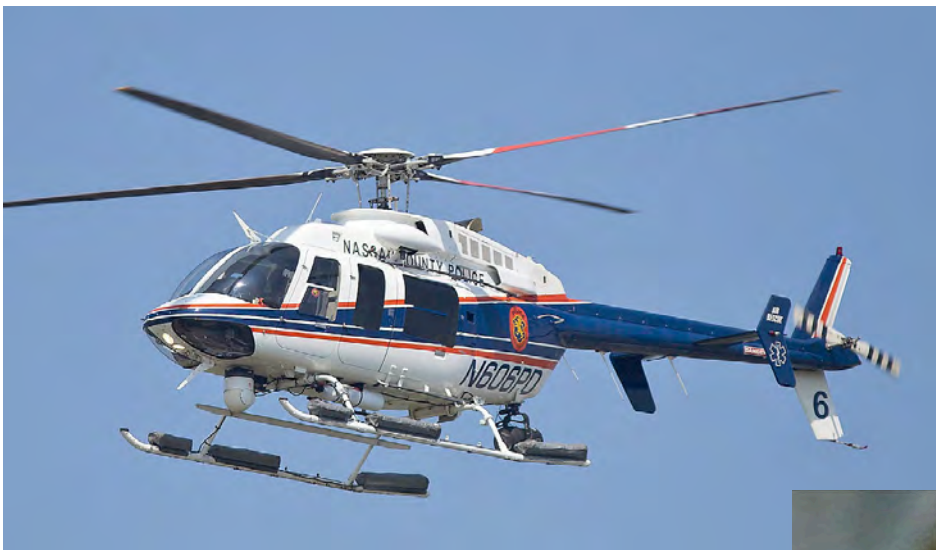
Left: The Bell Textron 407.
Below: Bell Textron, hardware from the air conditioning system clamp.

Smoke in the cockpit with ground power on was reported to Bell. A clamp was found contacting transistor.

The cause of this service difficulty was determined to be a clamp from the Air Comm Corporation air conditioner system fouling with the Bell Automatic Flight Control System (AFCS). The smoke was generated when the hardware that was used to secure the clamp contacted an electrical component of the AFCS. As a result of the Air Comm Corporation investigation, Service Bulletin (SB) 407-221012 was published. The SB provides instructions to resolve the potential fouling condition between the air conditioner system and the AFCS. Transport Canada Civil Aviation would like to raise awareness of this SB to the owners, operators and maintainers of Bell 407 helicopters with an Air Comm Corporation air conditioner system installed along with the AFCS or the provisions for the AFCS.

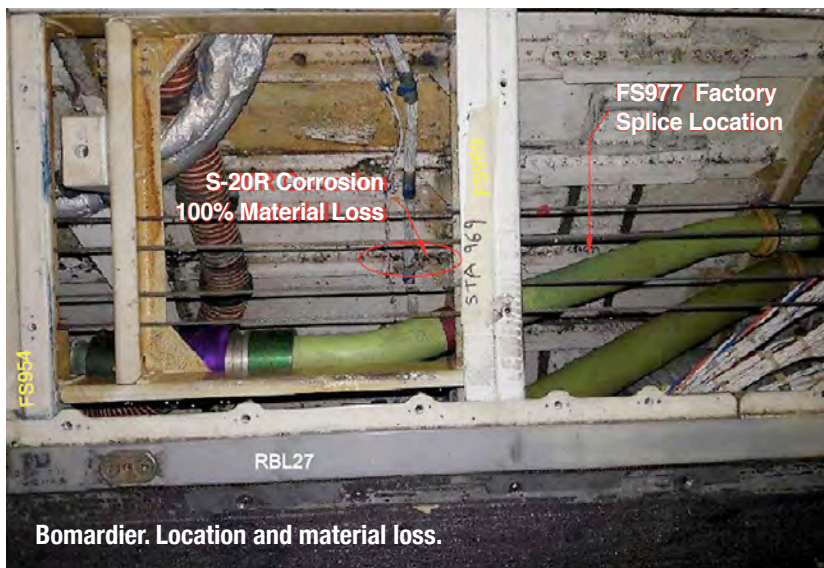
Bombardier. Location and material loss.

During a maintenance check, it was noted that stringer S20R had corrosion damage from fuselage station (FS) FS.927 to FS.954. The corrosion was found when the floor was removed and was located below the underfloor ducting. There was 100% material loss found and the stringer had to be replaced. The final repair was a replacement of the corroded stringer section from factory stringer splices at FS.920 and FS.977.

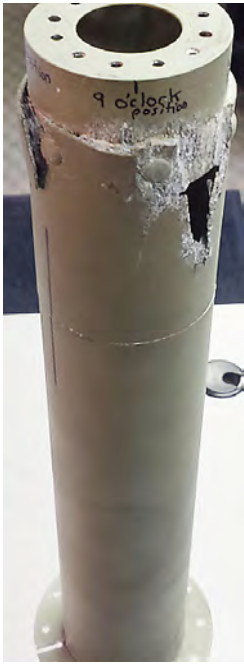
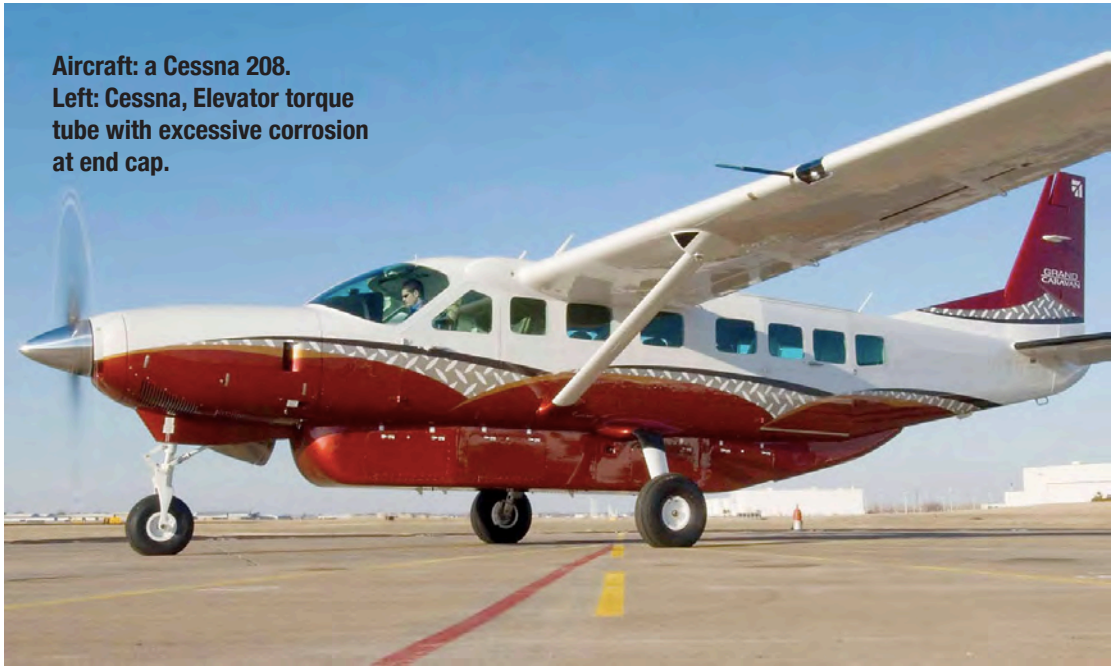
Aircraft: a Cessna 208.
Left: Cessna, Elevator torque tube with excessive corrosion at end cap.

Excessive corrosion was found on the left-hand (L/H) elevator torque tube assembly, originating at the end cap faying surface. Several cracks and converging cracks of varying sizes were found, including a triangle area of material missing due to corrosion. There was no apparent damage found on the visible inboard end of the torque tube assembly. The area of damage was not visible through routine inspection. The suspect area was inspected by removing the inboard leading edge skin, part number (P/N) 2634000-5. A visual inspection of the right-hand (R/H) elevator torque tube was carried out with a borescope through a tooling hole at the elevator inboard rib P/N 2634017-27, and no defects were noted. The aircraft is currently maintained under severe inspection time limits and operated as a float plane in a saltwater environment.

The subject Service Difficulty Report (SDR) is a clear example of corrosion found in a Cessna 208 aircraft operating in a severe environment. As the submitter experienced, it may not be obvious during routine inspection to identify corrosion in this area. As such, special attention should be given when inspecting this area. Textron Aviation recommends that this area be inspected every 1600 hours or 24 months.

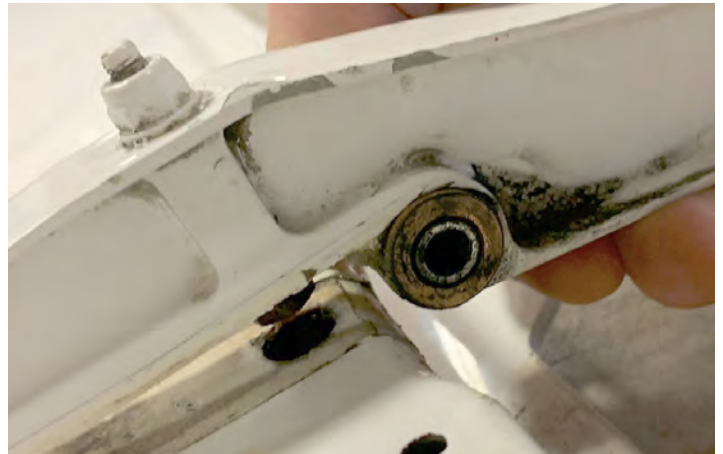
Above: Diamond, View of removed elevator (upside down). Forward attachment bolt worn through lower skin.

During the performance of a 300-hour inspection, the forward elevator control horn attachment bolt was found worn through the lower skin of the elevator.

The root cause of this failure is not entirely clear. Incorrect torque during the installation of the control horn bolt, and/or horizontal stabilizer water drain hole obstruction in combination with freeze/thaw cycles may have contributed to this failure. Maintainers are reminded to refer to the appropriate fastener installation torque values. In cases where specific torque values are not defined, standard torque values should be referenced.

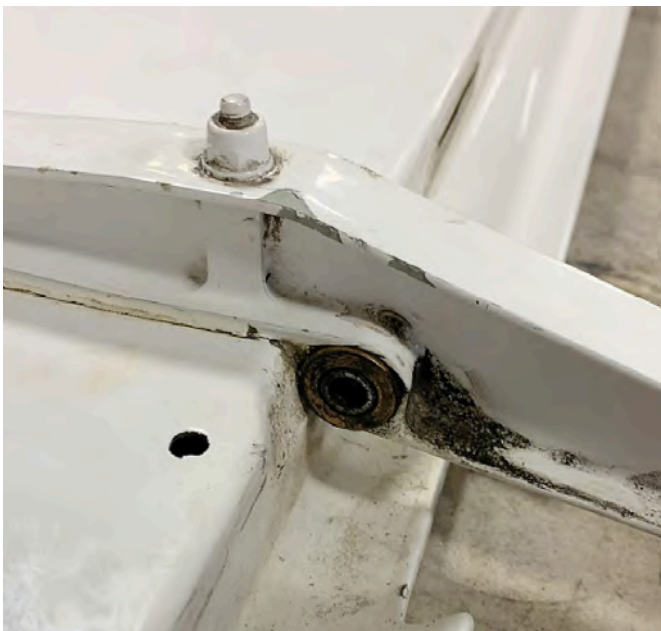
Left: Diamond, View of removed elevator (upside down). Elevator control horn as installed on elevator.

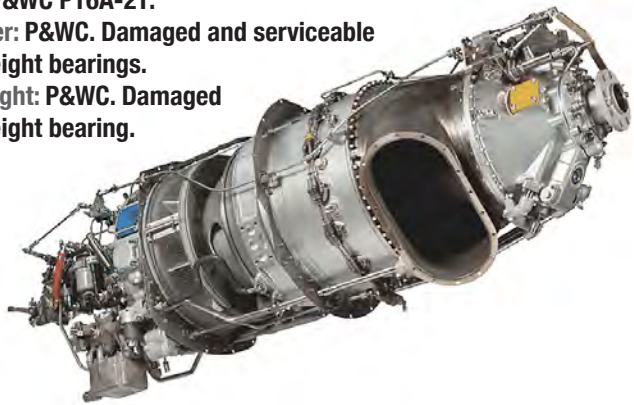
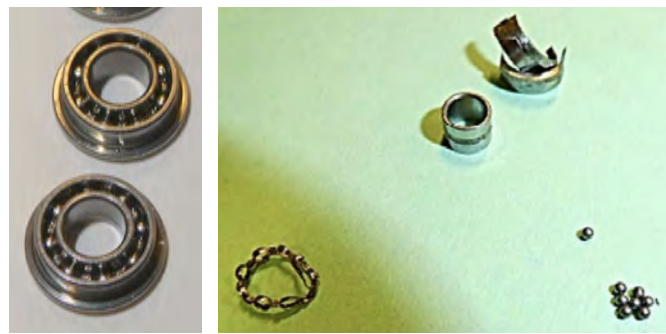
The P&WC PT6A-21.
Center: P&WC. Damaged and serviceable
flyweight bearings.
Far right: P&WC. Damaged
flyweight bearing.

Further to their investigation into this Service Difficulty Report (SDR), Pratt & Whitney Canada continues to promote compliance with Woodward SB 83053-61-027. Transport Canada Civil Aviation (TCCA) concurs with this position and would like to highlight the value in assessing and following manufacturers' recommendations, including those at the component or vendor level.

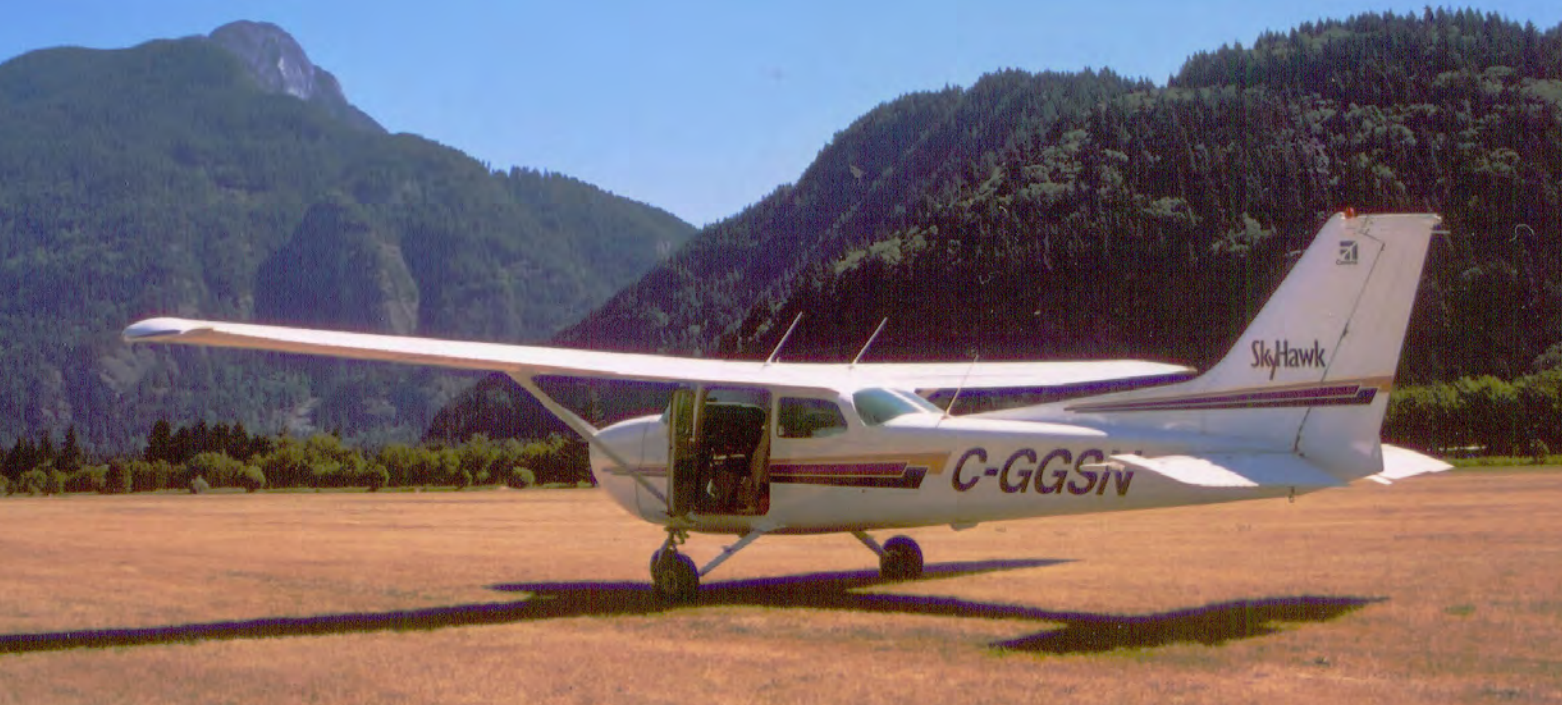
Above: Event Aircraft near Hope, BC. - Brian Burger photo

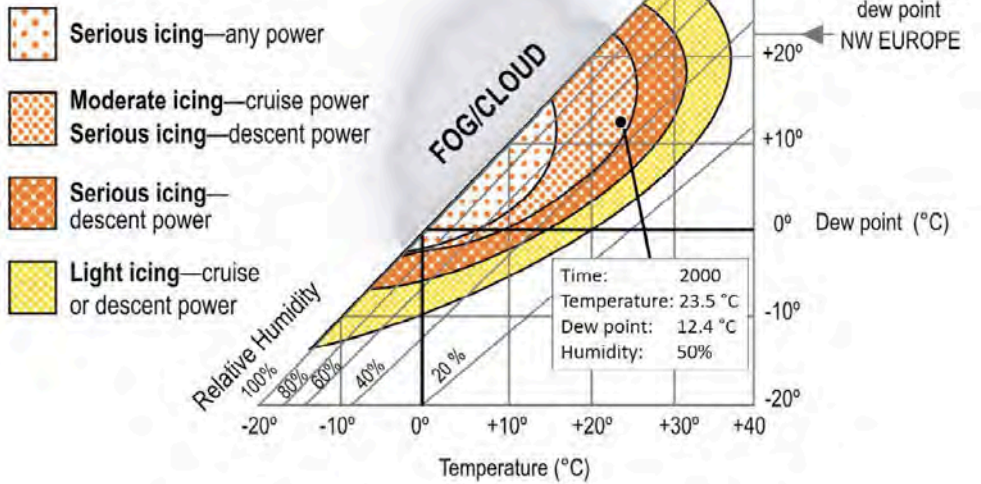
Left: Figure 3. Chart providing weather conditions that can induce carburetor icing based on temperature, dew point, and humidity with the CAT4 weather conditions plotted.

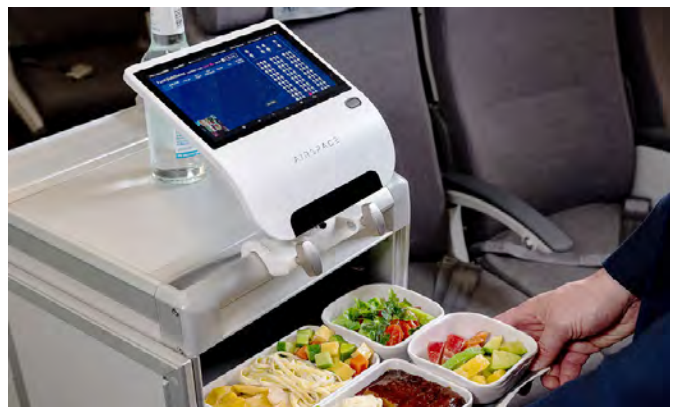
Airbus's Food Scanner is an AI-enabled device to analyze the composition of food in a point-and-shoot process.

the cabin attendant pulls it out from the trolley during the in-flight service, and subsequently captures pictures of what remains when the tray is returned. A horizontally-oriented barcode scanner tracks the beverage bottles and cans that typically are placed atop the trolley.

The Airbus digital solution to this challenge was the Food Scanner, an artificial intelligence-enabled device that analyses the composition of food in a simple point-and-shoot process. It uses the same principle as scanners that are increasingly available in supermarkets today. The Food Scanner’s downward-looking camera identifies what is on the meal tray as

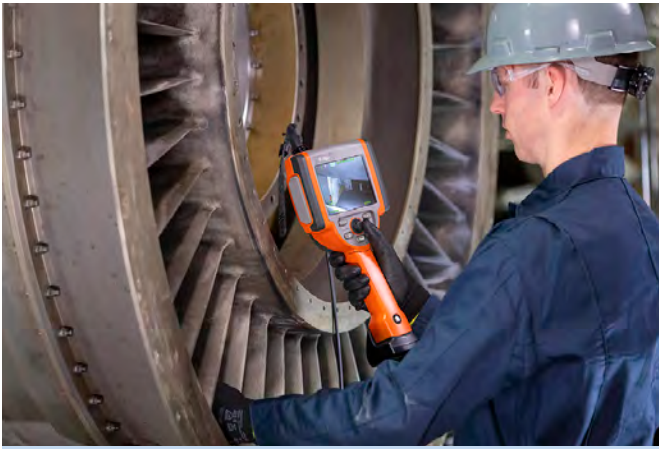
The Intelligent Borescope provides consistent and fast data collection.

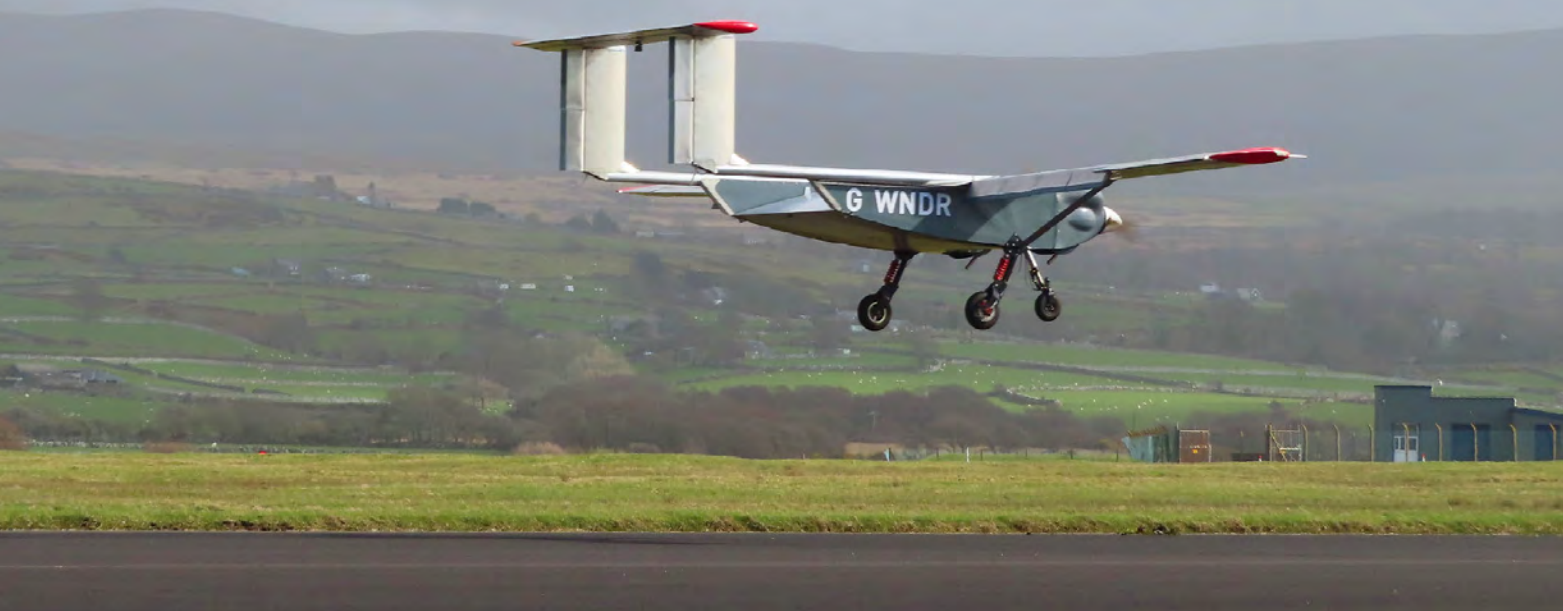
Designed for extreme environments like Antarctica, the Windracers ULTRA UAV (uncrewed aerial vehicle) is a twin-engine, 10-metre fixed-winged aircraft, capable of carrying 100 kilos of cargo or sensors up to 1,000 kilometres. It can take off, fly and land safely with minimal ground operator oversight thanks to its Masterless autopilot system, developed by Distributed Avionics.

Incorporating a high level of redundancy, the ULTRA can continue to fly even if one of the engines or components is damaged or fails. The flexible platform can also be configured as required to carry a range of sensors for collecting scientific data. Using AI-driven SWARM technology multiple autonomous drones can organize themselves as a single unified system to collect science data across a larger area.
