AirMaintenance

The Magazine for Aircraft Maintenance Professionals

June-July 2019
Volume 18/Issue 1

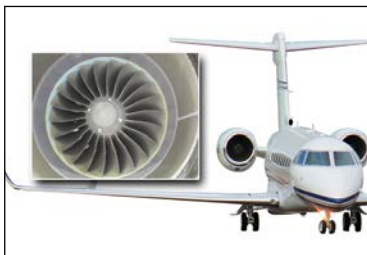
Quiet Technology Aerospace has received STC approval for its sixth airframe-specific carbon fibre engine inlet replacement barrel, which offers a terminating solution for Gulfstream G280 operators over the plaguing issue of engine inlet cowl inner barrel corrosion on the Honeywell HTF7250G engine inlets.

QTA's carbon graphite composite inner barrel comes with a lifetime warranty, assigned to the aircraft's serial number that automatically transfers to any future owner. In addition, the QTA upgraded inlet cowls have lifetime Product Liability Insurance placed via Lloyds of London.

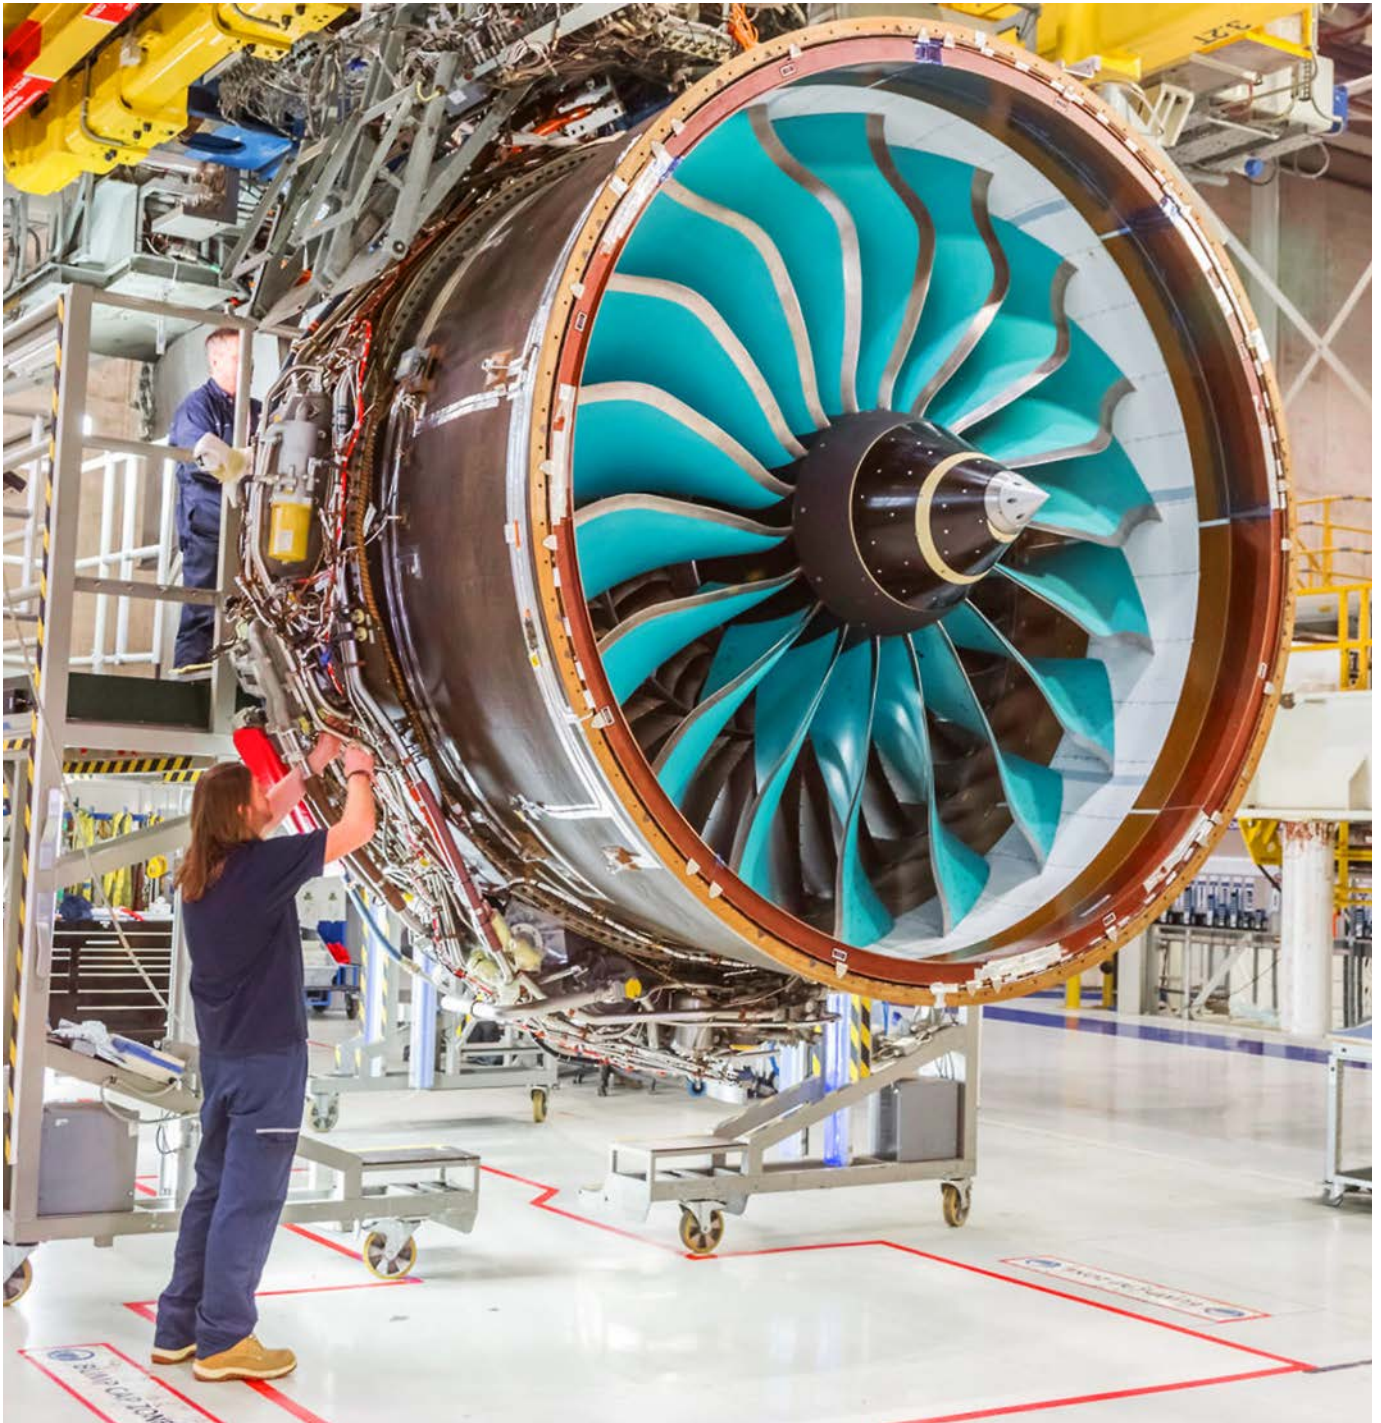
Newer engines are also being built to tighter tolerances. Consequently, it takes less damage to cause an internal engine component to fall beyond repairable limits set by the manufacturer. When this occurs, a full replacement of the damaged component is required.

Above: Newer engines are also being built to tighter tolerances.

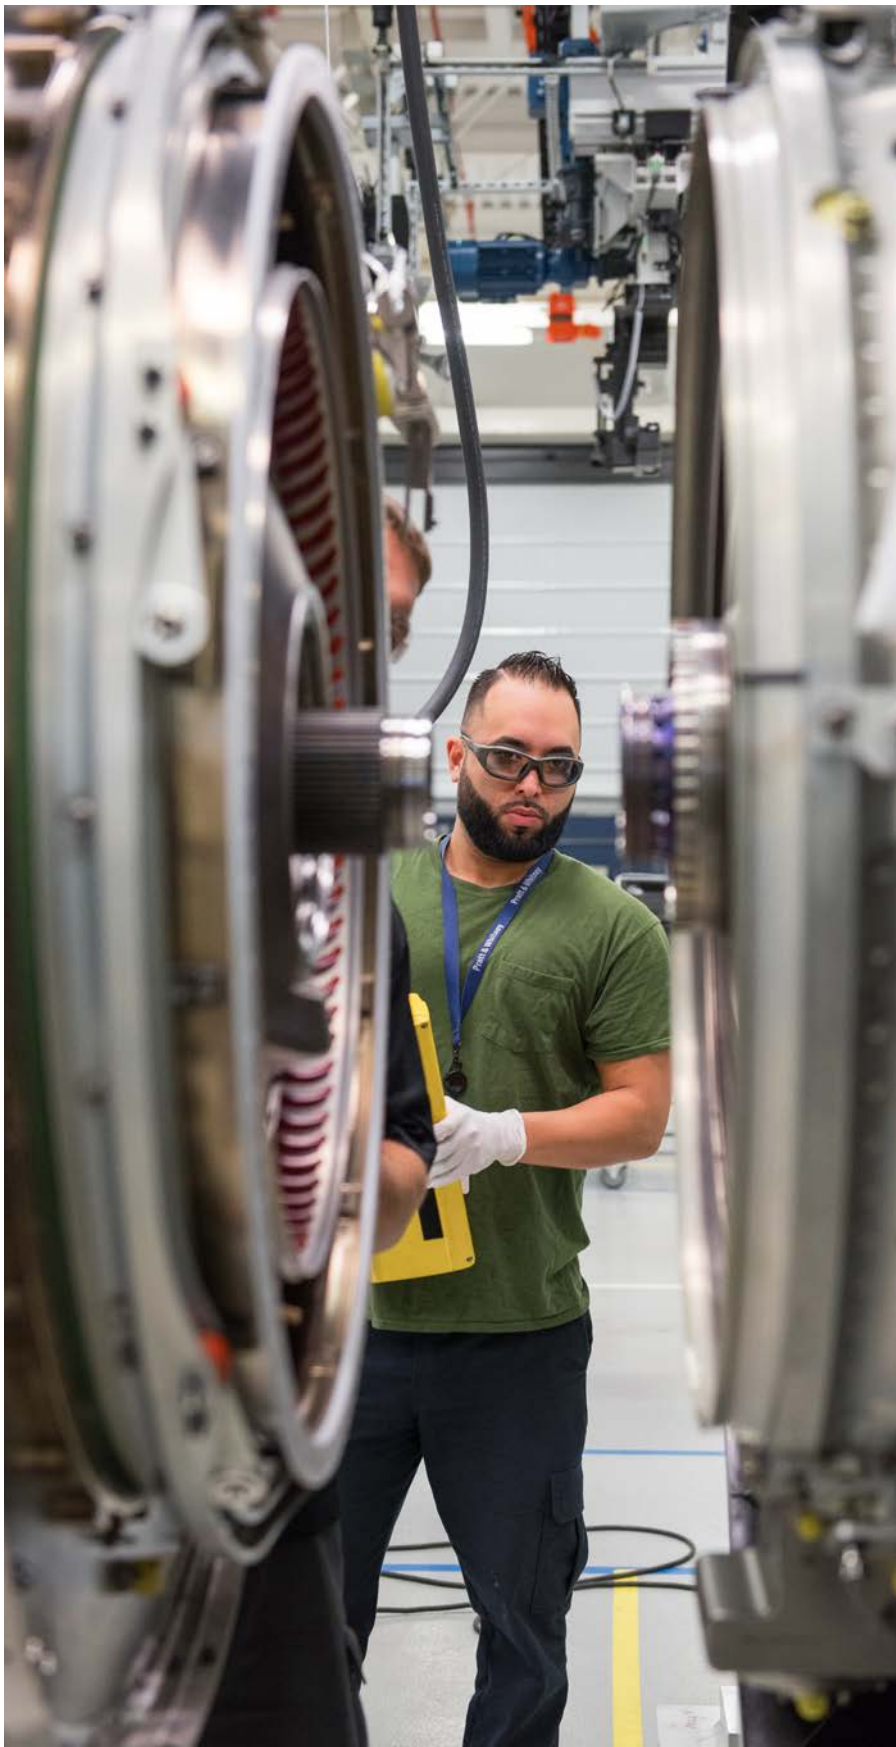
Above: While extensive repairs may be possible given the high value of engines, operators are sometimes reluctant to undertake them.

The new-generation aircraft engines used in airline applications can cost upwards of \$38 million. While extensive repairs may be possible given the high value of the engines, operators are sometimes reluctant to undertake them, preferring to replace the damaged engine instead.

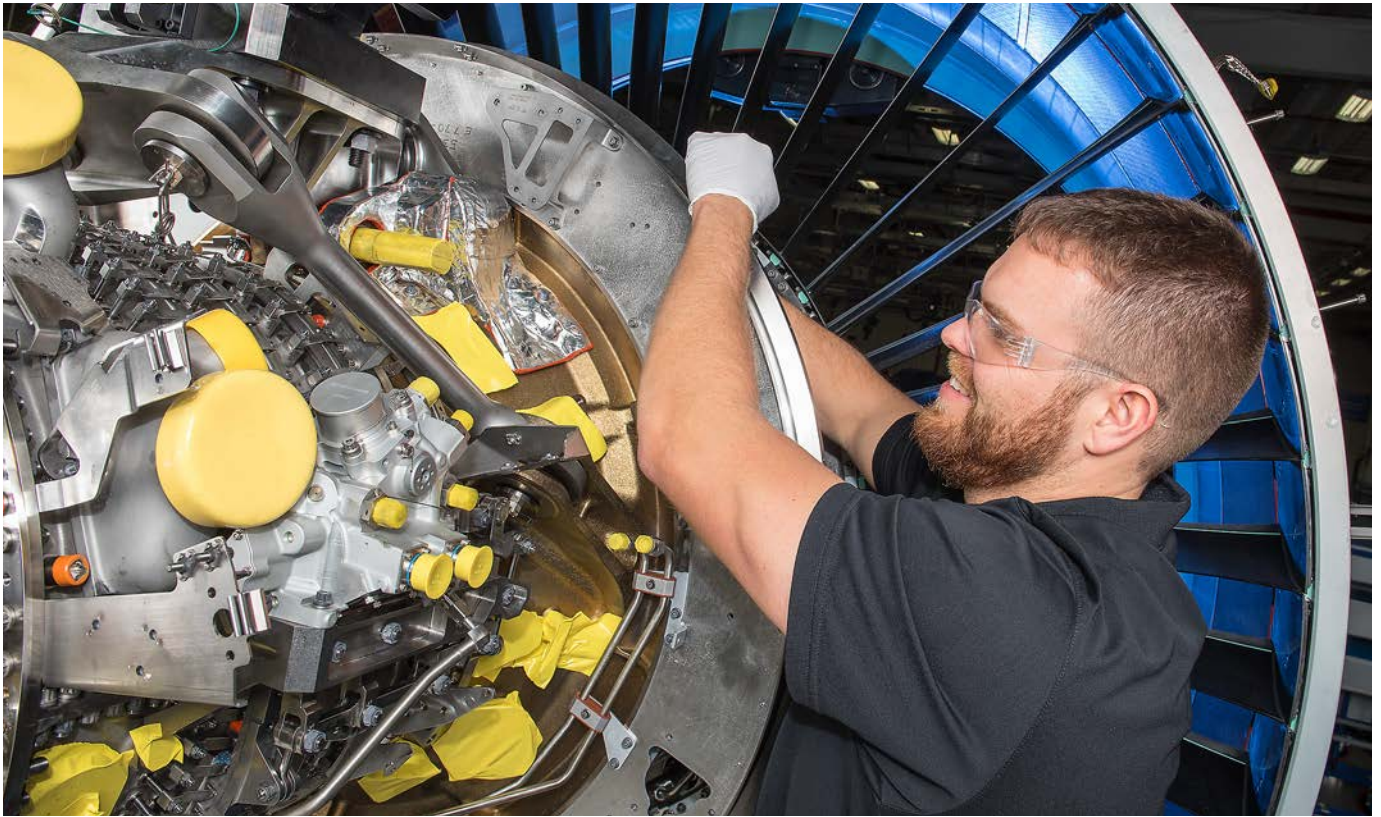
Above: Some newer aircraft engines have designs that make them more efficient and lighter in weight, but also make them more expensive to repair.

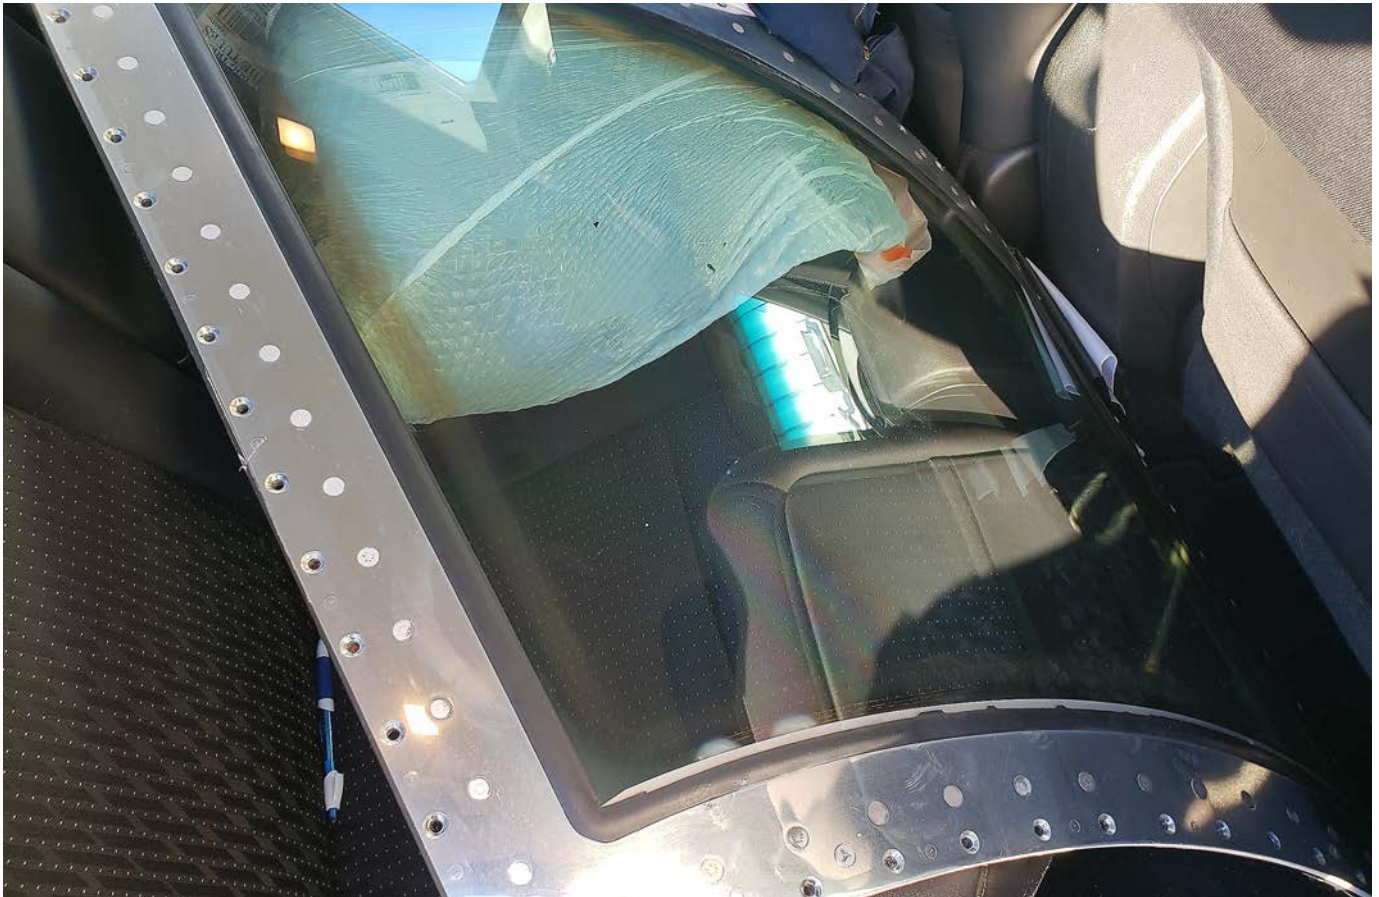
Above: Windows are among the most maintained or changed aircraft parts aside from wheels and brakes.

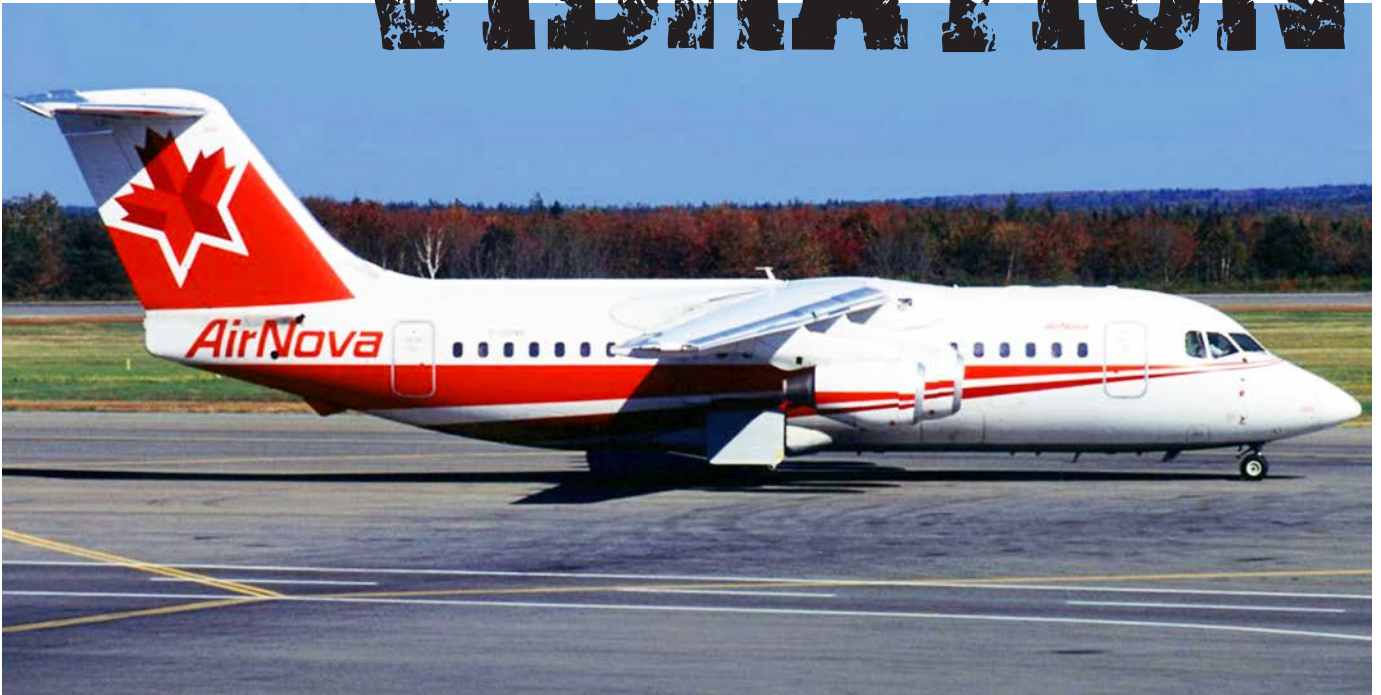
Above: As the aircraft was climbing through 9,000 feet above sea level out of Newark, the No. 4 engine vibration light illuminated.

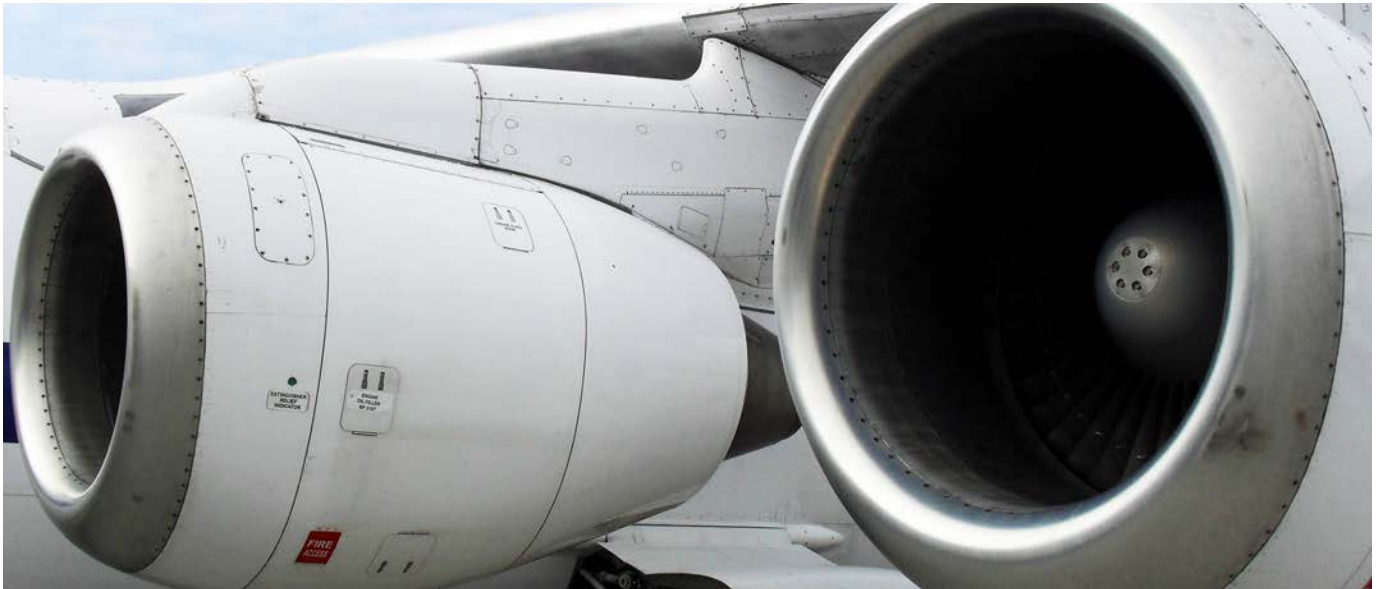
Above: A teardown of the No. 4 engine revealed a fractured third stage turbine blade.

cycle fatigue. It is possible that the lower-than-desired life after re-blade resulted from re-blading the turbine wheel at overhaul with used blades, with excessive tip shroud gaps between neighbouring blades.
