AirMaintenance

The Magazine for Aircraft Maintenance Professionals

December - January 2023
Volume 21/Issue 4

TC Feedback

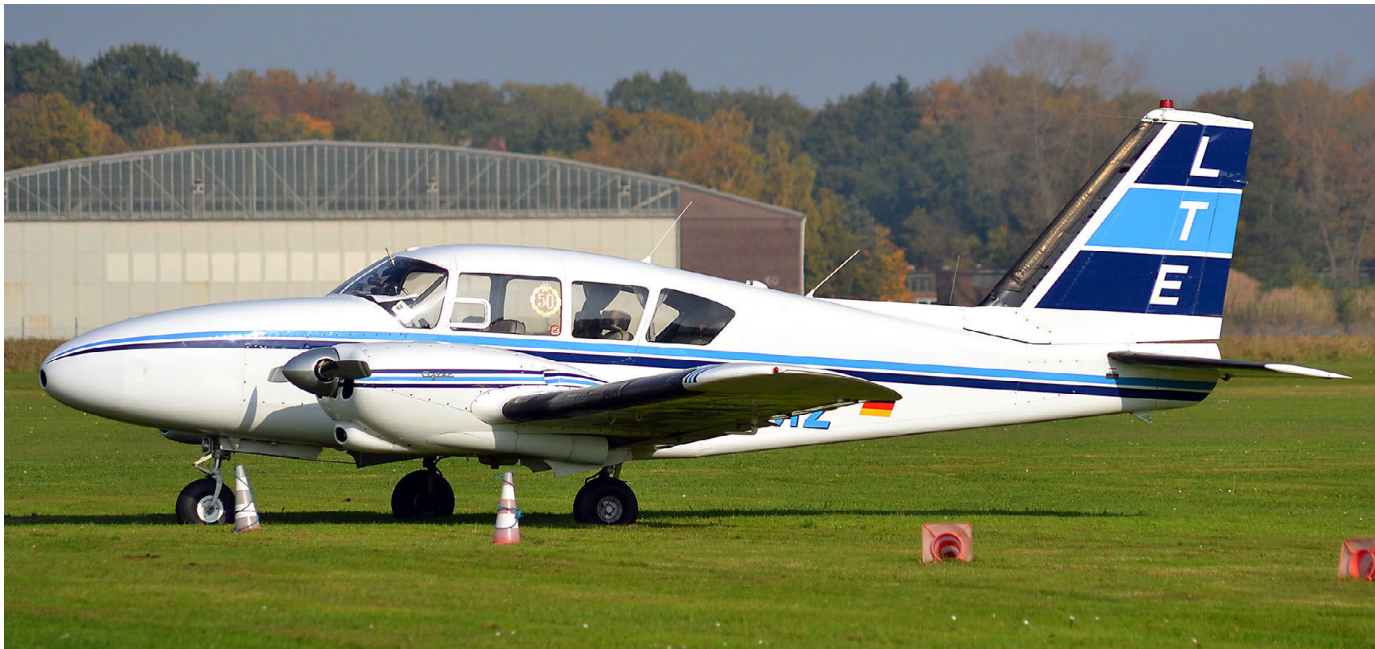
Below: Fracture located at swivel fitting connection.

Bottom: Broken fuel selector valve control cable inner wire.

Report: Piper PA-23 Aztec Fuel Selector Valve Control Cable Failure at Swivel Fitting

The engine power loss occurred during flight in the right-hand engine when the pilot selected the inboard fuel tank, as the outboard fuel tank capacity had been exhausted. An emergency was declared with the intention to land as soon as possible. While troubleshooting, the electric boost pump was turned on with no effect. The pilot utilized the fuel cross-feed system from the left-hand engine, which provided fuel supply and returned the right-hand engine power back to normal. The aircraft landed safely shortly thereafter.

Although the fuel selector valve control cable had been recently inspected prior to the incident, the defect was not uncovered at that time. The fuel selector valve control cable inner wire fractured under the crimping cup of the swivel fitting. It is important to remain vigilant and avoid complacency when completing all maintenance, with special attention to the requirements of an AD.

(AD) 80-18-10, which requires inspection of all fuel selector valve control cables using 10x power magnification each 100 hours. Piper Service Bulletin No. 507 has been referenced within the AD for specific inspection locations, highlighting all swivel fittings.

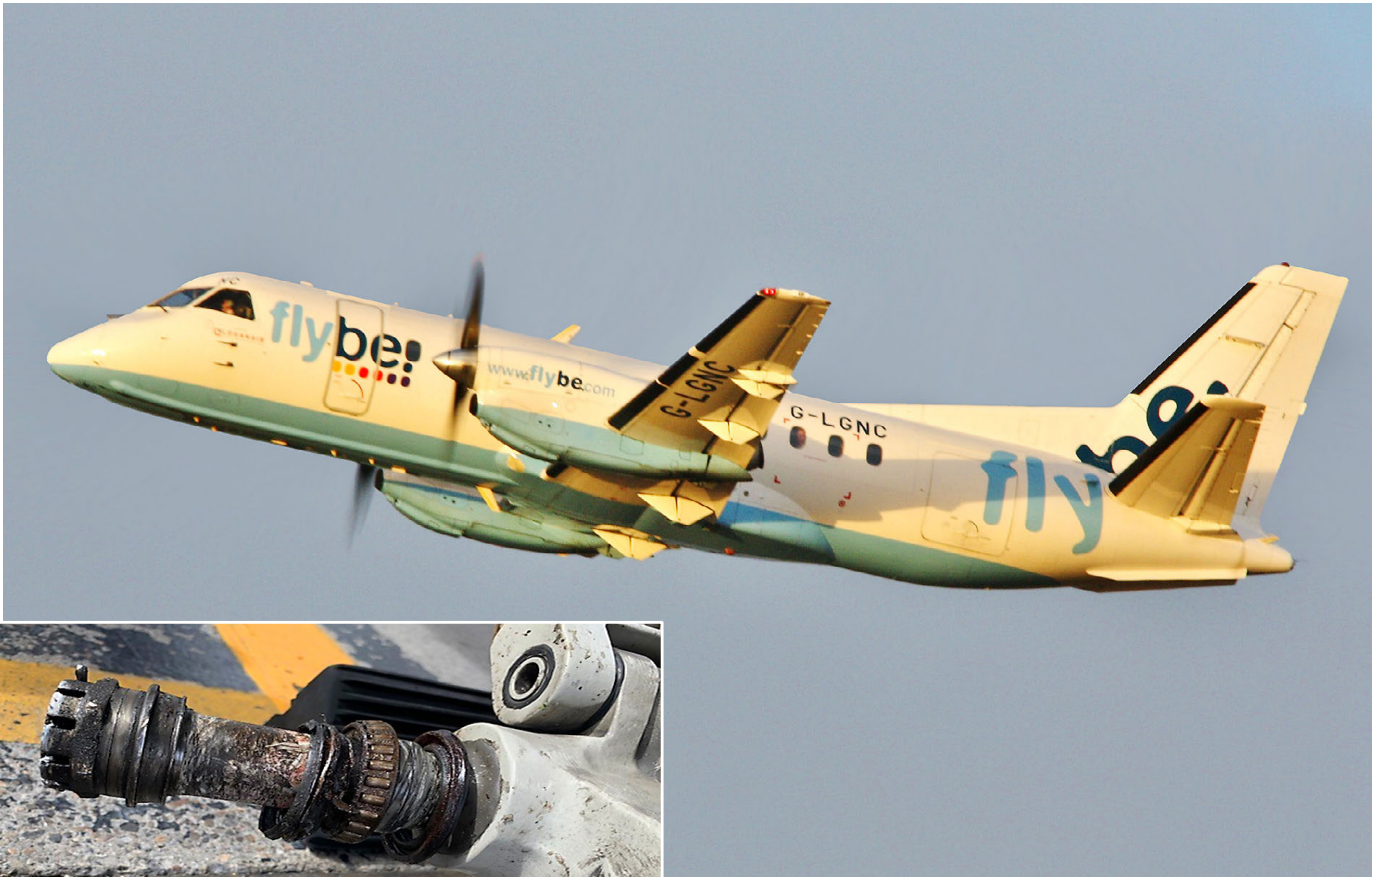
Above: A SAAB 340B in flight.
Left: The axle with the remainder of the wheel bearings after the wheel departed the aircraft on takeoff.

**Report: SAAB 340B
Nose Wheel Bearing Failure**

The pilot conducted an emergency landing. The maintenance crew inspected the nose landing gear and found that the nose wheel assembly bearing mount was still on the nose landing gear axle. The nose wheel axle was damaged. Upon inspecting the nose wheel bearing, it was suspected to be inadequately greased, causing bearing failure.

There have been a number of wheel bearing failures on a number of different aircraft models. Maintenance personnel are advised to ensure that wheel bearings are properly greased and torqued to specifications published by the manufacturer.

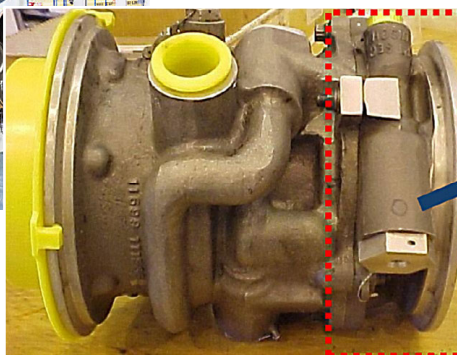
General Electric: Above, and Right: Main fuel pump secondary housing. Below right: Pinhole at secondary housing.

Report: General Electric CF34-3B1 Engine Main Fuel Pump

During a routine inspection, fuel was discovered in the lower engine cowl. Upon further investigation, it was discovered that the engine-driven fuel pump had developed a small pinhole in the inlet case allowing boost pump pressure to leak from the pump body. The affected pump was replaced, and the aircraft returned to service.

We have received several Service Difficulty Reports (SDRs) related to fuel leaks from a pinhole on this particular fuel pump part number. The leakage is attributed to a pinhole on the relief valve wall of the secondary housing as a result of erosion caused by the effect of cavitation over the relief valve cavity threads. These leaks may be barely detectable due to the size of the pinhole.

Transport Canada Civil Aviation (TCCA) would like to make operators and maintainers of similar models aware of these events, and urges everyone to be vigilant while inspecting the fuel pump area for leaks.

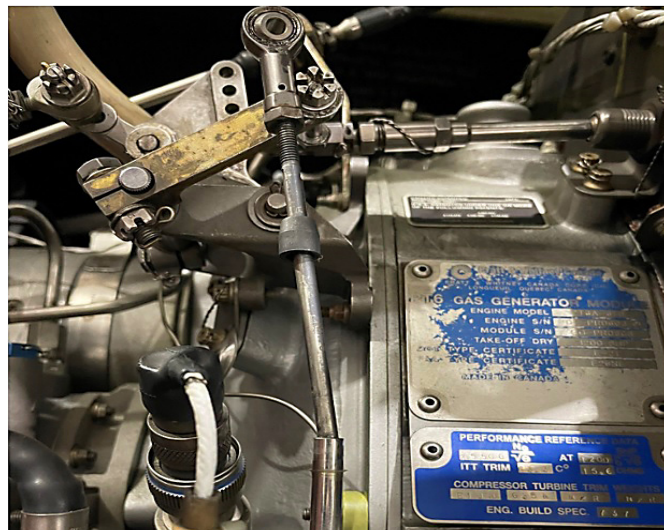
When selecting full travel (going to reverse), the power control cable rod end would over centre, and going out of reverse became difficult. On the previous power control cable, P/N 941.94.11.419, there was at least one more inch of solid portion of the cable. Pilatus provided a drawing of the power control cable, P/N 941.94.11.437, and the dimension of the rod end portion of the cable was 25 mm shorter on the newly installed power control cable assembly, P/N 941.94.11.437, than on the drawing. Pilatus noticed a production issue with this new power control cable and provided a replacement part under warranty.

Below: Pilatus PC-12/47, Cable deflection when fully extended.

This Feedback Article aims to make PC-12 aircraft operators aware of the production issue of this power control cable assembly, P/N 941.94.11.437. Maintainers should be vigilant when replacing the power control cable and performing the prescribed functional checks of the system.

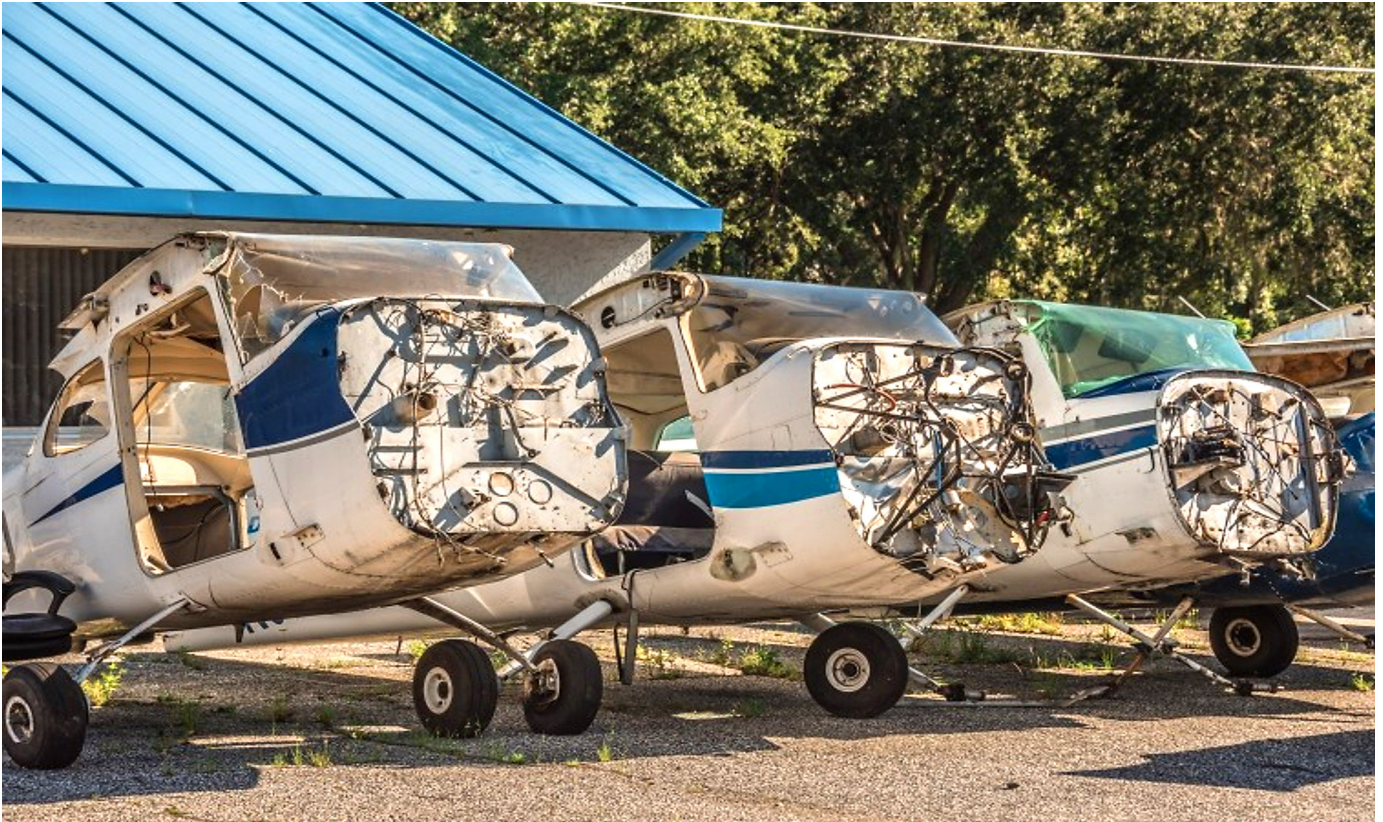
FAILURE TO ANNOTATE

Failure to annotate. During an overhaul the mechanic converted the engine from one model to another, but did not annotate the engine data plate.

AN aircraft owner purchased an engine from a salvage yard, and had it field overhauled. During the overhaul the mechanic converted the engine from one model to another, but did not annotate the engine data plate. During annual inspections nuts were consistently found to be loose, including the prop to crankshaft flange attachment. Ultimately, the number two cylinder departed the engine in flight, and the pilot made a successful off field landing without injury. DVI's material sci-

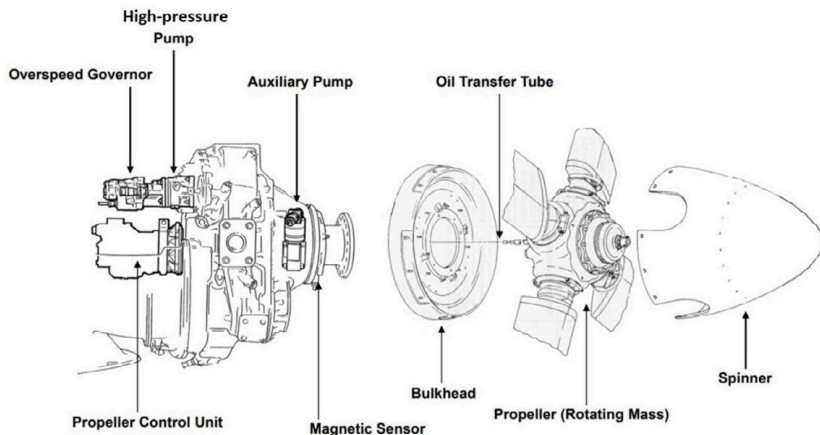
Opposite: Wreckage site. Above: The propeller system, with a propeller control unit, and the pitch change actuator, located within the rotating mass.

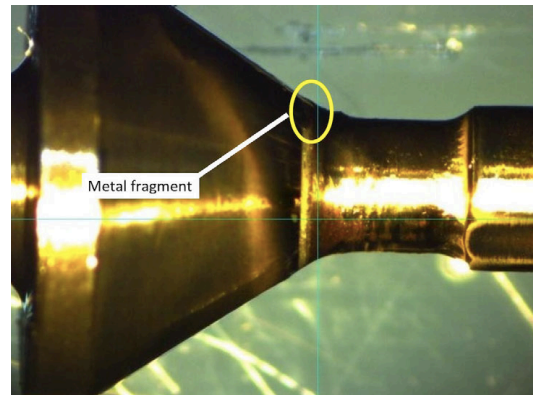
Above: Location of the metal fragment on the sealing surface on the high-pressure valve.

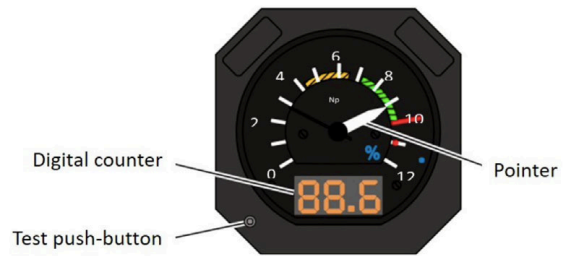
Above: Propeller rpm indicator, with digital counter, test push-button, and pointer labelled.
