The Magazine for Aircraft Maintenance Professionals

February - March 2023
Volume 21/Issue 5

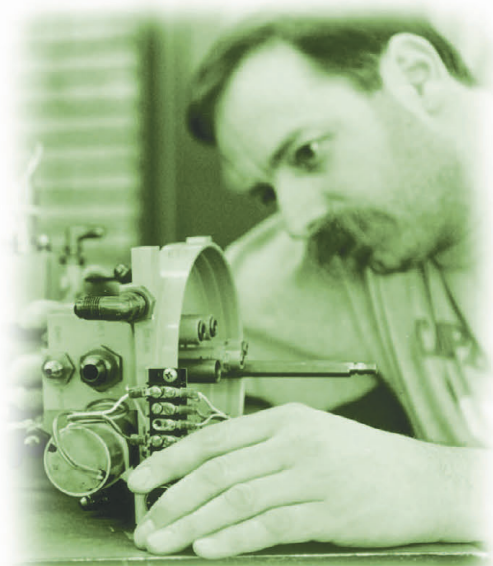
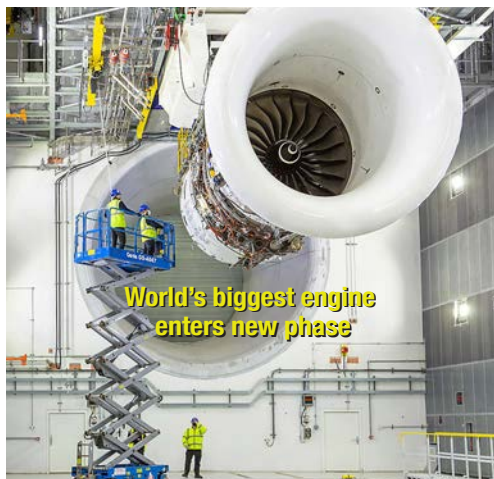
UltraFan rolls onto Testbed

World's biggest engine enters new phase

GO BIG OR GO HOME. The bigger the better. No replacement for displacement. Pick the cliché of your choice but they all boil down to one undeniable fact: when it comes to oversized objects nearly everyone finds a way to express interest and even admiration. Which is why Rolls-Royce now has the aviation industry's full attention as the British manufacturer continues progress on its massive UltraFan, an aircraft engine that is said to be the world's largest. Rolls-Royce announced in December that it has now finished building the first demonstrator for the UltraFan engine, which will eventually power airliners to be developed in the 2030s.

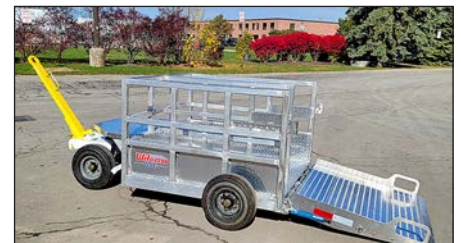
Trailer holds two wheels

The **Wilcox GSE Tire Trailer** is designed to easily transport two main aircraft wheels. Tires can quickly be loaded onto the cart via the light weight, non-slip extruded ramp and secured internally. The rear ramp lifts up easily with side assisted gas shock and locks into place. Solid tires will ensure never a flat and are locked when cart is not in use with towbar integrated brakes. Trailers are available in steel or aluminum construction. www.wilcoxgroundservices.com

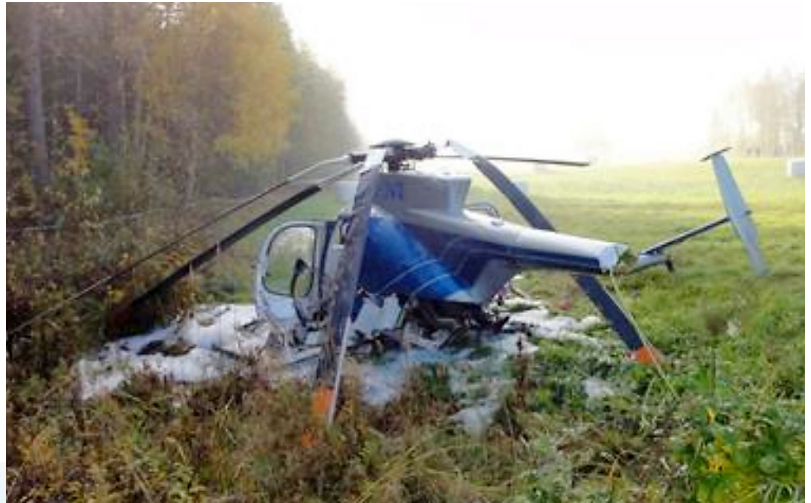
This page, right: The B-nut was involved in 33% of the cases of incorrect torquing or incomplete assembly of nuts, bolts, cutter pins, or safety wires.

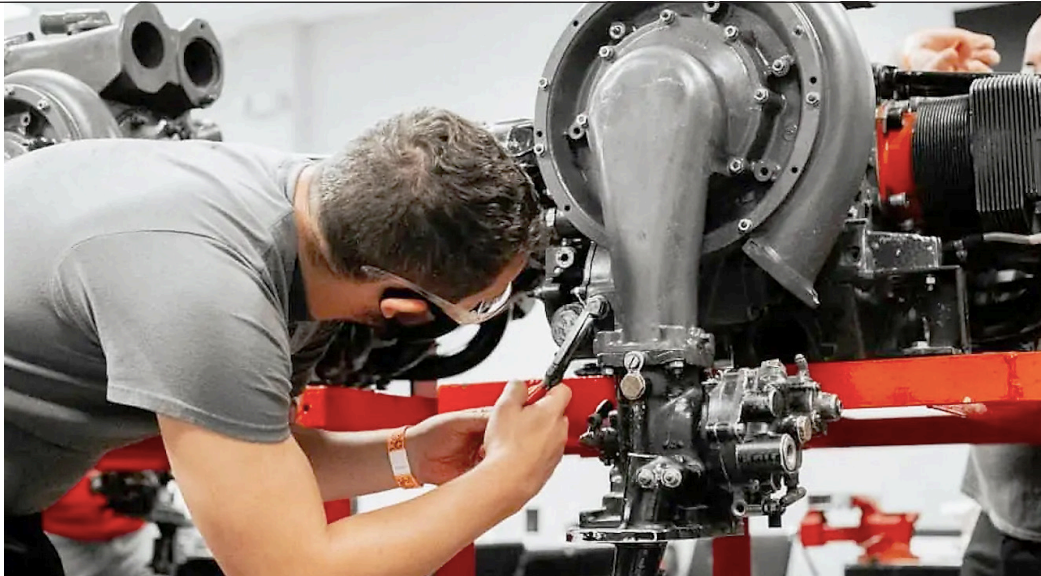
Above: Incorrect torquing or incomplete assembly of nuts, bolts, cutter pins, or safety wires accounts for a significant number of maintenance issues.

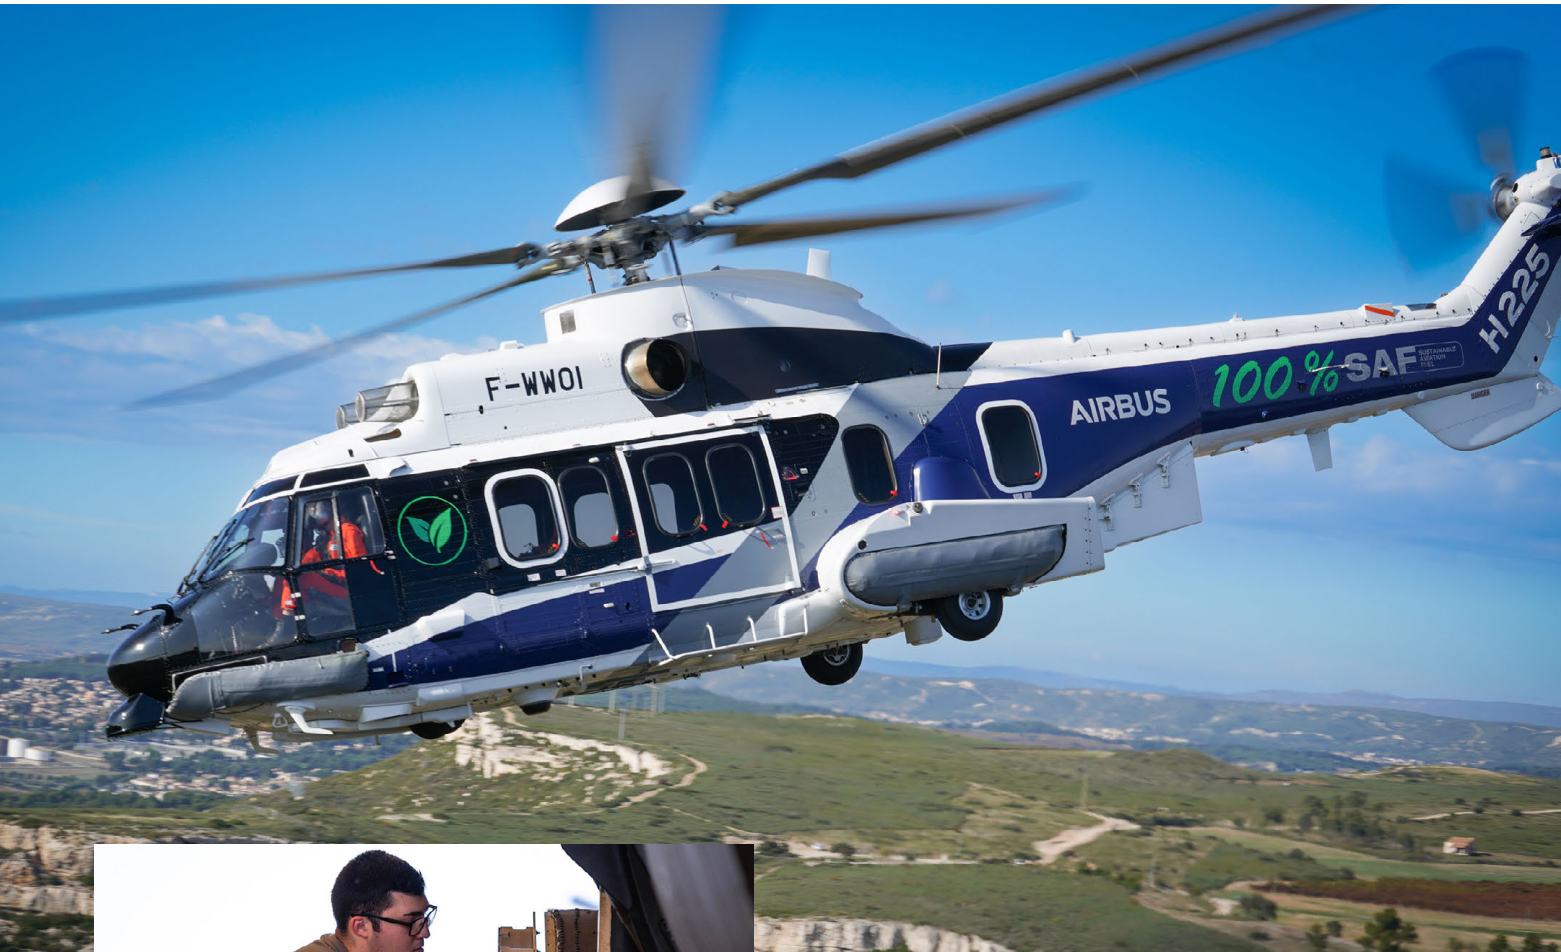
Above: The fundamental feature of a helicopter's design, a rotating wing, decouples the vehicle airspeed from that experienced by the airfoil or blade element on its main rotor.

By the same token however, rotating the wing raises a host of design and operational challenges and complexities, including issues related to vibrations and wear-out of a variety

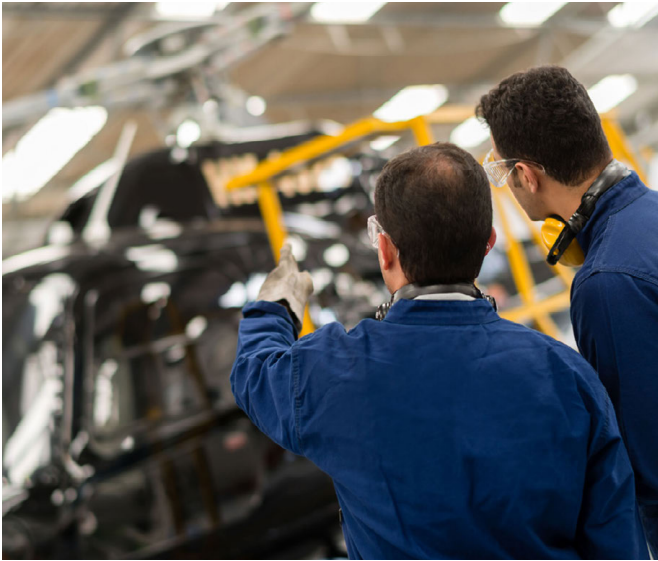
There is a clear and significant clustering of helicopter accidents immediately following maintenance and inspection.

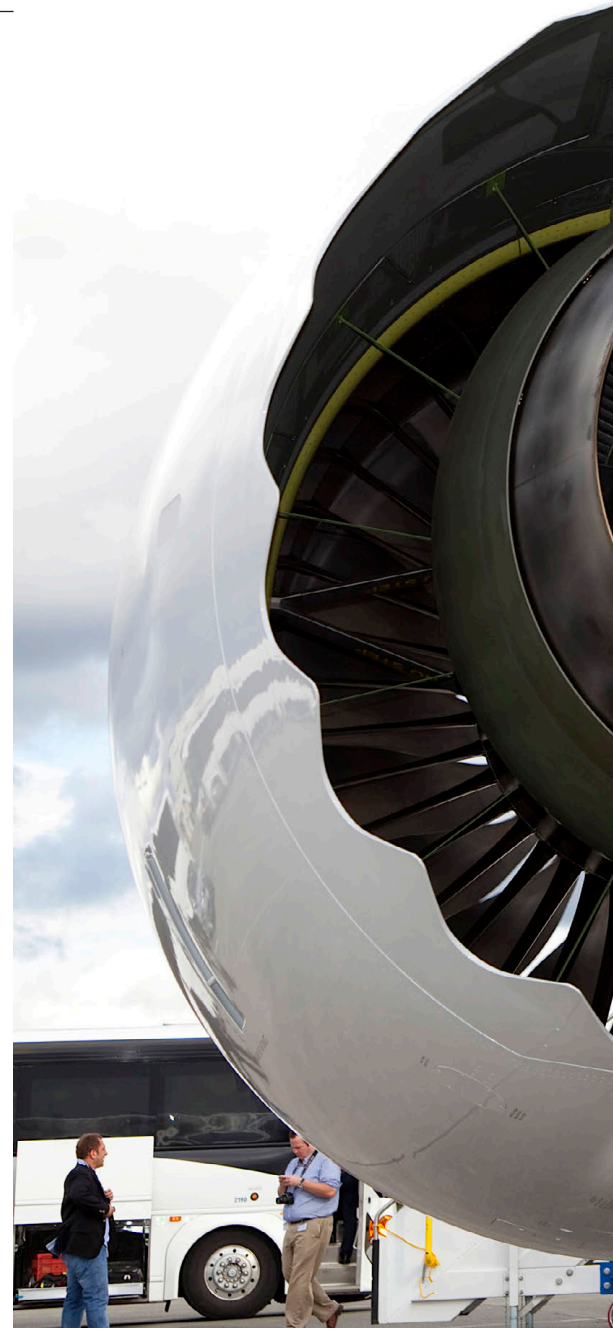
Left: The simple measurement used in old-fashioned lifing methods is based on a worst-case scenario.

That more realistic measurement of actual wear for the parts and engines makes it possible to keep them on wing longer. The simple measurement used in old-fashioned lifing methods, is based on a worst-case scenario which might see parts removed well before their actual wear would justify that. In order to achieve optimum effectiveness, methodology such as that requires lots of information to be provided to Rolls-Royce, some of which will be coming from Neos's MRO software Aircraft Maintenance and Engineering System (AMOS) that the airline has been using since 2004.

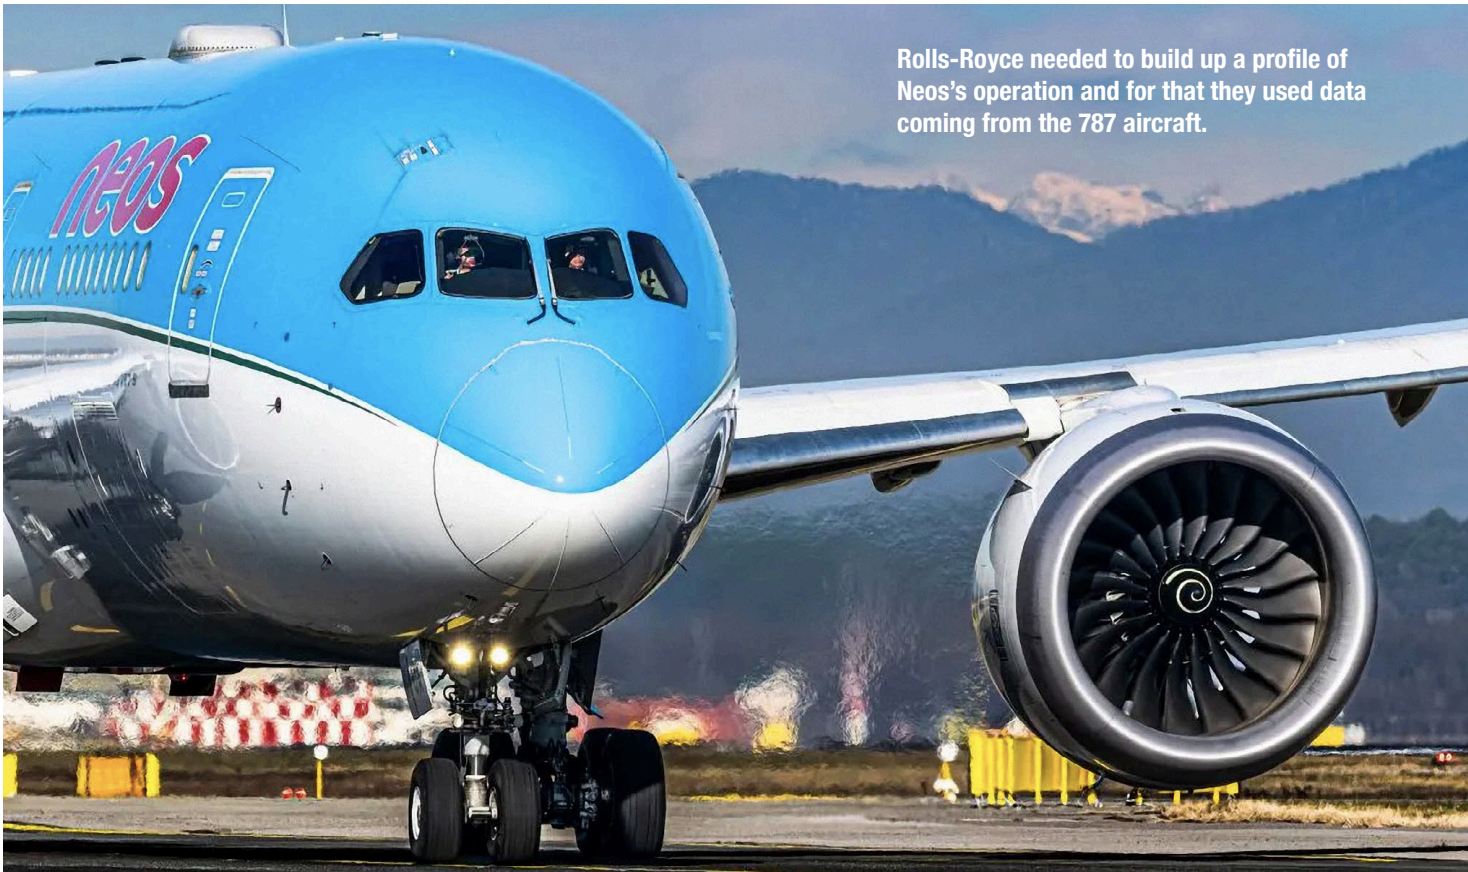
Rolls-Royce needed to build up a profile of Neos's operation and for that they used data coming from the 787 aircraft.

When Neos Air took delivery of its Rolls-Royce Trent powered 787s, in order to be able to measure the life and calculate the life expectancy of life-limited parts in each engine, Rolls-Royce first needed to build up a profile of Neos's operation (phase one). For that they used data coming from the 787 with ACARS messaging using a downlink from the aircraft. A second set of telemetric data that was generated by each engine during the flight and downloaded by the maintenance crew after the aircraft had landed.

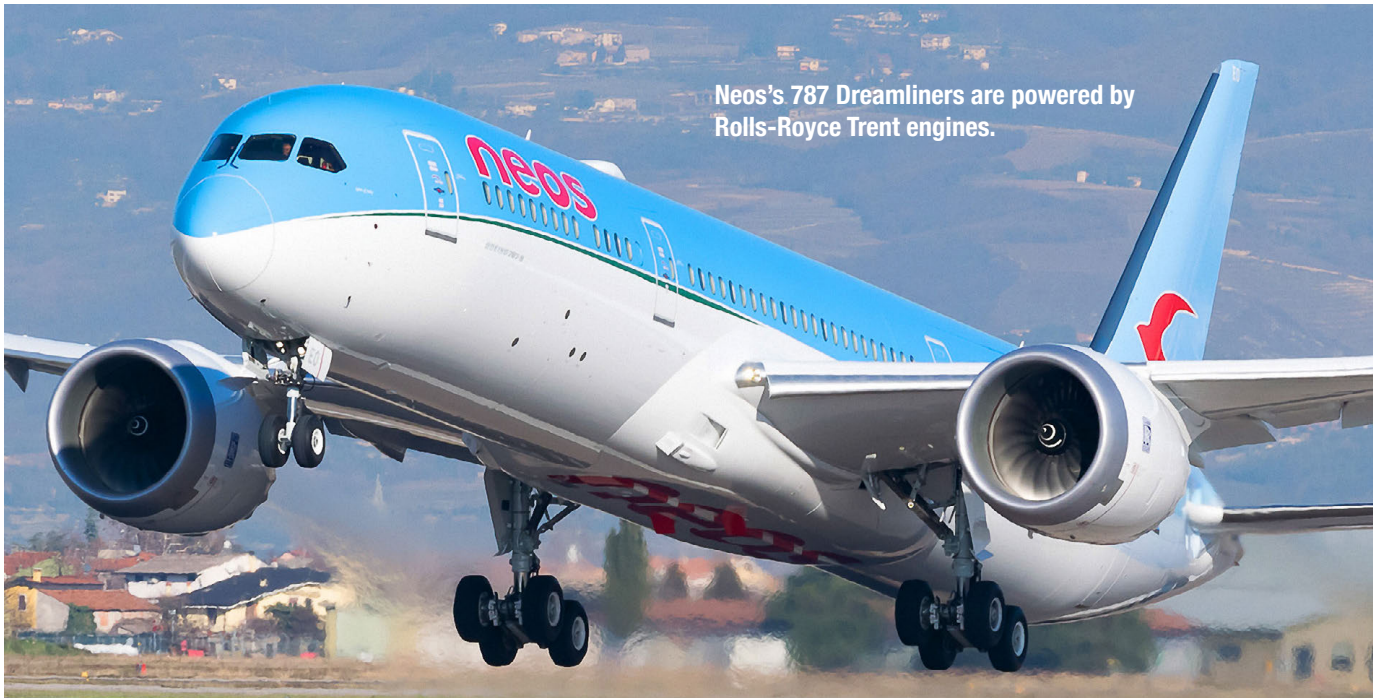
Neos's 787 Dreamliners are powered by Rolls-Royce Trent engines.

Neos's 787 Dreamliners are powered by Rolls-Royce Trent engines and, as part of the engine management plan implemented by the OEM to increase MTBSR (Mean Time Between Scheduled Repairs), they introduced a method called DAC (Direct Accumulation Count) of cycles for aircraft engine management. The purpose is to increase cyclic life by analytically determining how much of that life is consumed during

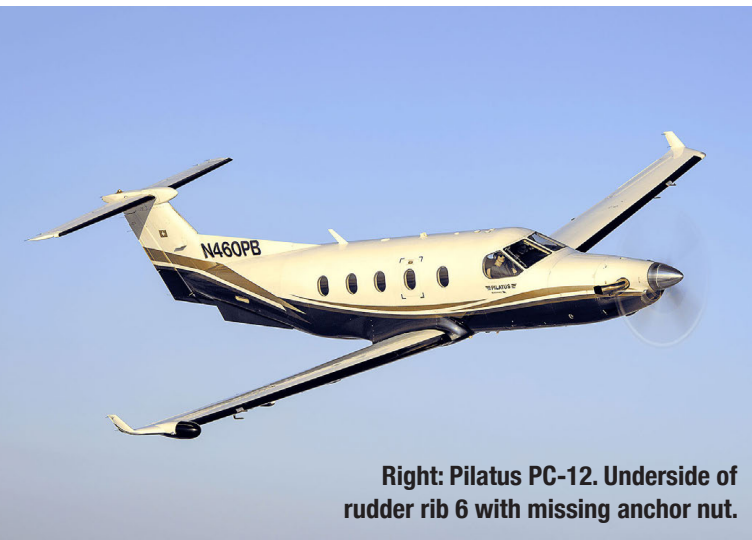
Right: Pilatus PC-12. Underside of rudder rib 6 with missing anchor nut.

During a maintenance check, the rudder was removed to inspect for play at the hinge point, and a Structural Repair Manual (SRM) repair was carried out by installing a bushing. During the rudder re-installation, when mounting the top rudder attach point bolt, a rattling noise was heard of something that had dislodged and fallen inside the rudder. Upon further investigation, it was noted that the anchor nut to which the bolt must be attached had fallen inside the rudder. After the anchor nut was retrieved, it was noted that the anchor nut was still riveted to the broken piece of rudder rib 6.

Pilatus offers another repair, Rudder Upper Hinge Attachment Repair RM05387 (Replacement of the nutplate with a self-locking nut and washer). This repair replaces the anchor nut with a self-locking nut and washer. This repair also adds an inspection panel to access the lower portion of rudder rib 6.

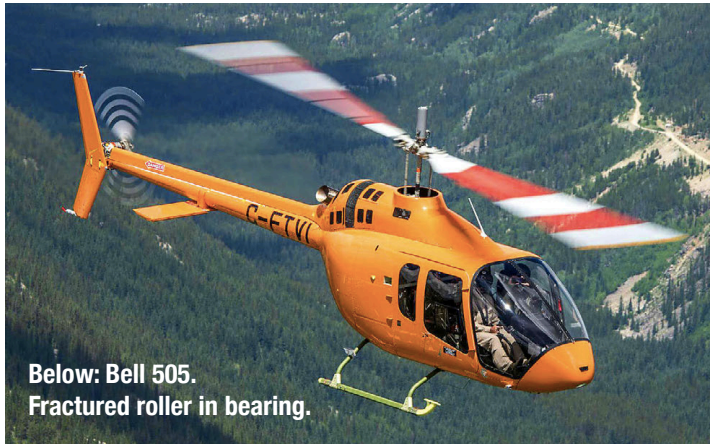
Below: Bell 505.
Fractured roller in bearing.

Feathering bearing, part number (P/N) 206-011-118-001, was removed from a main rotor hub of a Bell model 505 helicopter. The main rotor hub has not been disassembled since new. Total time is 197.2 hours since new. The feathering bearing was found damaged upon removal. Bell Helicopter has been notified.

Bell investigated this service difficulty and indicated that it may have been possible for the bearing to have been inadvertently damaged during the assembly of the main rotor hub. Although the roller was found fractured, an inspection of the rollers mating surface on the main rotor yoke showed no damage.

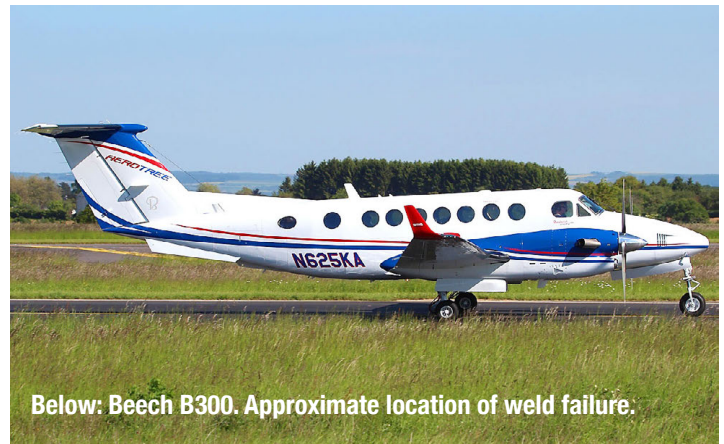
Below: Beech B300. Approximate location of weld failure.

Similar failures have also been reported on other King Air models (not limited to King Air 300 Series aircraft) that utilize an inlet de-ice lip heated by exhaust gas from a collector in the exhaust stack. Failures include weld failure of the inlet/outlet tubes as depicted below, anti-ice flex hose failure, or connection points failure. Flight crews may be unaware that the air intake anti-ice lip heating function is degraded or completely unavailable since there are no shutoff, caution, or temperature indications for this system.

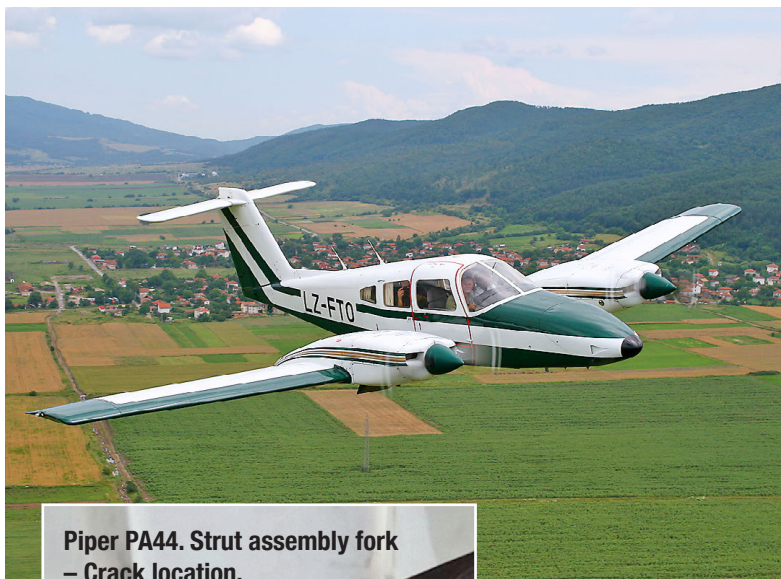
Piper PA44. Strut assembly fork – Crack location.

During an inspection of the gear down-lock switch on the right-hand (R/H) MLG, an aircraft maintenance engineer (AME) found, by chance, a crack on the lower strut assembly inboard of the axle, where the brake torque plate bolts attach. The crack is slightly above the bolt at the 1 o'clock position, and it is where the strut joins the axle. The location of the crack is in a significant load bearing area.

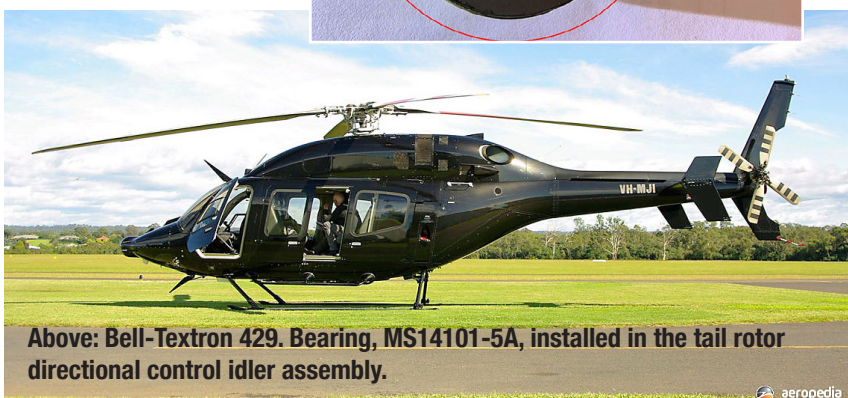
Above: Bell-Textron 429. Bearing, MS14101-5A, installed in the tail rotor directional control idler assembly.

The following was reported to Bell upon the 800-hour inspection. Excessive wear was found on the bearing of the directional control idler.

The worn bearing, part number (P/N) MS14101-5A, is a component of the tail rotor directional control idler assembly, P/N 429-001-721-105. Several Service Difficulty Re-

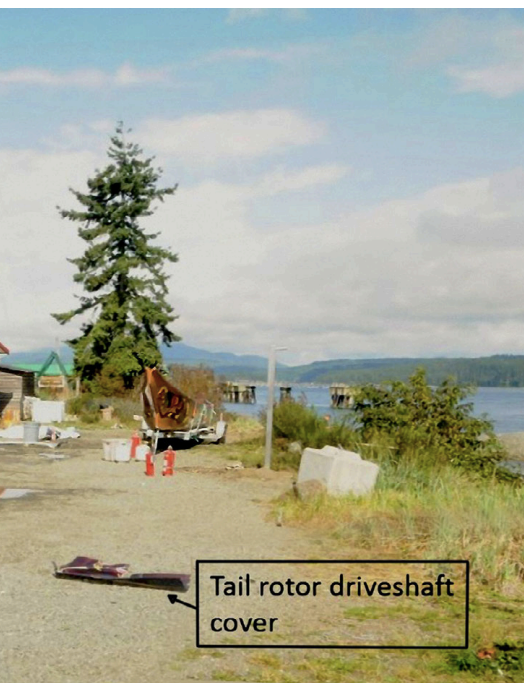
Tail rotor driveshaft cover

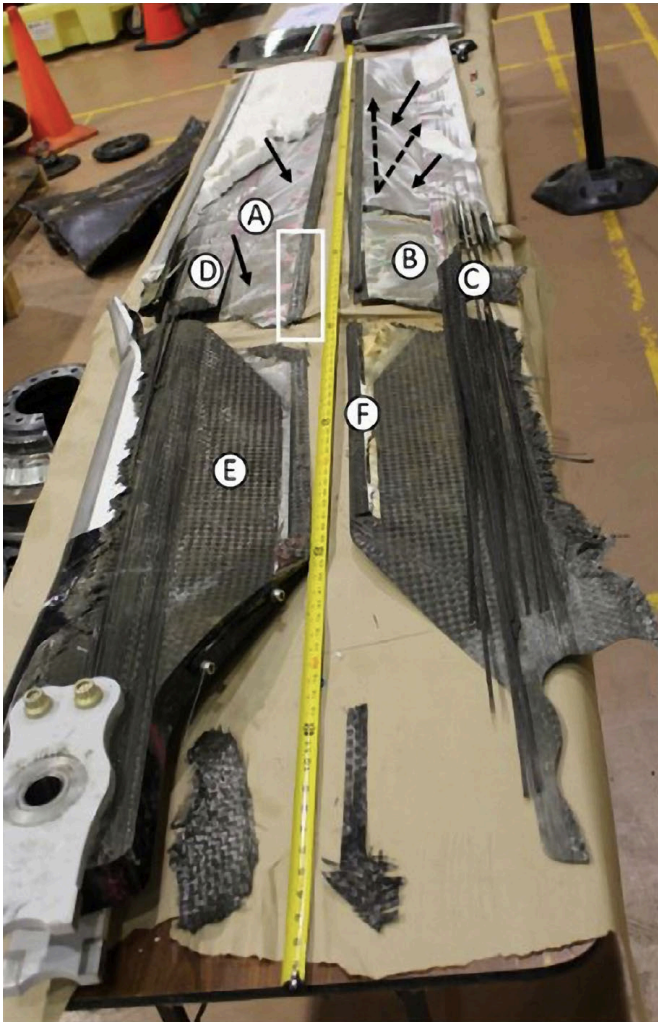
Opposite, right: Main rotor blade upper and lower skins sectioned by the TSB for examination.

A-Lower skin
B-Upper skin
C-Upper spar
D-Lower spar
E-Upper filler ply stack
F-Trailing edge strip

Solid black arrows - symmetrical fracture arrest lines or tidal marks
 Dashed black arrows - direction of failure at station 60
 White rectangle - area of discoloration on trailing edge strip

Staff at the TSB Engineering Laboratory in Ottawa, Ontario, conducted an examination of the main rotor blades with the manufacturer present. The examination identified that the damage to both blades featured characteristics of different failure mechanisms, namely fibre breakage, ply separation, delamination, and debonding.
