# AirMaintenance

The Magazine for Aircraft Maintenance Professionals

April - May 2023  
Volume 21/Issue 6

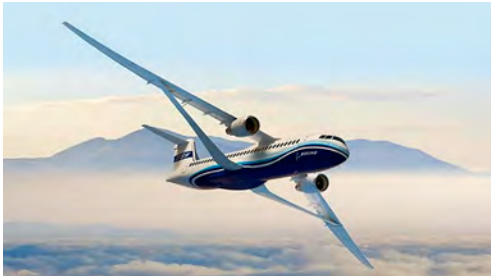
# Project Transonic Truss-brace

Under a Funded Space Act Agreement, Boeing will work with NASA to build and fly a full-scale Transonic truss-braced wing demonstrator aircraft aimed at lowering emissions. The concept aircraft involves extra-long, thin wings stabilized by diagonal struts. This design theoretically results in an aircraft that is much more fuel efficient than a traditional airliner due to a shape that would create less drag – resulting in its burning less fuel.

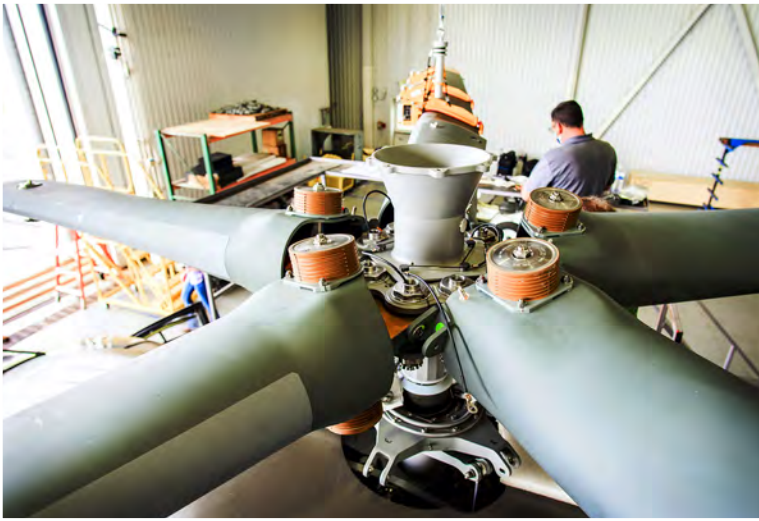
**Left: Users found the track conditions of the rotor directly related to vibrations in the airframe.**

Users found the track conditions of the rotor directly related to vibrations in the airframe. Experimentally it was found that the vibration information could be used to adjust pitch links and tabs to produce minimum vibrations at all forward speeds. After this process was complete, the blade track could be measured optically and surprisingly the blades were not in

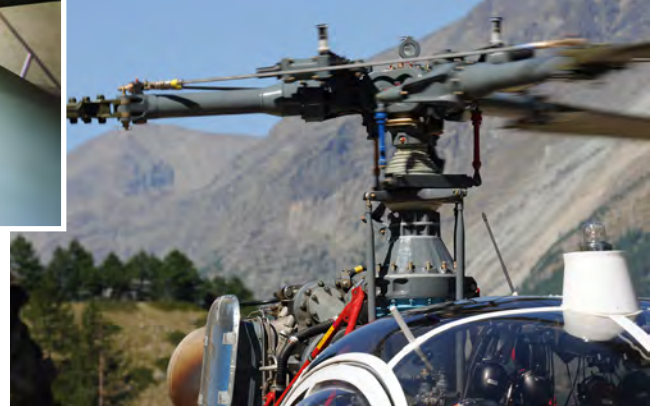
**Above: A bad damper may produce a subtle transient vibration effect during turns.**

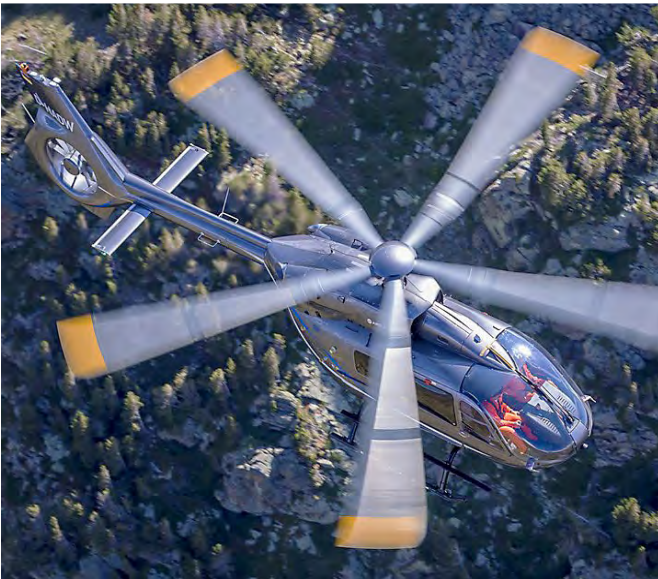
**Left: If alternating blades are set to fly high and then low, each blade will have calmer air to fly through resulting in smoother flight.**

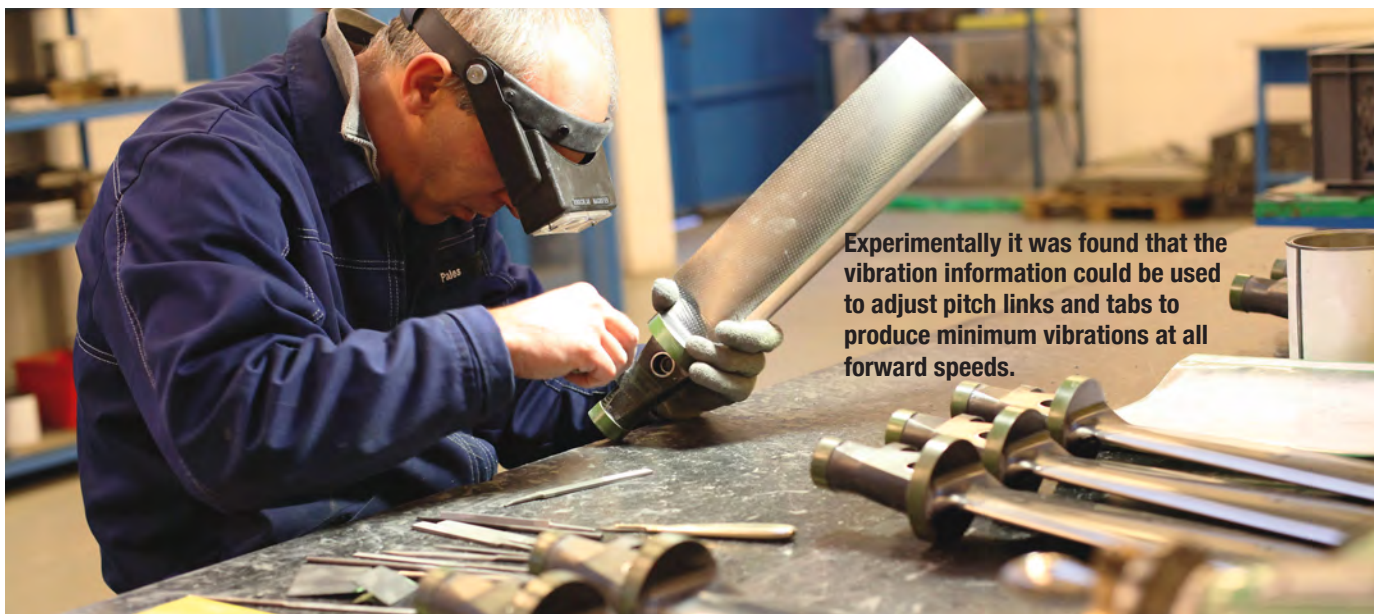
Experimentally it was found that the vibration information could be used to adjust pitch links and tabs to produce minimum vibrations at all forward speeds.

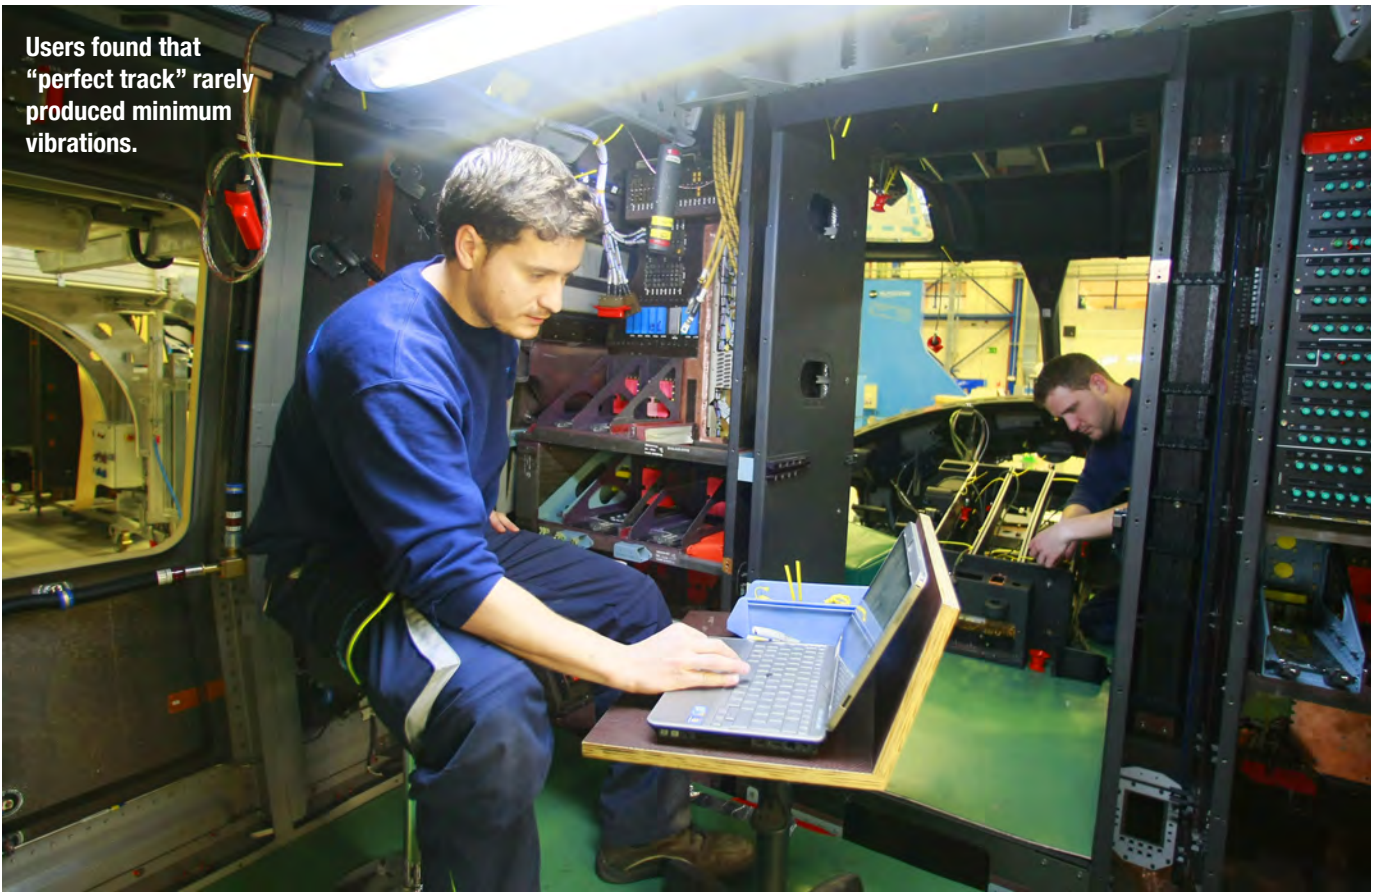
Users found that "perfect track" rarely produced minimum vibrations.

In the process of using these tracking methods and measuring the vibrations that resulted, users found that “perfect track” rarely produced minimum vibrations. Various theories have been proposed to explain this effect. One theory is that each blade has a slightly different shape, twist, flexibility etc. and only by putting them slightly out of track can these variations in lift be compensated. Another theory is that each blade produces a “turbulent wake” that the trailing blade must fly through. If alternating blades are set to fly high and then low, each blade will have calmer air to fly through resulting in smoother flight. This effect is more pronounced on aircraft with four or more blades on the main rotor.

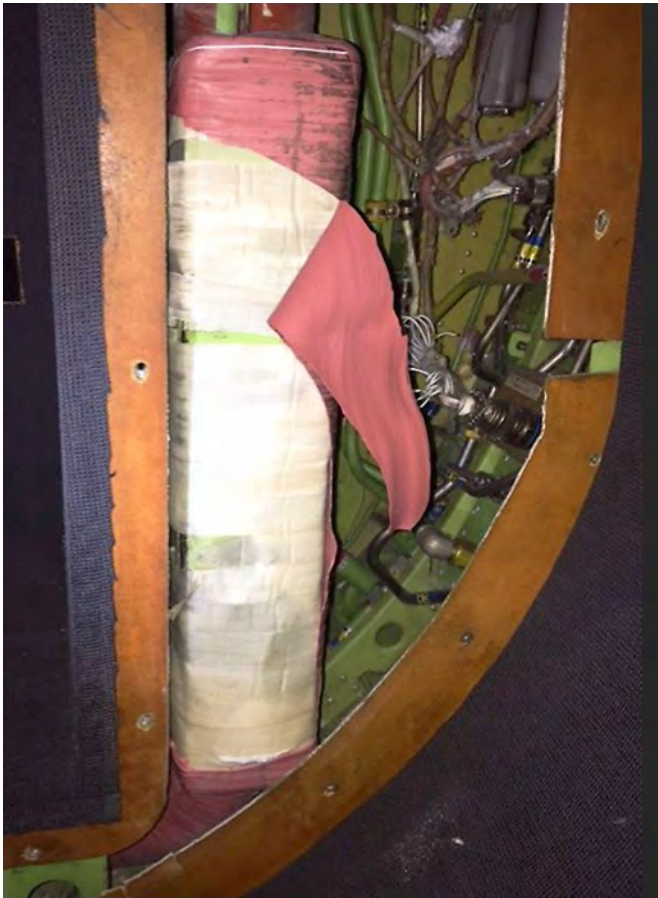
**Left: Muffler as installed, adjacent to the hydraulic filter manifold, outer insulation wrapping damage is evident. Above: A Learjet 45**

During routine maintenance, insulation was found blown into the hydraulic access panel and filter areas. Further investigation revealed that the cockpit ECS muffler assembly had cracked in two places (one crack was 2 1/8" long and the other was 3 1/8" long). No issues were noted in flight prior to the finding. This muffler was installed in 2000, in accordance with Service Bulletin 45-21-4 Modification of the Environ-

This area is routinely accessed during a 300 hour hydraulic filter replacement. Damaged or loose outer insulation wrapping around the muffler or insulation material located near the hydraulic manifold is a good indication that the cockpit ECS muffler may be cracked.

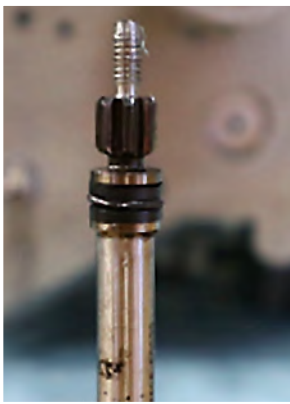
**Left: General Electric CF6. Main Engine Control driveshaft.**

Troubleshooting was carried out and identified the Main Engine Control (MEC) as being at fault. Upon maintenance removing the MEC from the accessory gearbox, the driveshaft was found no longer mated to the MEC. The driveshaft had migrated towards the gearbox and was no longer rotating the MEC internal shaft. The nut, attaching the driveshaft within the MEC, had backed off to allow this migration of the shaft. The MEC was replaced, and the aircraft was returned to service.

From viewing the MEC driveshaft threads photograph, it appears that the threads were worn or damaged. This condition may have been a factor contributing to the attaching nut backing off. The use of wrong hardware, cross threading or over torque of the securing nut, and thread strength, are a few possible causes of thread damage. Until an investigation is carried out, the root cause of this event remains undetermined.

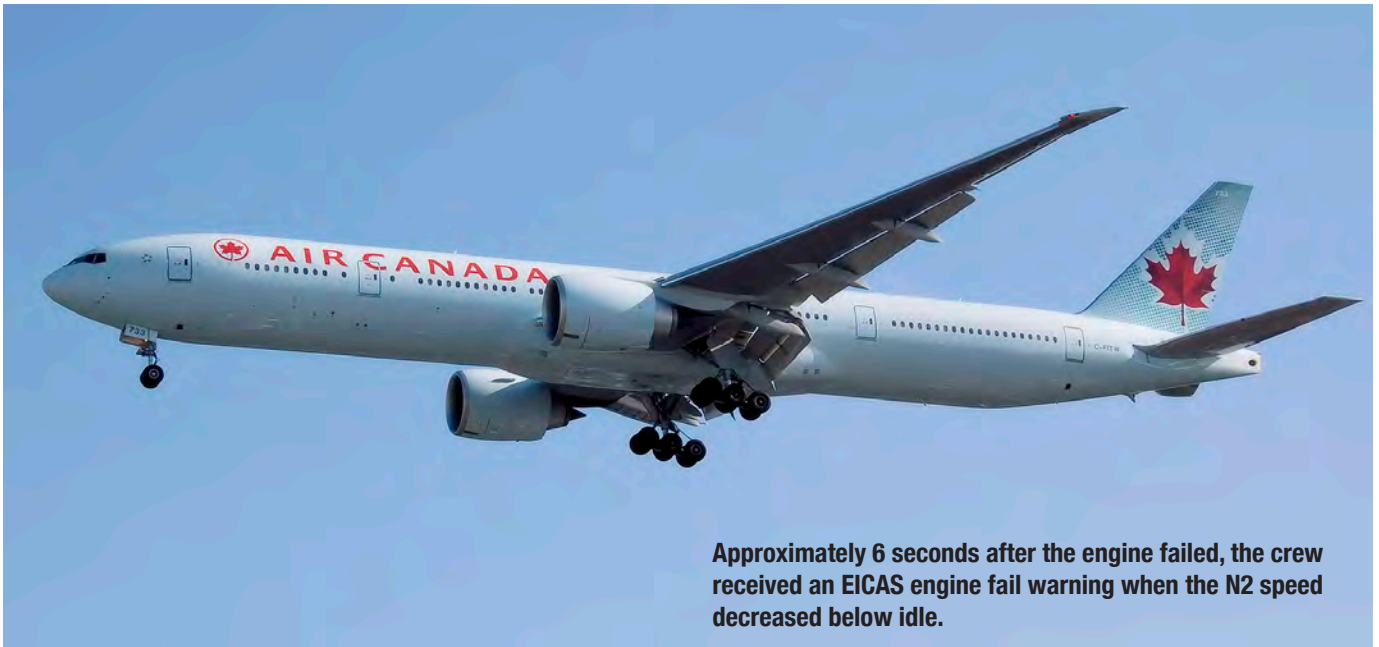
**Approximately 6 seconds after the engine failed, the crew received an EICAS engine fail warning when the N2 speed decreased below idle.**

Approximately 6 seconds after the engine failed, the crew received an EICAS engine fail warning when the N2 speed

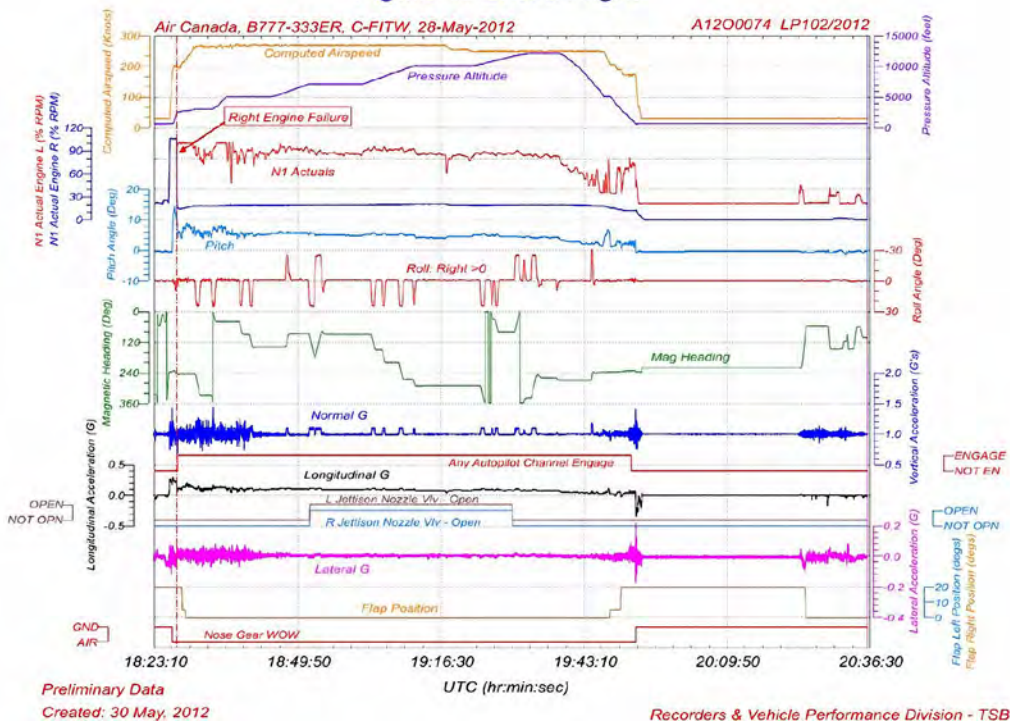
Figure 1: Entire Flight

Left: Flight data recorder data.
