AirMaintenance

The Magazine for Aircraft Maintenance Professionals

**RAISING THE BAR:
Vanishing Ice
CARBURETOR ICING**

**February - March 2024
Volume 22/Issue 5**

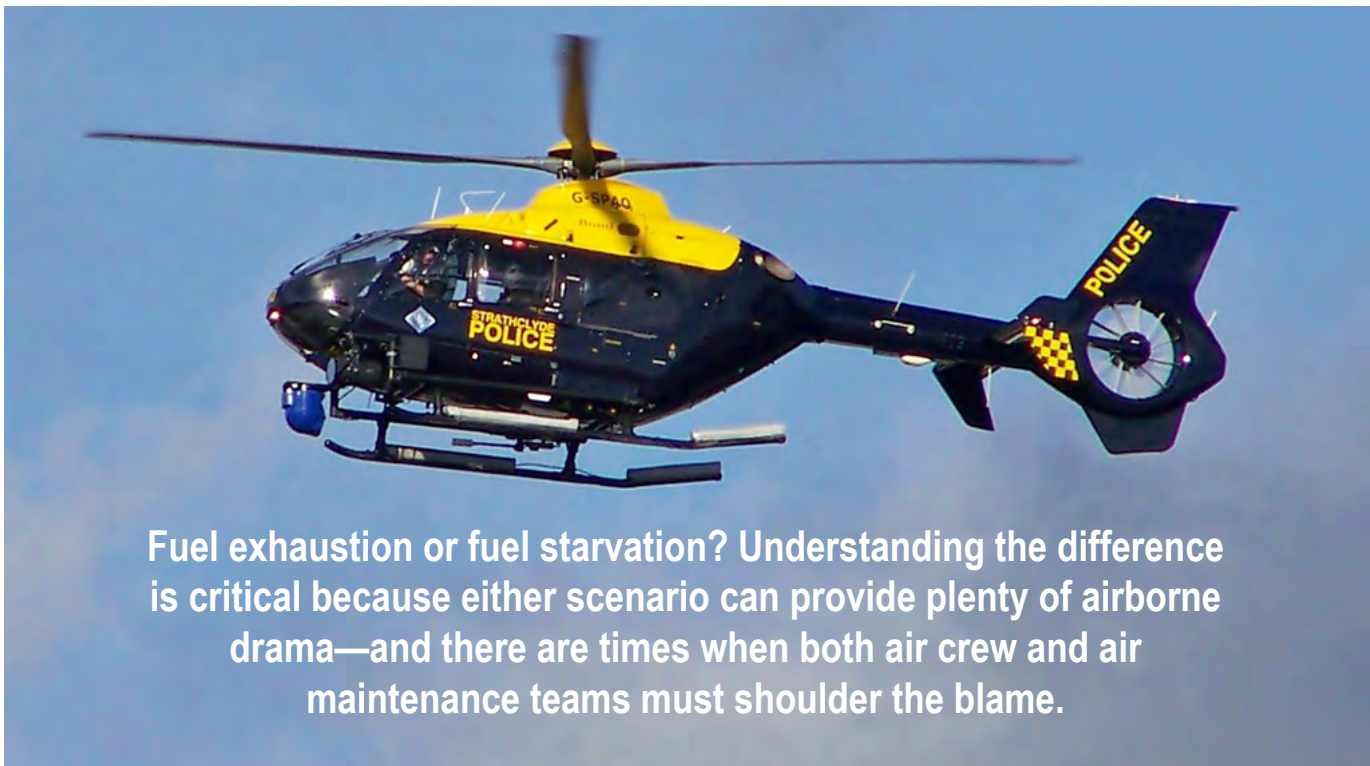
An Airbus Helicopters EC135 was lost after both engines flamed out following fuel starvation.

EC35, VICINITY GLASGOW CITY HELIPORT UK, 2013 (As seen on page 10)

On November 29, 2013, control of an Airbus Helicopters EC135 undertaking a night VMC flight for policing purposes was lost after both engines flamed out following fuel starvation. The subsequent crash killed the three occupants and seven on the ground, seriously injuring eleven others. The Investigation found that although the pilot had acknowledged low fuel warnings after both fuel transfer pumps had been switched off, the helicopter had not then been landed within 10 minutes as required. No evidence of any relevant airworthiness defects was found and without FDR/CVR data, a full explanation of the accident circumstances was not possible.

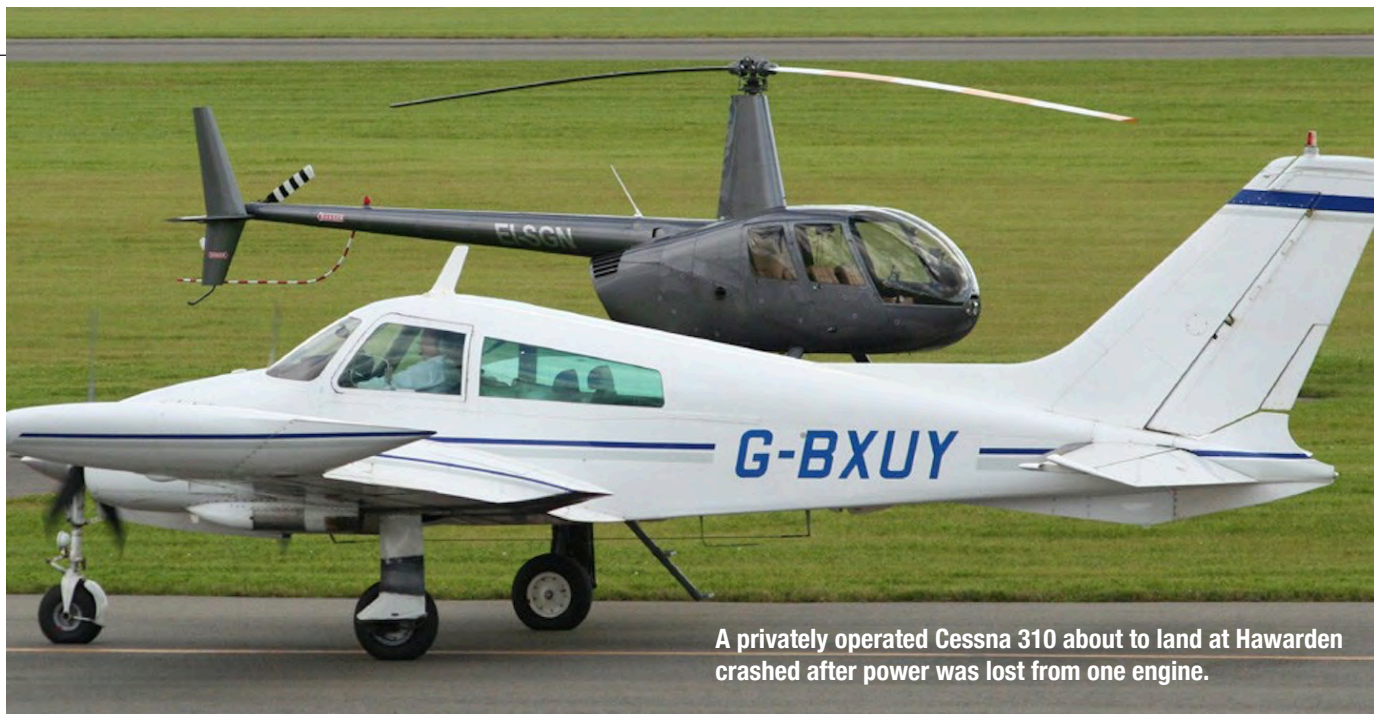
A privately operated Cessna 310 about to land at Hawarden crashed after power was lost from one engine.

On November 15, 2013, a privately operated Cessna 310 about to land at Hawarden crashed after power was lost from one engine and the experienced pilot appeared to have attempted to initiate a go around rather than land on the grass next to the runway. The Investigation found that both main fuel tanks were effectively empty after normal fuel use during the flight and since unused fuel remained in the auxiliary tanks, it was concluded that fuel starvation attributable to enroute fuel system mismanagement had occurred. The other engine had been at full power but with fuel starvation imminent.

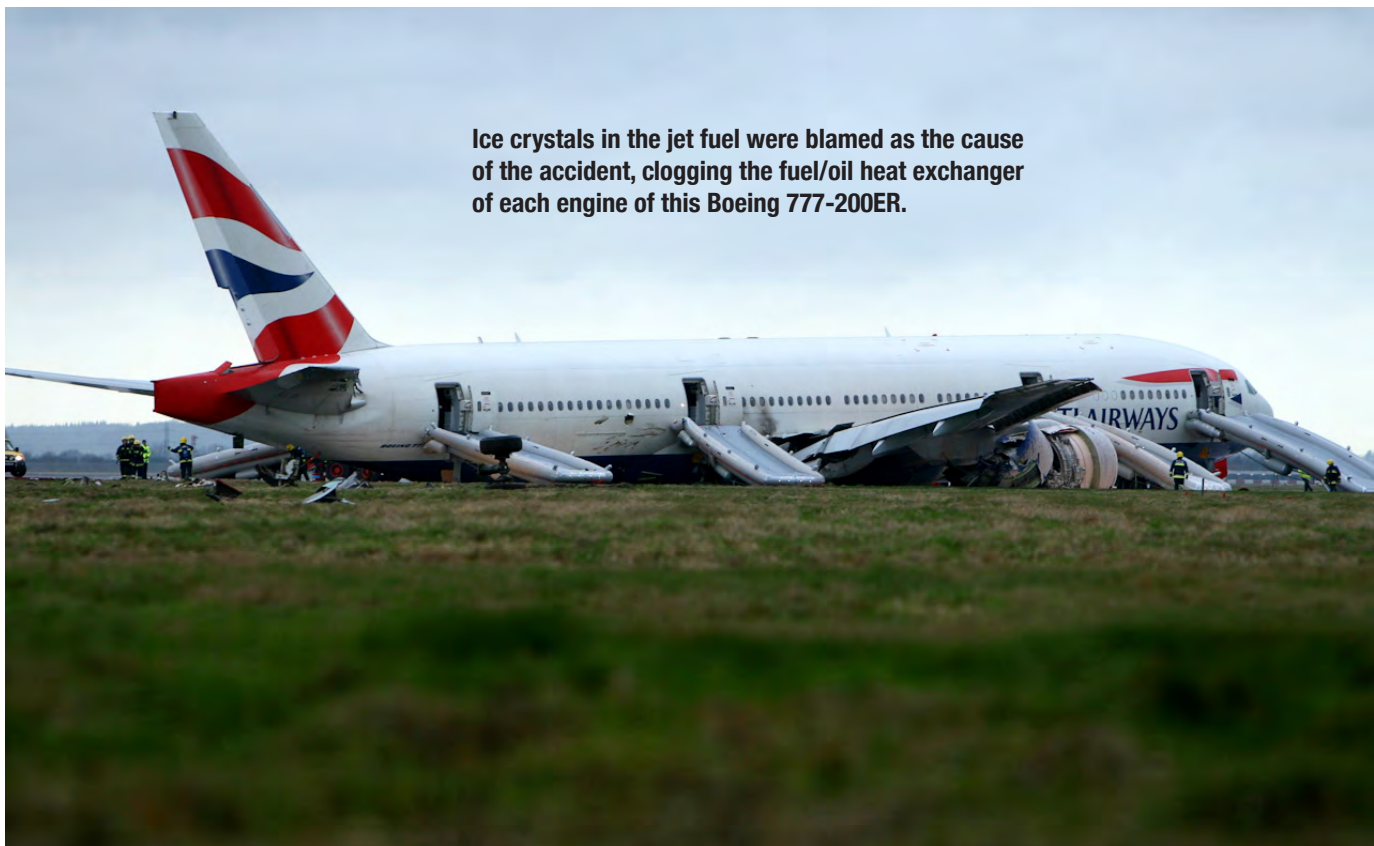
Ice crystals in the jet fuel were blamed as the cause of the accident, clogging the fuel/oil heat exchanger of each engine of this Boeing 777-200ER.

B772, LONDON HEATHROW UK, 2008 (top, page 12)

On January 17, 2008, a British Airways Boeing 777 200ER crash-landed 330 metres short of the intended landing runway, 27L, at London Heathrow after a loss of engine thrust on short final. This un-commanded reduction of thrust was found to have been the result of ice causing a restriction in the fuel feed system. Prompt crew response minimized the extent of the inevitable undershoot so that it occurred within the airport perimeter.

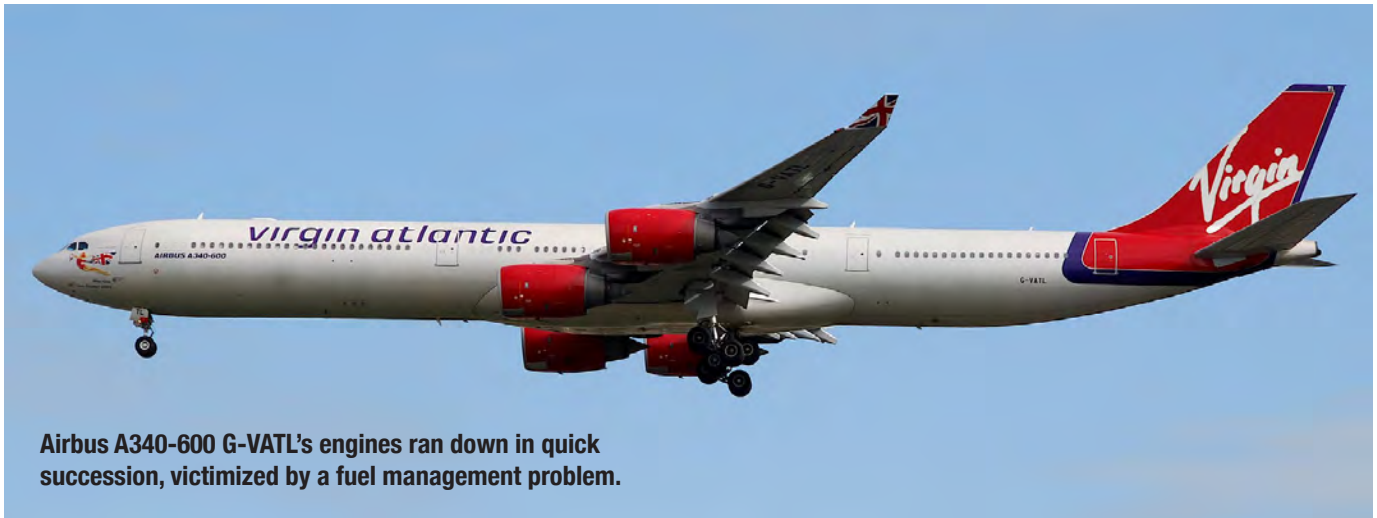
Airbus A340-600 G-VATL's engines ran down in quick succession, victimized by a fuel management problem.

A346, ENROUTE, NEAR AMSTERDAM NETHERLANDS, 2005

On February 8 2005, an Airbus A340-600 was 11 hours into its flight from Hong Kong to London Heathrow when the No. 1 and No. 4 engines ran down in quick succession. A fuel management problem rather than a fuel shortage was then diagnosed but a manual transfer was only partially successful and a diversion to Amsterdam was made on three engines. The investigation found that the master Fuel Control and Monitoring Computer had failed, that timely warnings of automated fuel control system malfunctions were not provided and that alternate low fuel level warnings were inhibited by inappropriate system design.

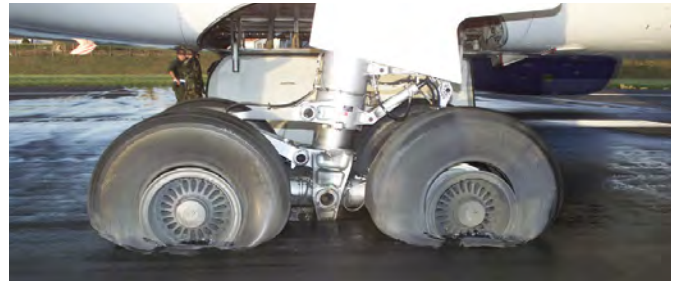
The Airbus 330 C-GIT'S landing was rough with extensive damage but no loss of life.

Inevitably, No. 2 engine flamed out from fuel starvation and 13 minutes later so did No. 1 engine. The captain was forced to making a gliding descent without hydraulic power for the flaps, alternate brakes, and spoilers. The landing was rough with extensive damage but no loss of life.

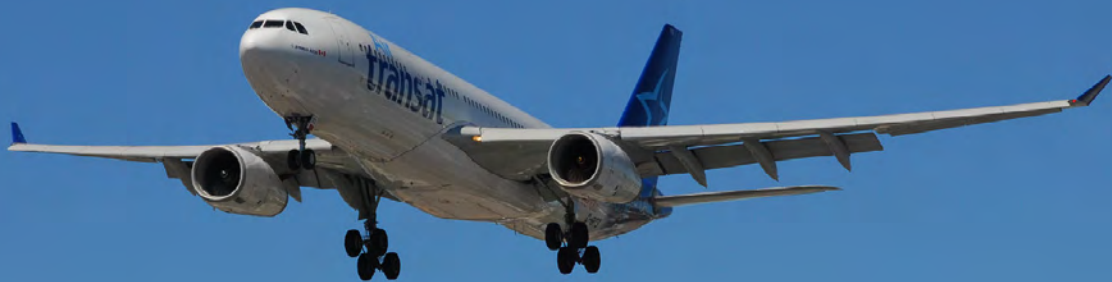
The Airbus 330 C-GITS lost all engine power while flying over the Atlantic Ocean on August 24, 2001. This incident resulted in Air Directive from the FAA.

The accident led to the FAA issuing an airworthiness directive requiring all operators of Airbus models A318, A319, A320 and A321 narrow-body aircraft to revise their flight manuals, stressing that crews should ensure that any fuel imbalance is not caused by a fuel leak before opening the cross-feed valve. ■

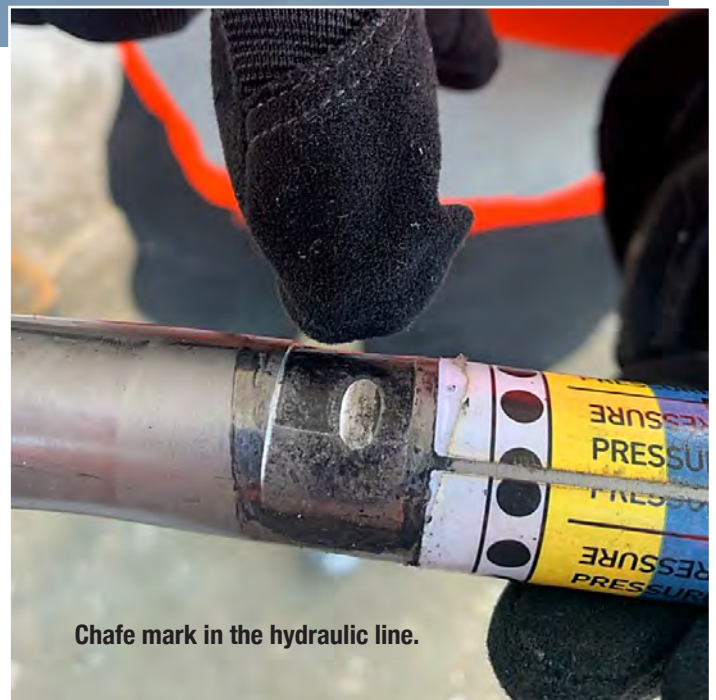
Chafe mark in the hydraulic line.

Yellow system reservoir low-level Electronic Centralized Aircraft Monitoring (ECAM) in climb. ECAM procedure applied. Yellow system reservoir indicating empty. Pan declared; the aircraft landed safely. The hydraulic line was chaffing under a clamp, pipe assembly was replaced. The yellow system pressure line in the pylon was replaced in accordance with the aircraft maintenance manual chapter 29-13-49-400-008A. Leak checks carried out, checked serviceable. #1 fan cowl closed and #1 FIREX bottle install.

the entire contents of the Yellow hydraulic system were lost because of the smallest hole. More redundancy is built into the system on large aircraft to absorb such a loss. Smaller aircraft may not be so lucky. Some of the signs of a hydraulic leak could include the following: blistering paint; dirt build-up around a line or on the structure adjacent to the line; or swollen clamp material. Please be vigilant when performing walk-around or pointed inspections.

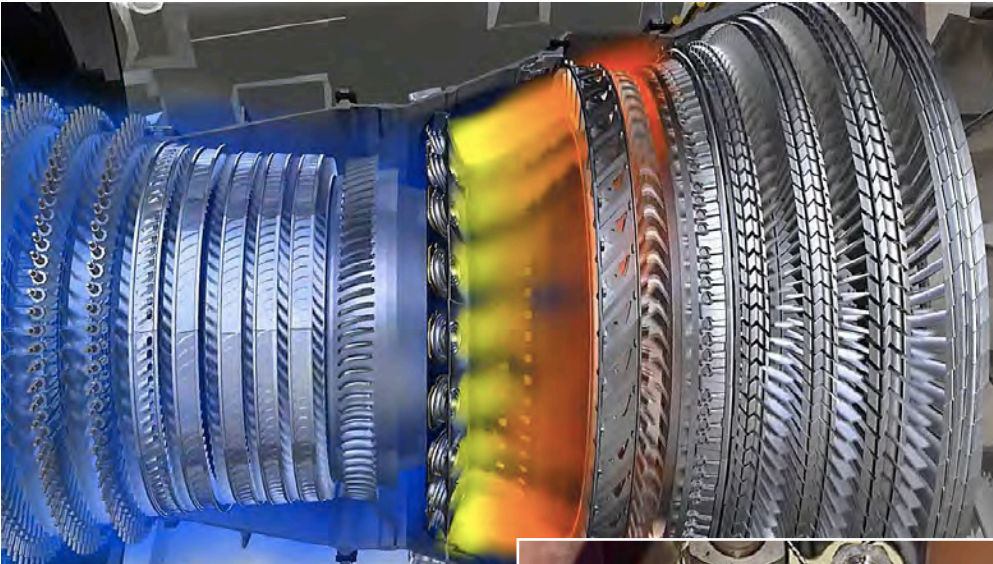
Left: 2CFM-CFM56
Below: 2CFM-Ruptured fuel line.

Dripping fuel from right-hand engine fan cowl was found on a walk around. Further inspection of the area showed a ruptured integrated drive generator (IDG) heat exchanger fuel line. The fuel oil heat exchanger tube/line was replaced.

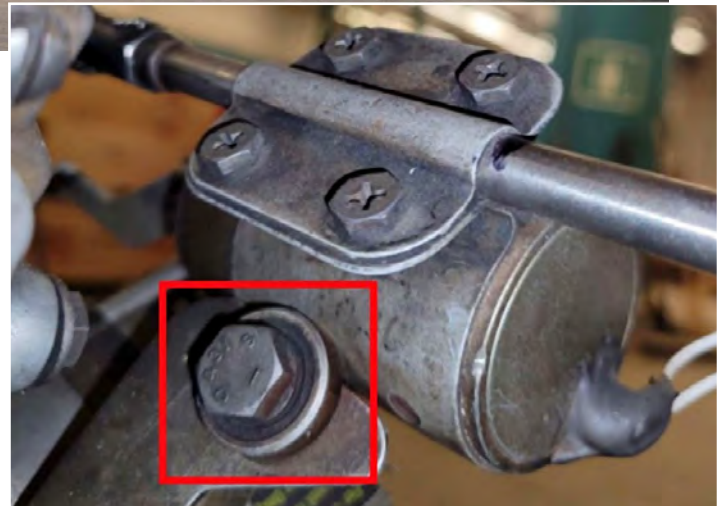
Below, right: Wear marks observed in the body of the solenoid bracket.

and there were signs of corrosion noted. Examination of the beta solenoid brackets found wear markings from their respective roller bearings evident along the working line of contact, from the normal in-flight position to the retracted position when the reversing cable is pulled by the pilot utilizing the power lever. The through-thickness hole on the LH bracket was observed. The location of these worn engine assemblies would make it difficult to observe the wearing marks unless disassembly during routine maintenance in the area was performed.

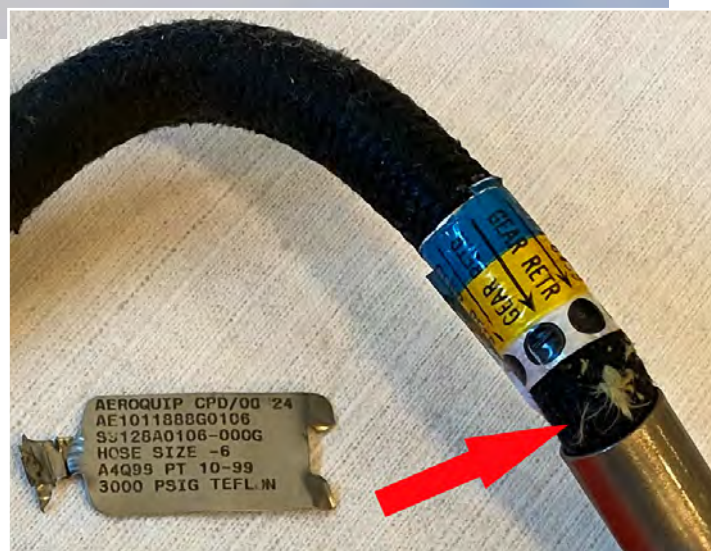
Cessna-750 Citation X.
Below: Hose assembly failure location.

retraction hose had burst. The aircraft has now been repaired and is back in service. Hose part number (P/N) S3128A0106-000G manufactured 4q99. This hose is original to this aircraft. No applicable SB (Service Bulletin) or SL (Service Letter) has been found related to this part, and there are no TLMC (Time Limit Maintenance Check) requirements for this hose.

In all cases reported, emergency extension of the gear using the free fall or pneumatic blow-down methods resulted in positive gear down indication and subsequent safe landing. Transport Canada suggests owners, operators, and maintainers pay attention to the age and condition of the RH main landing gear retraction hose. In particular, the section in close proximity to the swage end of the hose assembly.

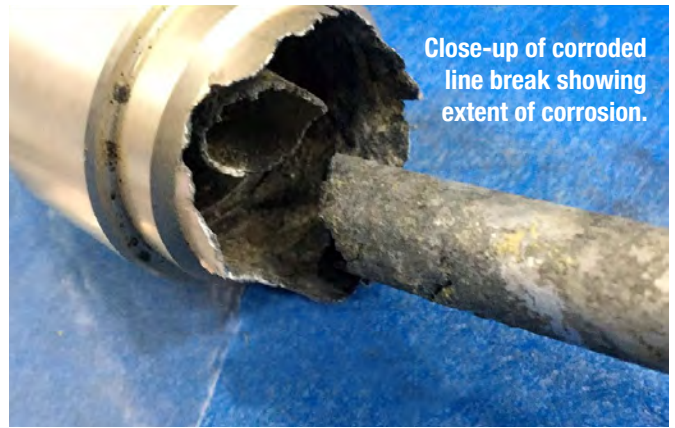
Close-up of corroded line break showing extent of corrosion.

While running the auxiliary power unit (APU), maintenance discovered a fuel leak. The investigation determined that the fuel leak was caused by severe corrosion of the APU fuel feed line. Maintenance attempted to rob a replacement fuel line from another aircraft but found that the line was also corroded at the same location. The fuel lines are to be replaced with serviceable parts.

However, the area is still known to be susceptible to significant corrosion defects. The Illustrated Parts Manual, Section 28-20-00, Figure 5, shows the area where defects have been found, and the lines, shrouds and fittings in this area that can be affected by corrosion and develop leaks. Removal of the shroud is required to inspect and find the corrosion defects because they originate inside the shroud and on the lines.

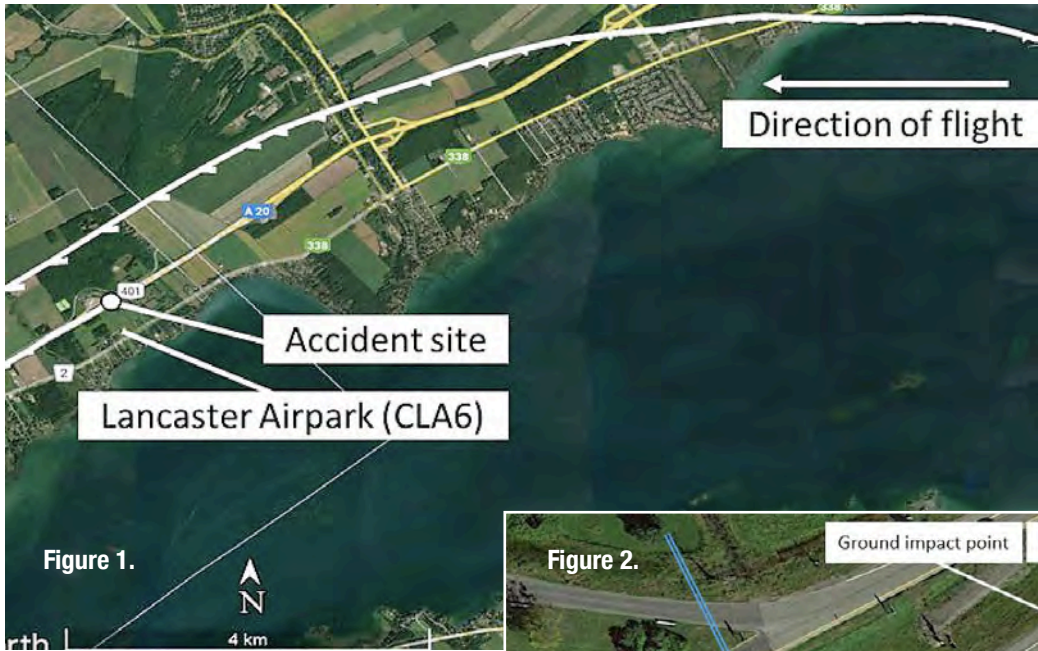
Figure 1. Satellite image showing the route flown.

The aircraft departed CSD3 at 1952, turned toward the northwest, and climbed to 1500 feet above sea level. After crossing the St. Lawrence River, the aircraft turned to the southwest toward CYCC, flying north of the shoreline along Quebec provincial Highway A20 (**Figure 1, top of page 29**).

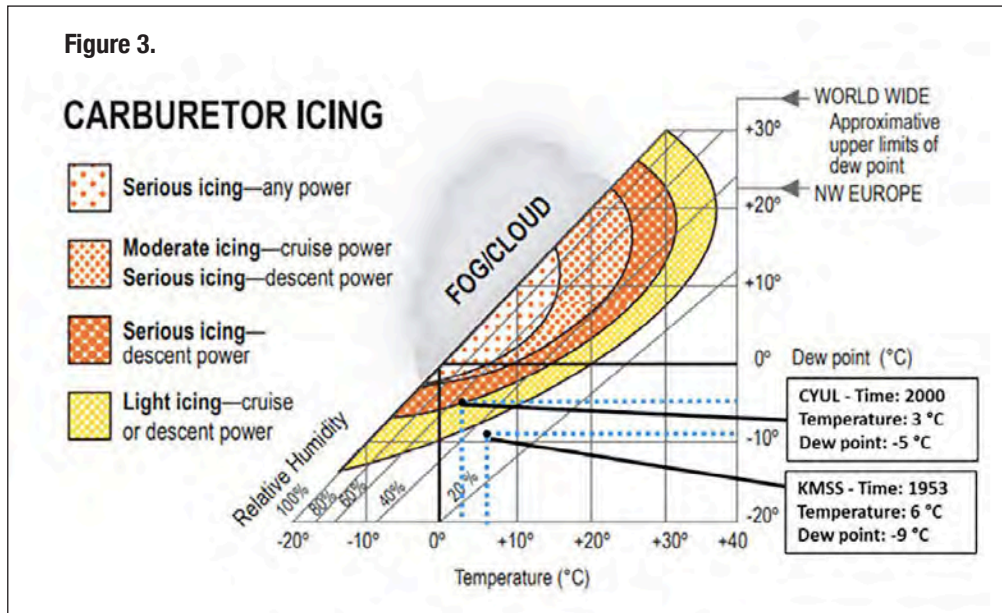
Carburetor icing potential based on ground-level weather conditions near Montréal/Pierre Elliott Trudeau International Airport, and Massena International-Richards Field Airport.

To help determine whether atmospheric conditions are likely to produce carburetor ice, charts that compare outside ambient temperature, dew point, and relative humidity have been produced (Figure 3, above).

However, it is important to note that the formation of carburetor ice is also possible in conditions outside those depicted on the charts. Although the chart indicates that the temperature and dew point at KMSS were not conducive to carburetor icing at the time of the occurrence, it indicates that there was potential for serious carburetor icing at descent power in the CYUL area.

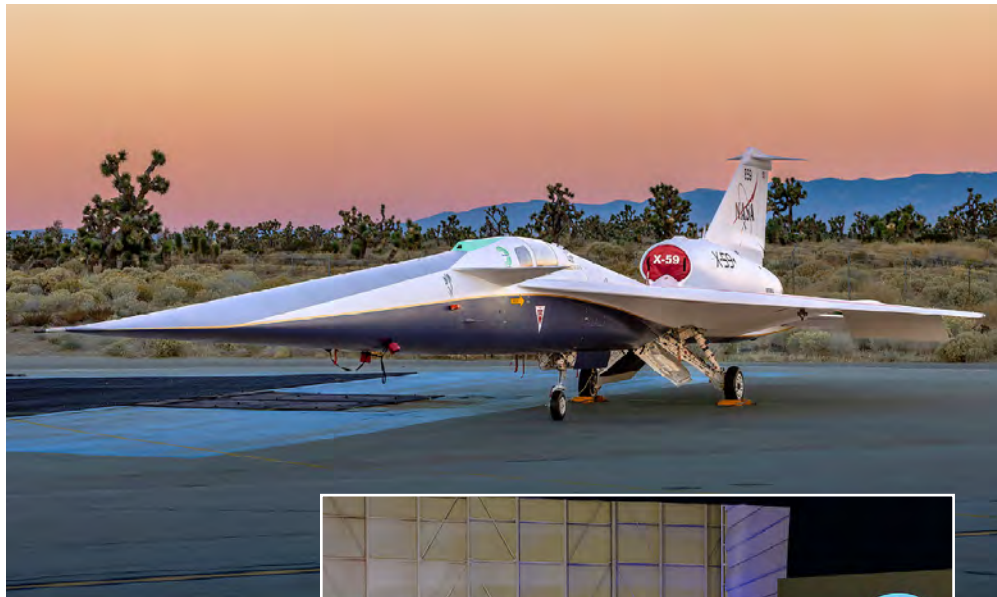
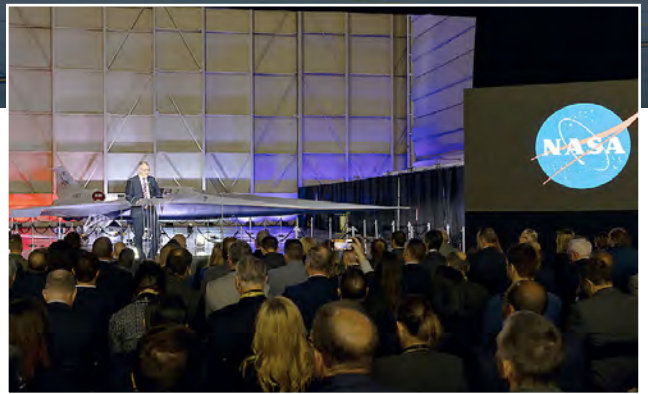
The Quesst X-59 is 99.7 feet long with

a 29.5-foot wingspan for a maximum takeoff weight of 32,300 pounds. Propelled by a General Electric F414 engine, it should reach a maximum speed of Mach 1.5 or 990 mph, and cruise at Mach 1.42 or 940 mph at 55,000 feet. The cockpit, ejection seat and canopy come from a Northrop T-38 and the landing gear from an F-16. With afterburner, its engine will provide 22,000 lbf of thrust.

In collaboration with NASA's Quest Mission, the Lockheed Martin Skunk Works team is determined to solve one of the most persistent challenges of supersonic flight – the sonic boom. To that end, Lockheed rolled out its Quest (Quiet SuperSonic Technology) X-59 experimental aircraft during a ceremony in early January in Palmdale, California. Rollout ceremonies are a long-standing aviation tradition, and in the case of the X-59 it celebrated technical advancements, collaboration and innovation that stemmed from years of research, development and production of a one-of-a-kind technology demonstrator aircraft that will reduce the loudness of sonic booms to a gentle thump.

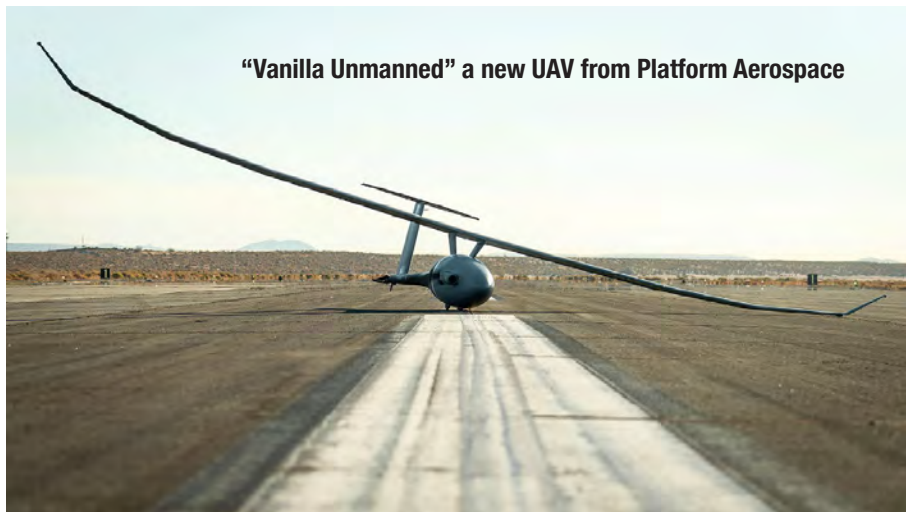
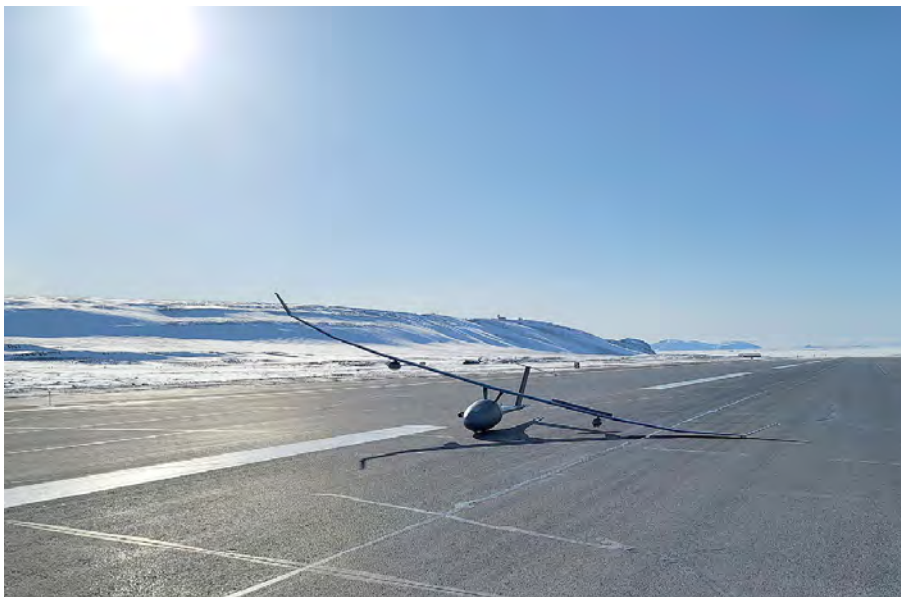
"Vanilla Unmanned" a new UAV from Platform Aerospace

Vanilla Unmanned—a long-endurance, low-cost UAV produced by American manufacturer Platform Aerospace—has now flown a mission for NASA to the inland sheet of Greenland. Thule Air Base, now known as Pituffik Space Base was the destination to which Vanilla carried a sensor provided by the Center for Remote Sensing of Ice Sheets (CRISIS).

Platform Aerospace continues to test and demonstrate environmental hardening technologies and techniques to operate the Vanilla UAV in subfreezing conditions, such as testing an anti-icing coating on the propeller. The Danish Air Authorities, Thule Space Force Base, and NASA all gave airworthiness and airspace approvals, due to the flight paths

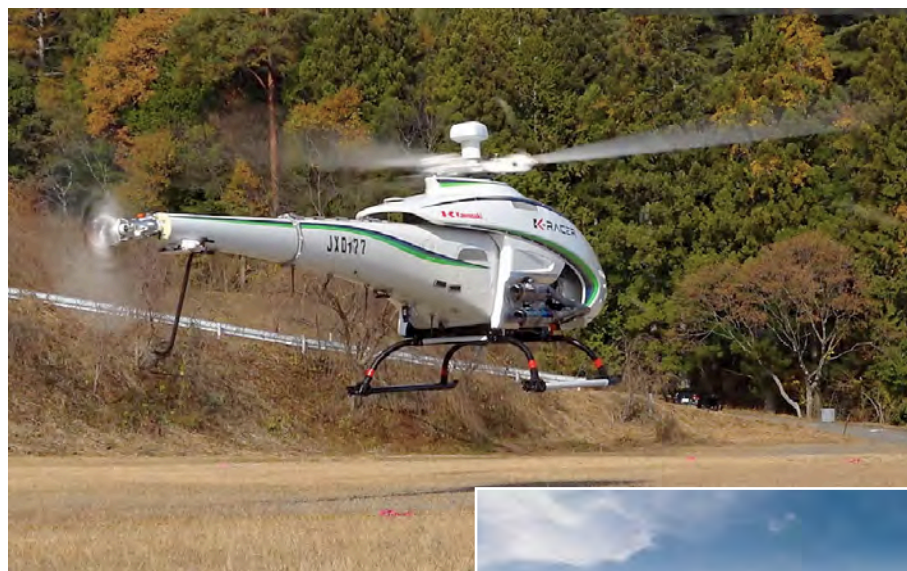
The legendary connection between motorcycles and aircraft has been an unbreakable bond basically since the earliest days of their inventions. And now Kawasaki Heavy Industries has added another chapter to the mythic tale with the ongoing development of its uncrewed K-RACER-X2 demo helicopter,

which is powered by the 300-horsepower, supercharged engine from Kawasaki's H2R hyperbike, a tarmac-burning monster motorcycle capable of a claimed 249 mph in top gear. Recently, Kawasaki reached a milestone when the K-RACER-X2 set a record by carrying a remarkable payload capacity of 440 pounds. This accomplishment marks the largest payload ever flown by an uncrewed aircraft developed in Japan.

range of 62 miles and distinctive configuration called a compound helicopter. It has a main rotor (diameter: 13 feet), and main wings and propellers on both sides instead of a tail rotor. The left and right propellers counter the torque associated with the main rotor's rotations and generate thrust to move the helicopter forward. In forward flight, the main wings share lift and reduce the load on the main rotor in order to achieve high-speed flight which is not possible for conventional helicopters.

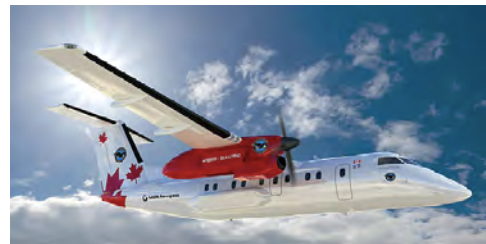
Pratt & Whitney Canada has announced the development of an advanced mobile charging unit (MCU) capable of charging high-power batteries at up to 1,500 volts, making it compatible with Megawatt Charging System standards the industry is advancing for high voltage power applications. The MCU was developed in collaboration with the National Research Council (NRC) of Canada and the Innovative Vehicle Institute (IVI) as part of the RTX hybrid-electric flight demonstrator project.

The NRC focused on the hardware design, assembly, testing and delivery of two charger units, which will be used on the hybrid-electric flight demonstrator project. The charger's bidirectional capability enables it to both charge and discharge batteries, which creates opportunities to recycle unused energy back into the electrical grid.
