# AirMaintenance

The Magazine for Aircraft Maintenance Professionals

December-January 2021  
Volume 19/Issue 4

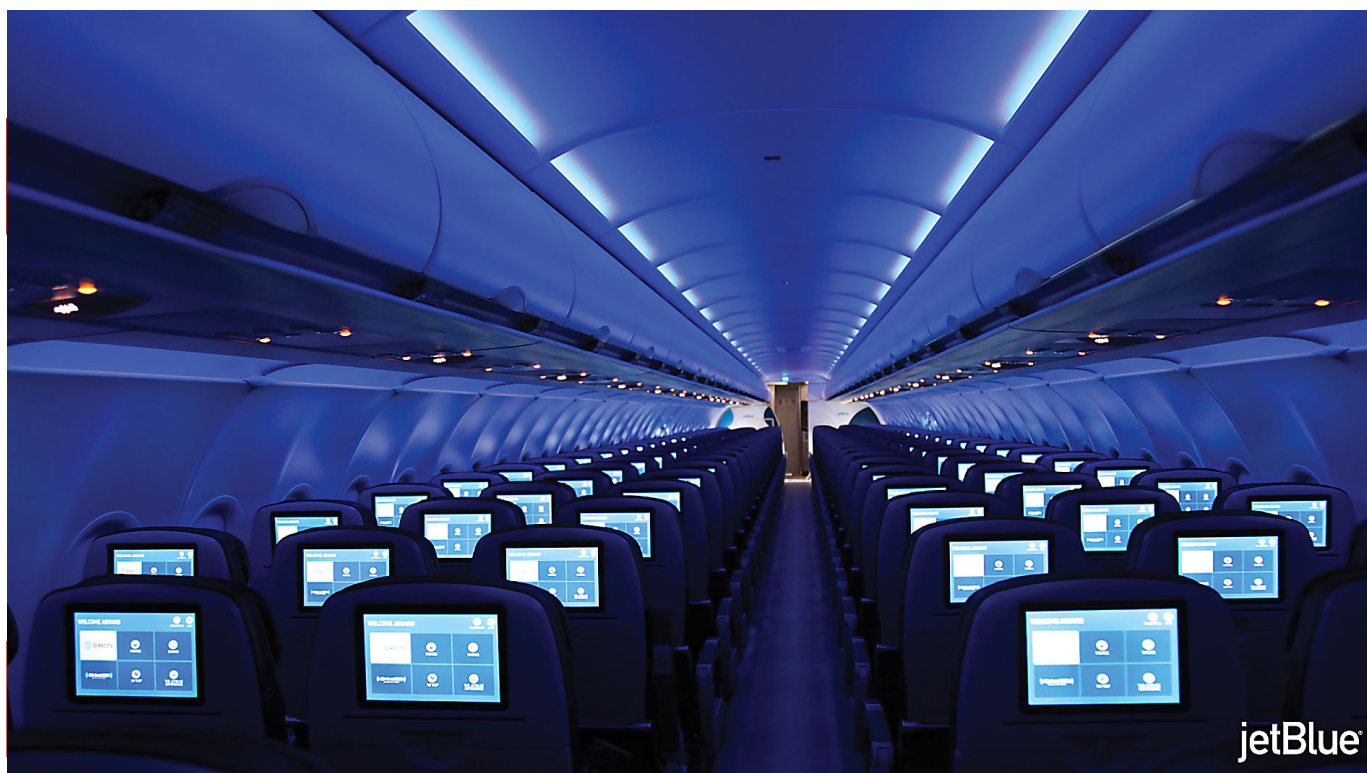
**Above:** LED cabin lights, which can be programmed to shift in brightness, warmth, and colour throughout the flight, have become common on new planes.

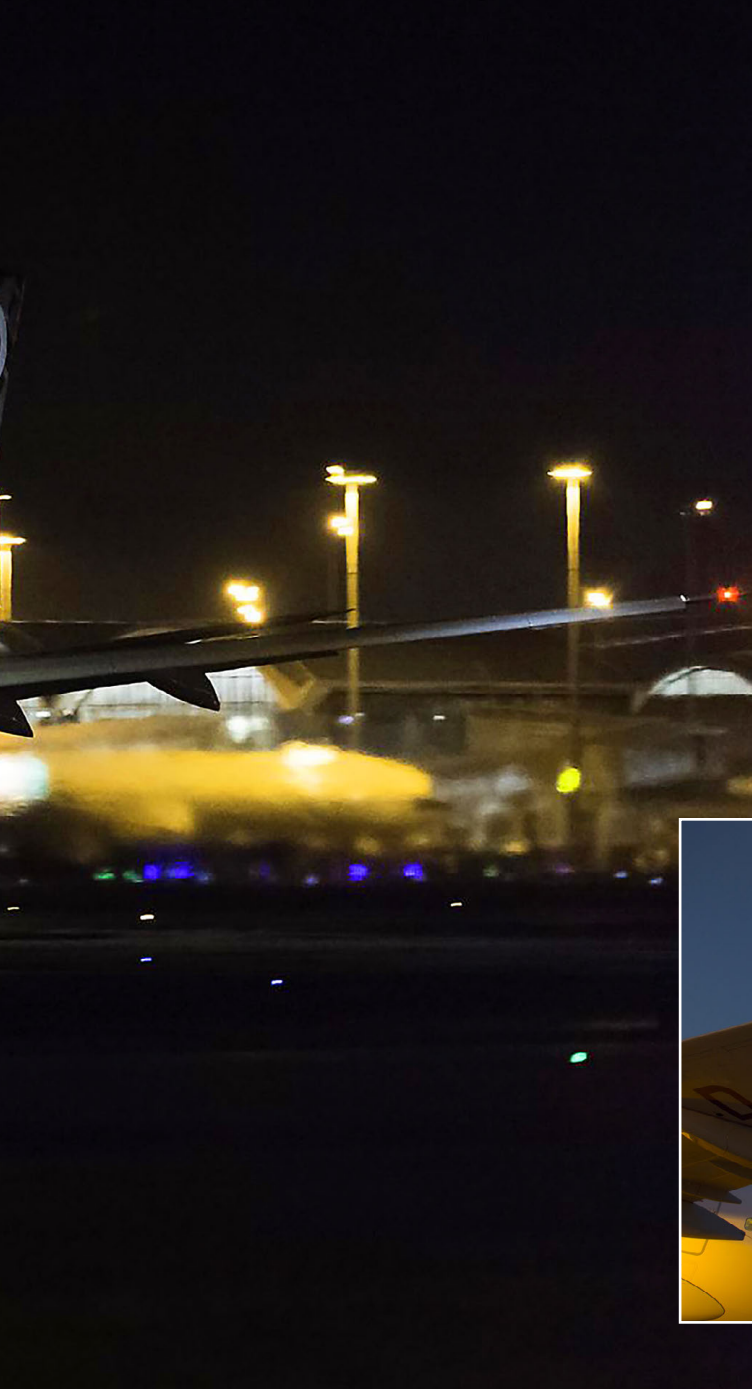
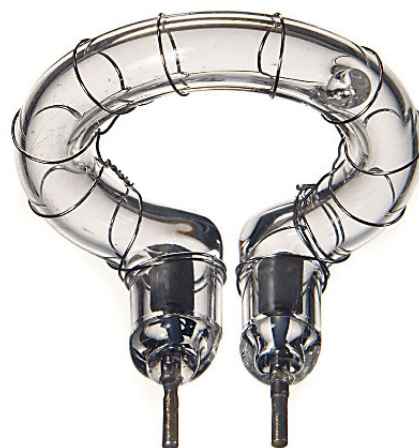
Xenon flashlamps are used primarily for wing tip and other identification lighting and may be the strobes or flashing lights on aircraft wing tips and tails.

**3. XENON FLASHLAMPS**, a standard in the market, are used primarily for wing tip and other identification lighting and may be the strobes or flashing lights on aircraft wing tips and tails. They produce light by passing electricity through ionized xenon gas at high pressure and are used on both

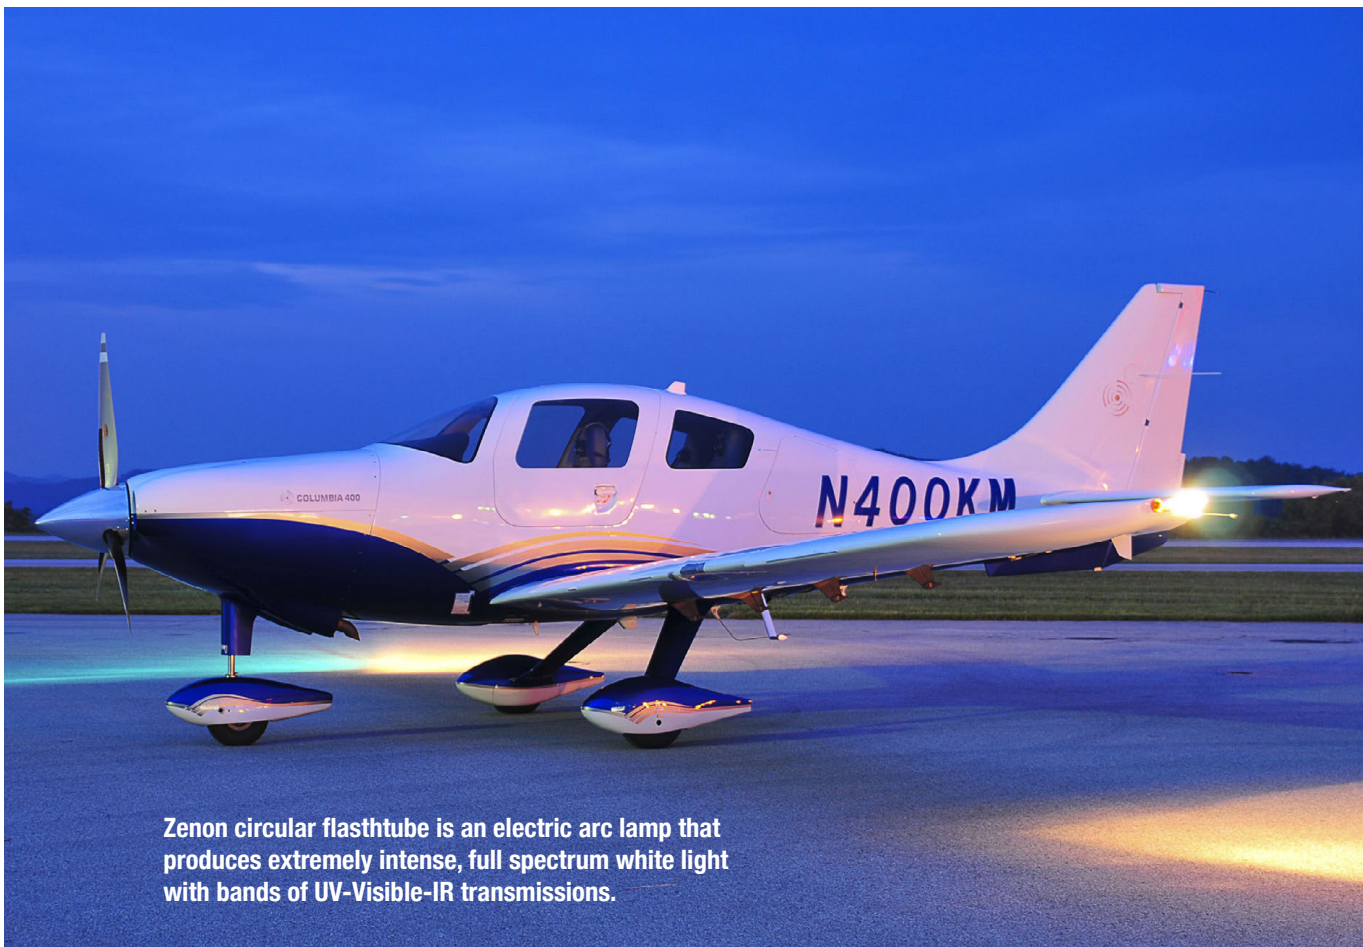
**Xenon circular flashtube is an electric arc lamp that produces extremely intense, full spectrum white light with bands of UV-Visible-IR transmissions.**

older and newer types of aircraft. The life of the xenon lamp depends on the number of flashes emitted. They typically last between five and ten million flashes, depending on the usage of the plane. Their costs are in range with halogen lamps and xenon flashlamps also are available through OEM parts catalogues. However, not all xenon flashlamps are manufactured the same. Be sure to check that the manufacturing process of the lamp is strictly controlled to ensure there is no exposure to moisture and foreign elements and that they are produced in clean room-like environments.

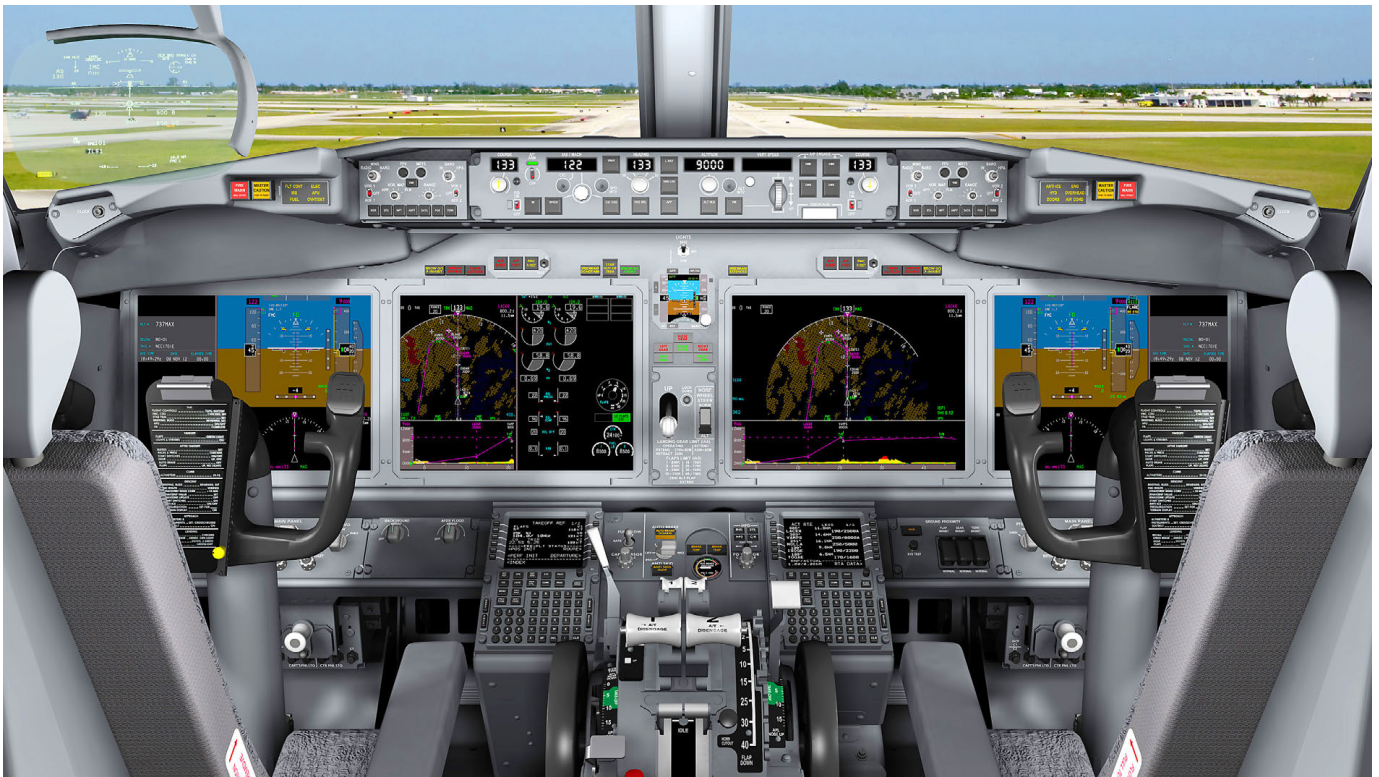
**Boeing 737 MAX Flight Deck Displays.**

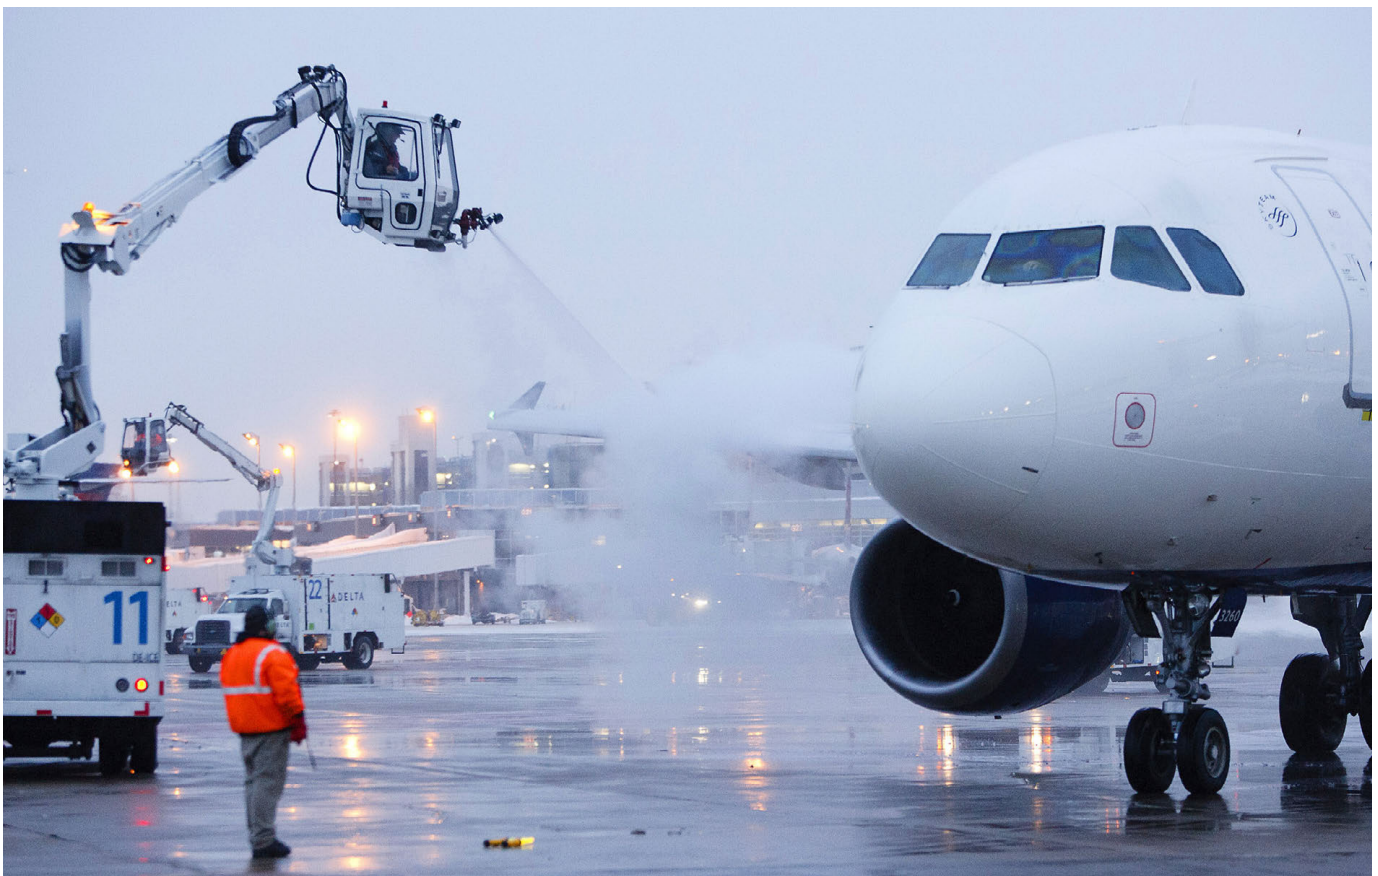
Typical de-icing fluid is a mixture of propylene glycol and water heated between 160 and 180F.

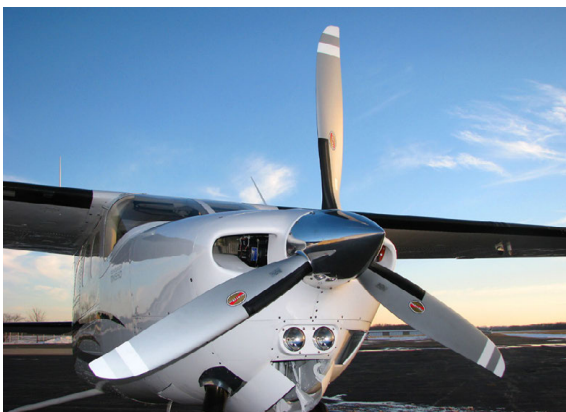
**Thermal-electric deicing propeller systems use either heating wires or a layer of etched foil embedded inside rubber boots, which are attached to the inner part of the leading edge of each propeller blade.**

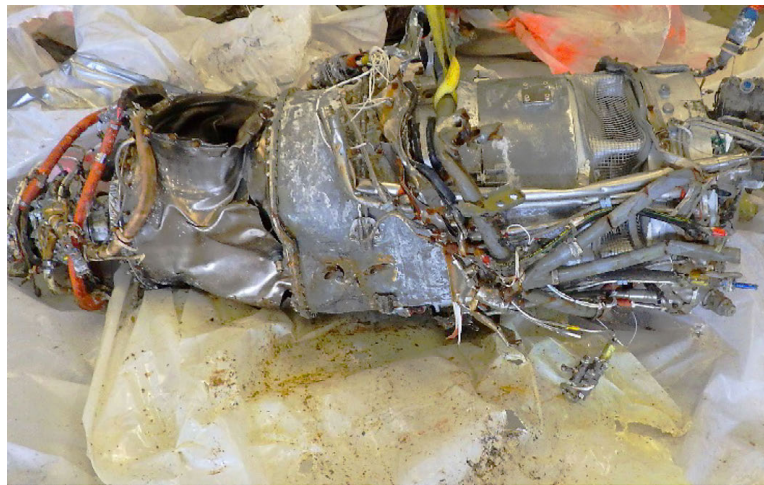
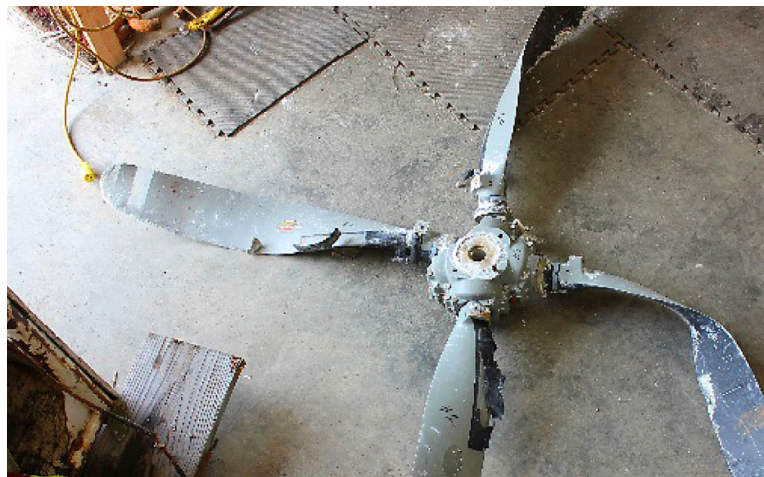
**Above: The remains of the left engine.**
